# Improving the Ecological Character of Moulting Lagoon and Apsley Marshes: Long Point and The Grange Hydrological Restoration Plan

Report to NRM South

23<sup>rd</sup> February 2022

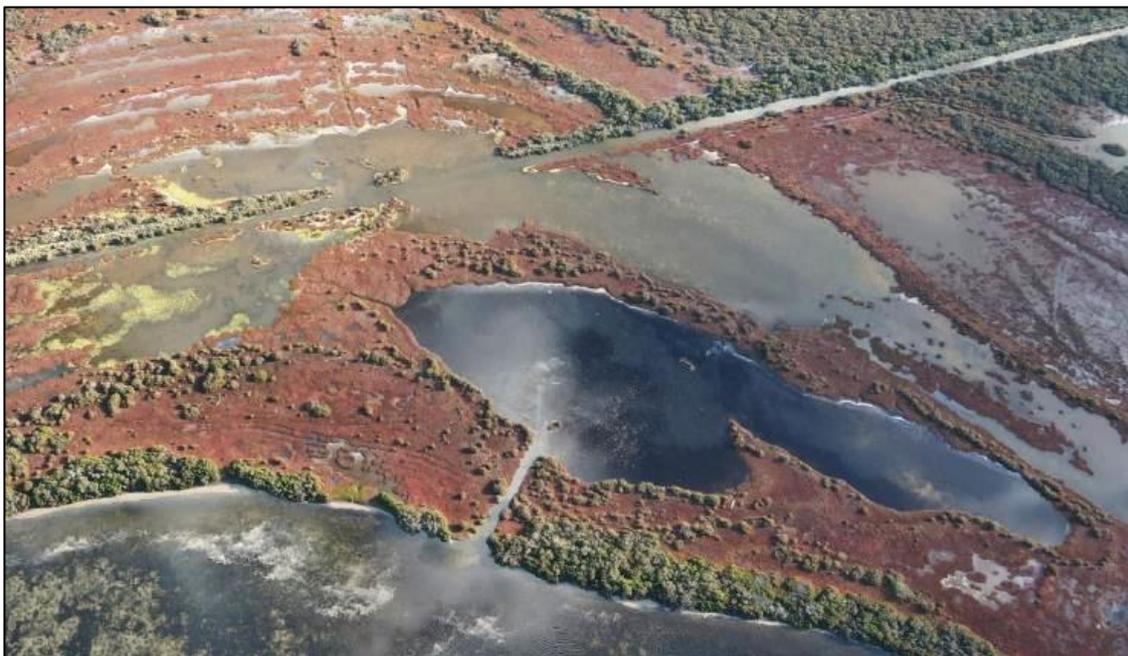
**Figure 10:** The small channel on the edge of Moulting Lagoon into a wetland on Long Point c. mid-1990s. Note that this image is looking south-west, with a portion of the main eastern (L-shaped) levee in the background.

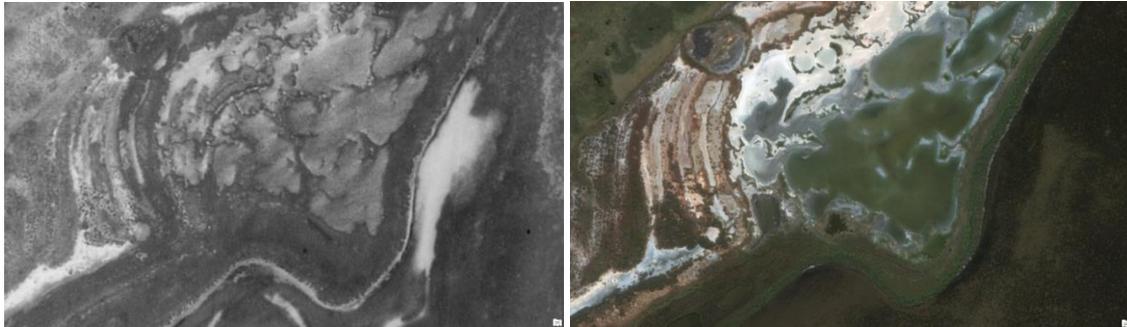
Comparison of aerial imagery shows displacement of saltmarsh by mudflat/open water in some areas (**Figure 29**). This trend is only observable in a few, low-lying locations across Long Point. Note the shoreline has remained consistent over time, despite the observed recent increase in coastal inundation.

*a) low-lying area northeast of Round Hole and southeast of Gum Tree Hole, Long Point*

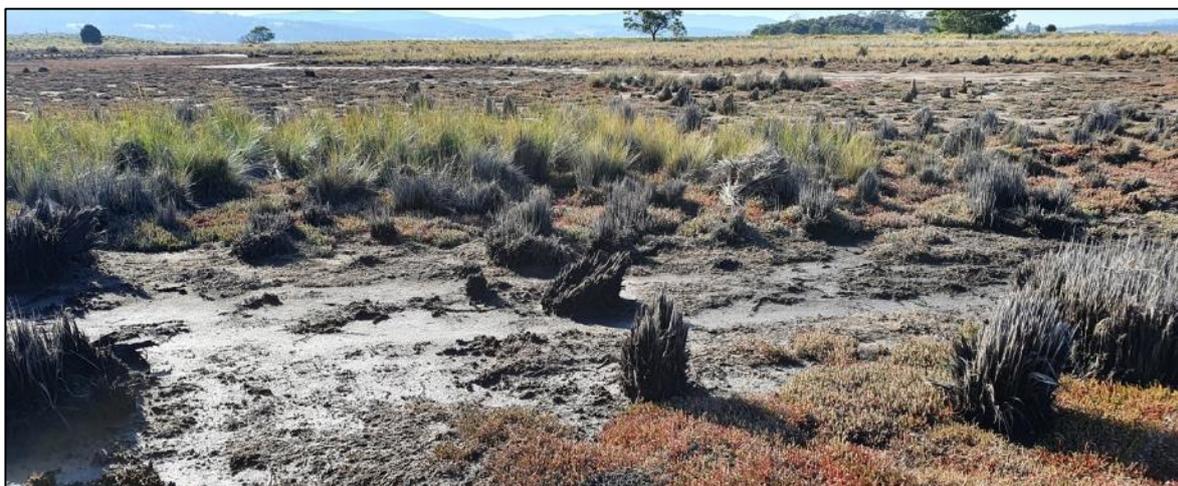
**Figure 30:** Variability in health of Thatching Grass (*Gahnia filum*) at Long Point, corresponding with elevation. Here, the Thatching Grass growing on a slight rise is persisting while the species is dying out of the adjacent lower areas.

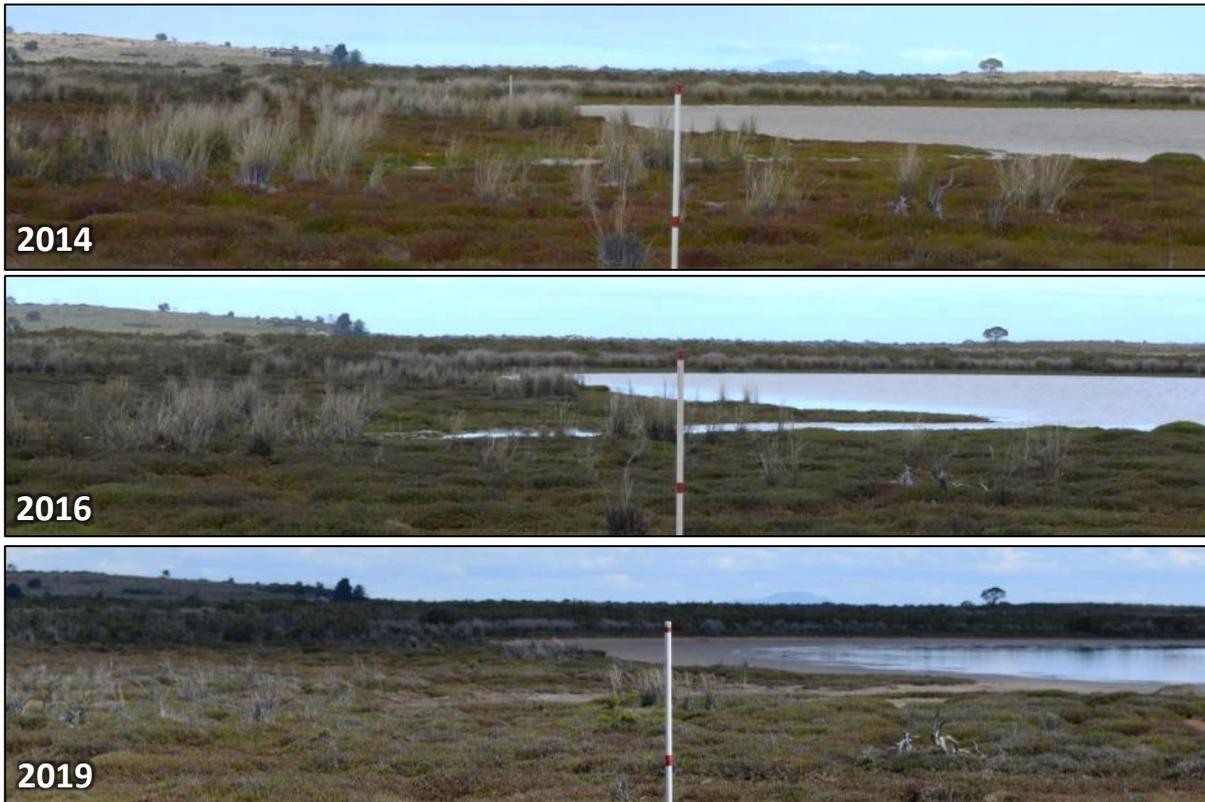
**Figure 31:** Thatching Grass (*Gahnia filum*) dieback between 2014 and 2019 at Long Point.  
Photos: Tasmanian Land Conservancy

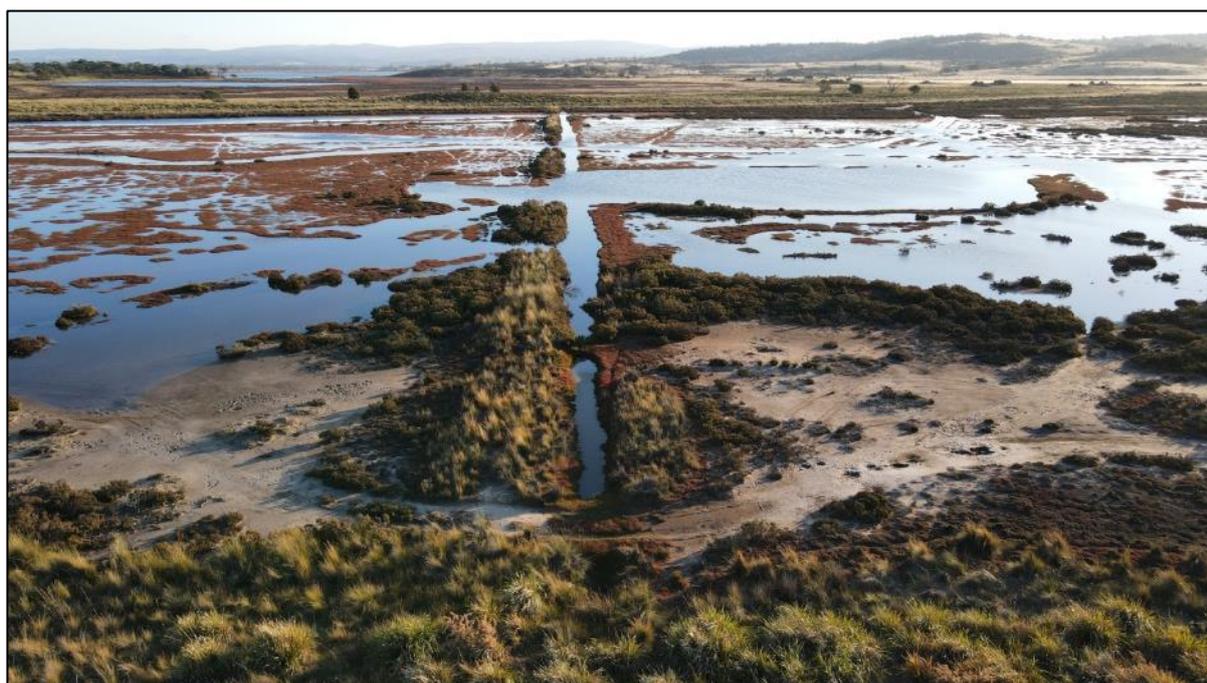
**Figure 32:** Looking south-west over the shorter, western levee bank – also showing multiple locations where it has been breached in the approximately 150 years since it was constructed. Photo: Mark Bachmann

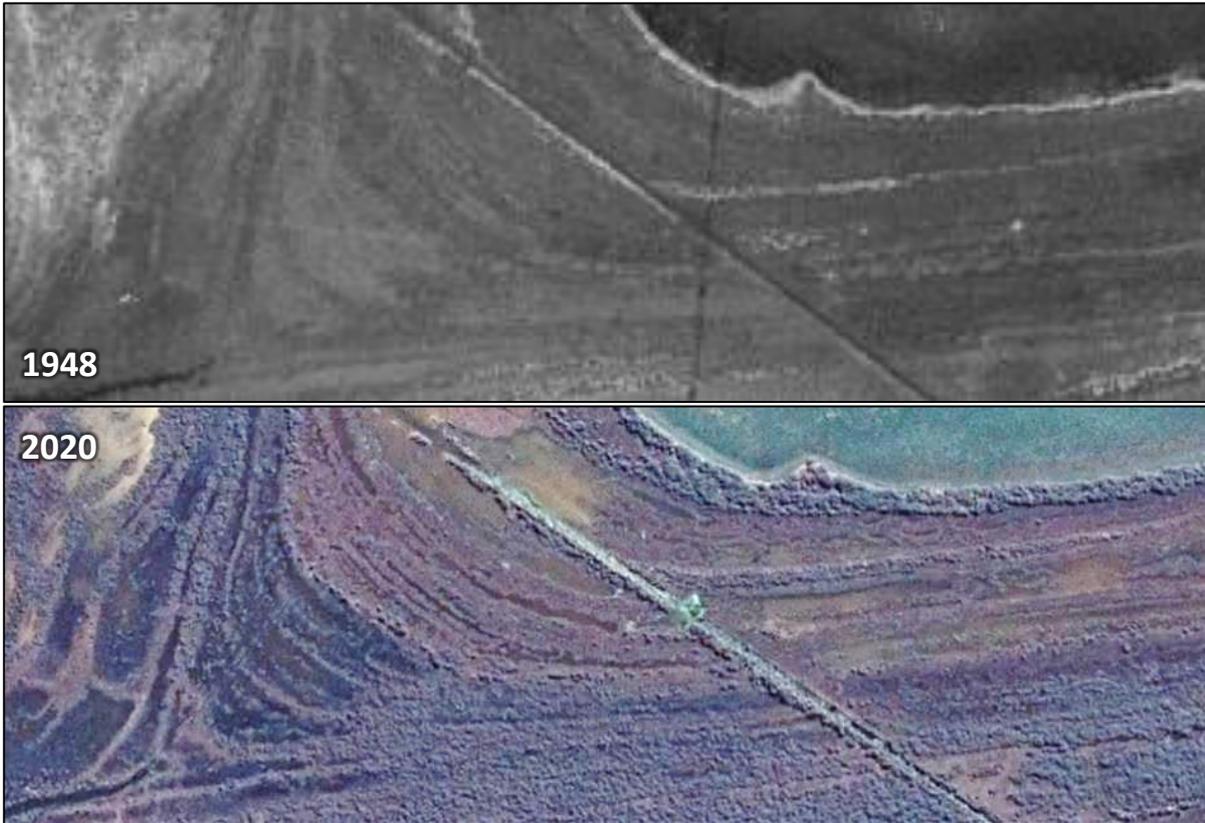
**Figure 33:** The northern end of the eastern levee bank at Long Point. This is where natural patterns visible in the bands of saltmarsh vegetation, growing under high tidal influence, have been interrupted by the levee bank altering water regime. These changes in vegetation were already apparent in the 1948 image, indicating the levee bank was long established by that time.

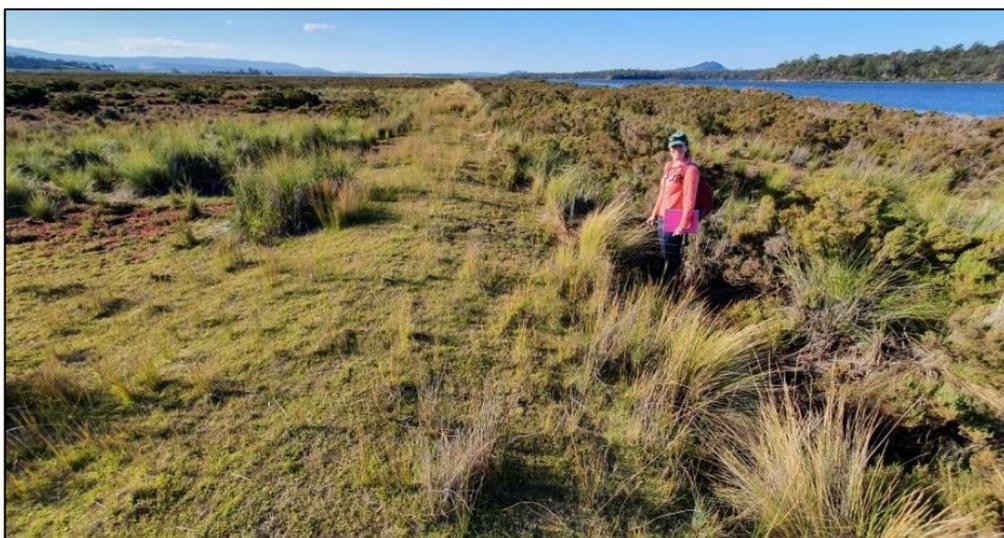
**Figure 34:** Looking north along the eastern levee bank at Long Point. Cath Dickon from the TLC is standing in the channel that was created when the levee was built, to indicate its depth. Note the significant difference in vegetation either side of the bank, where the natural gradient of the saltmarsh and vegetation ecotones have been disrupted. Photo: Mark Bachmann

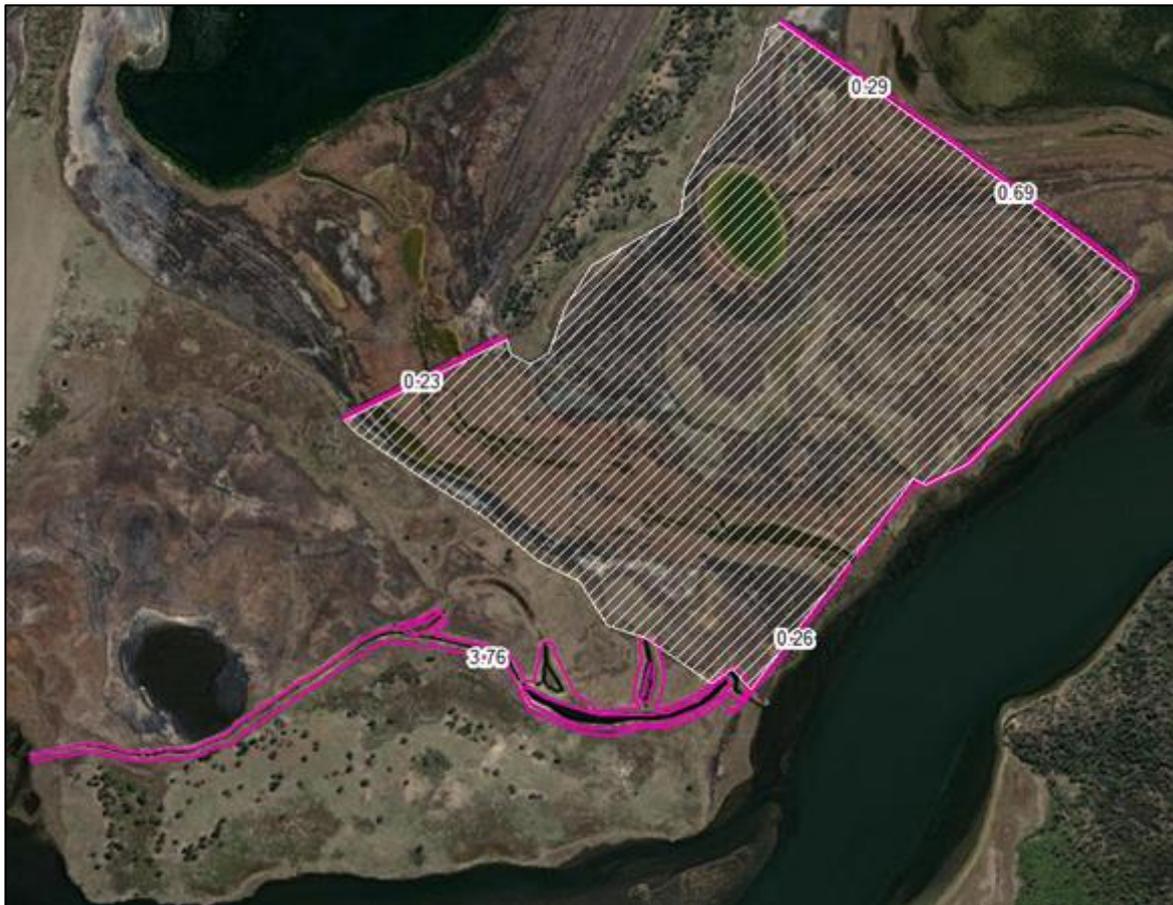
**Figure 35:** Artificial drainage footprint at Long Point. Direct impact areas are marked pink, with hectares shown. The 80 hectare area potentially impacted by broader hydrological changes is hatched.

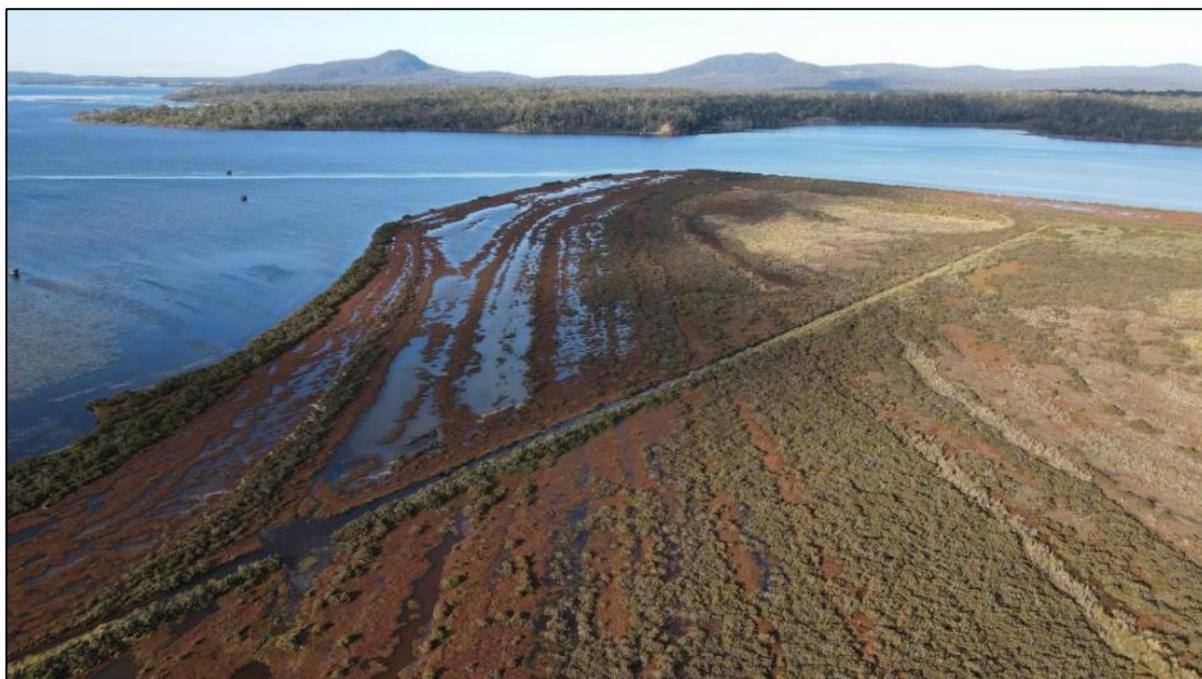
**Figure 36:** The northern arm of the eastern levee at Long Point, showing the change to natural landform. Photo: Mark Bachmann

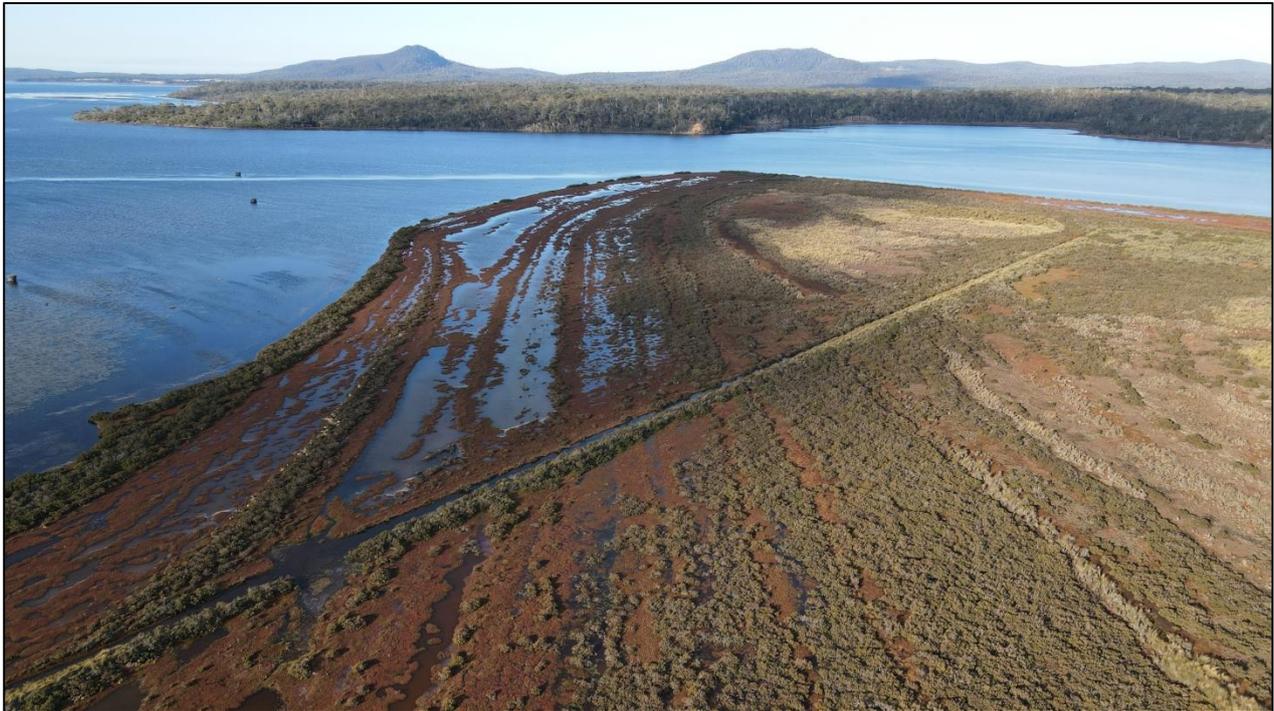
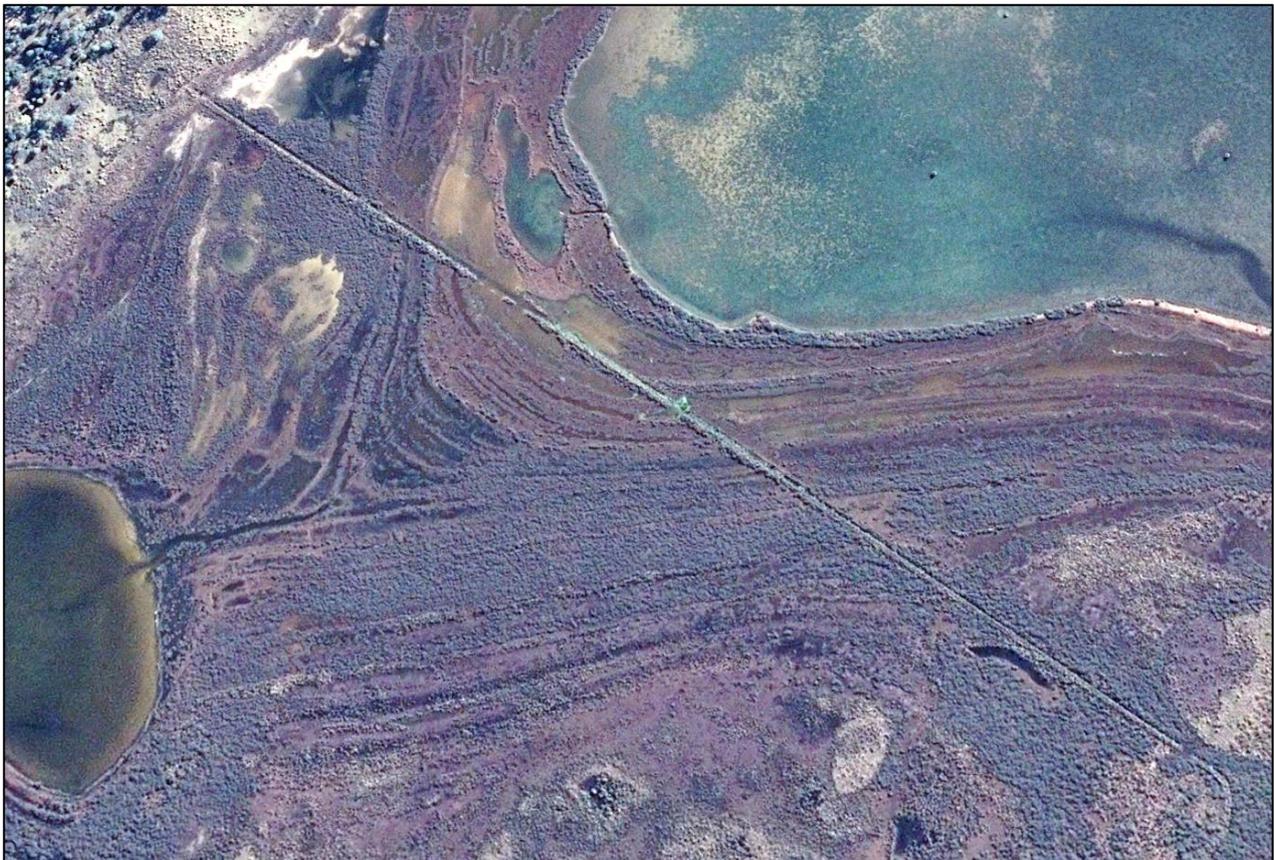
**Figure 52:** The northern arm of the eastern (main L-shaped) levee, Long Point – current conditions (oblique [Photo: Mark Bachmann] and aerial images) showing works area and disturbance footprint.

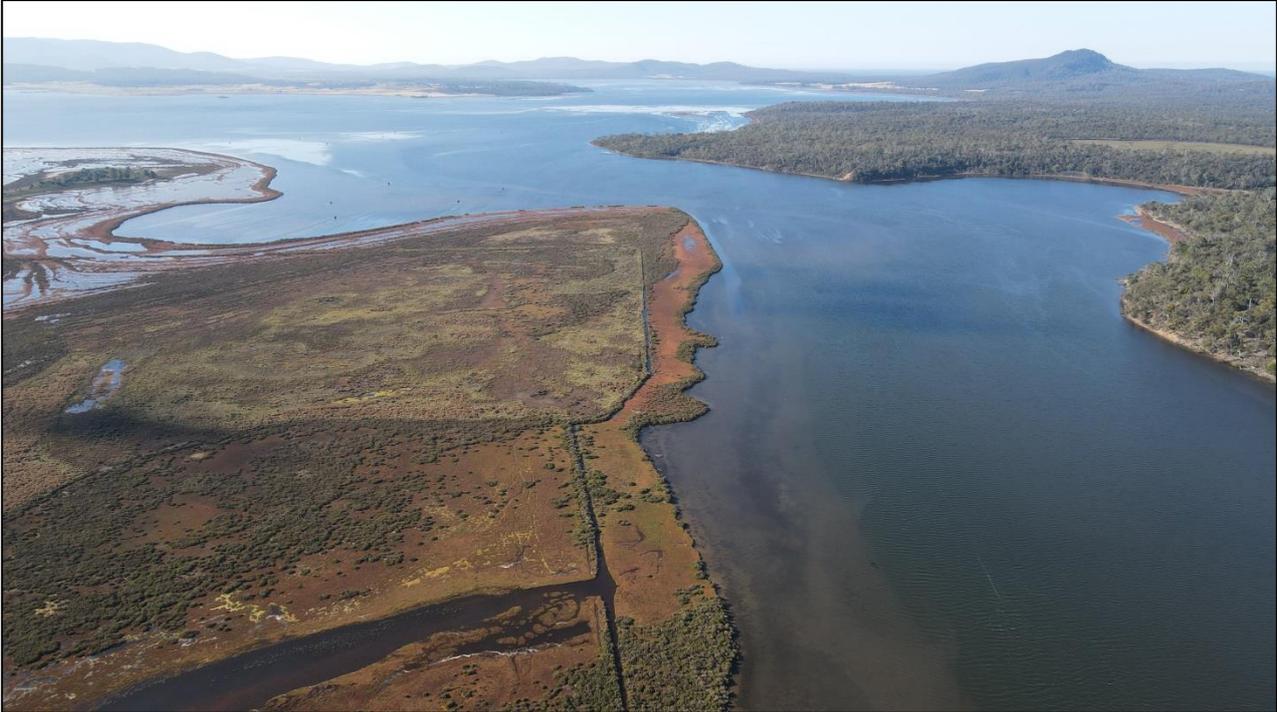
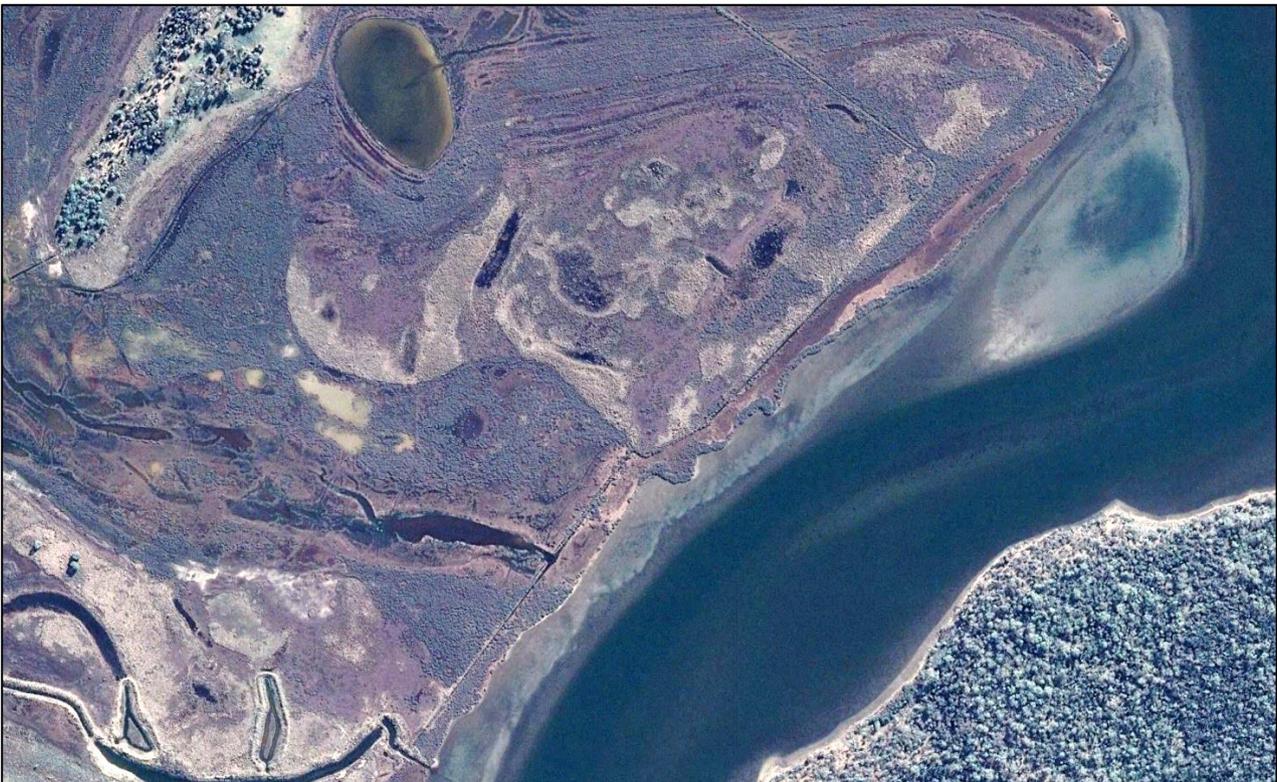
**Figure 53:** The eastern arm of the eastern (main L-shaped) levee, Long Point – current conditions (oblique [Photo: Mark Bachmann] and aerial images) showing works area and disturbance footprint.

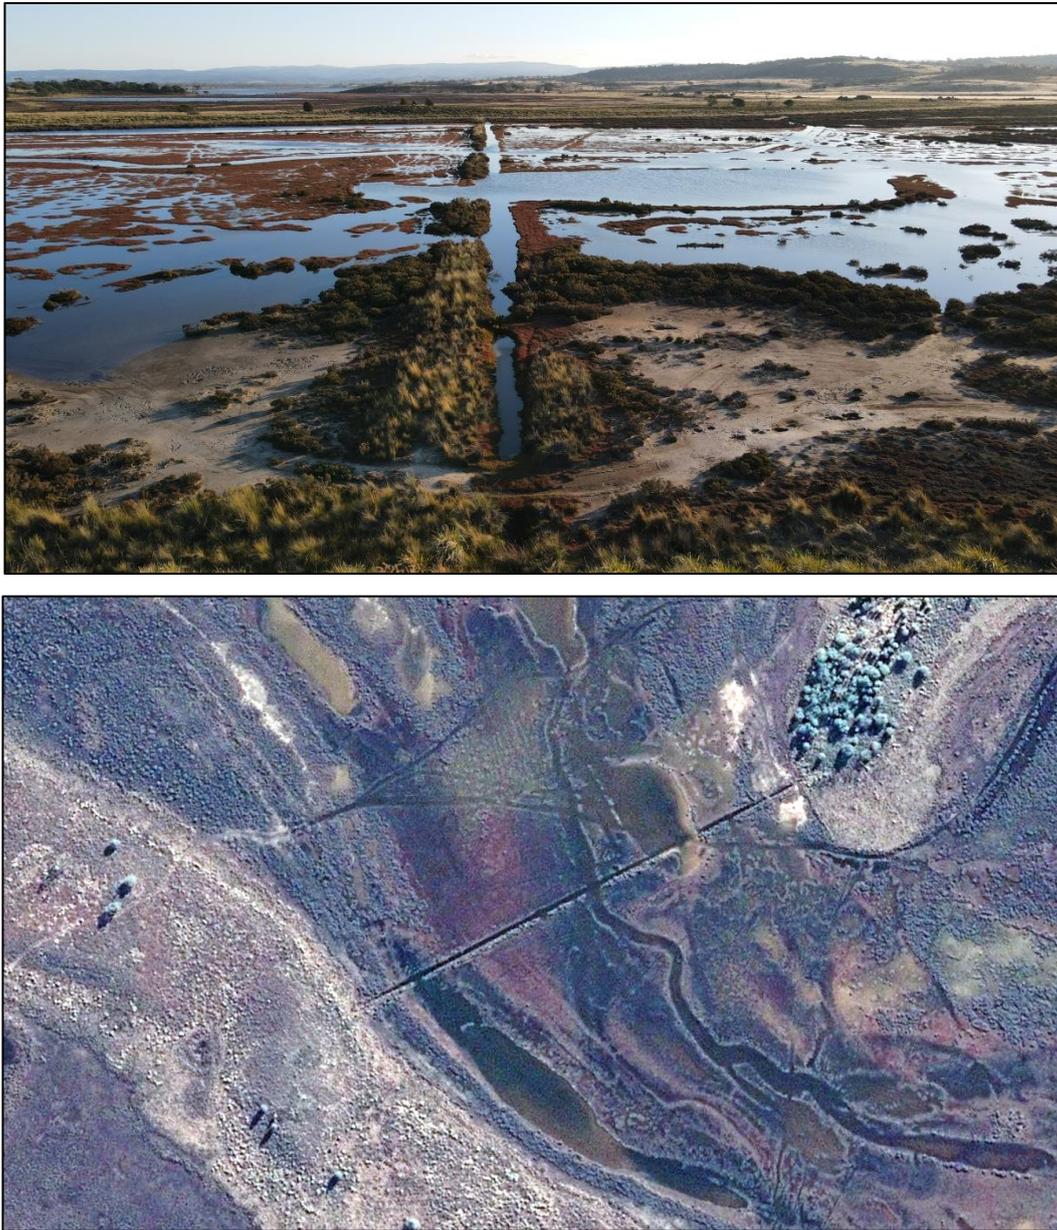
**Figure 54:** Western (minor) levee, Long Point – current conditions (oblique [Photo: Mark Bachmann] and aerial images) showing works area and disturbance footprint.
