Ecohydrological Restoration Assessment of the Aldinga Washpool

Report to the Green Adelaide Board

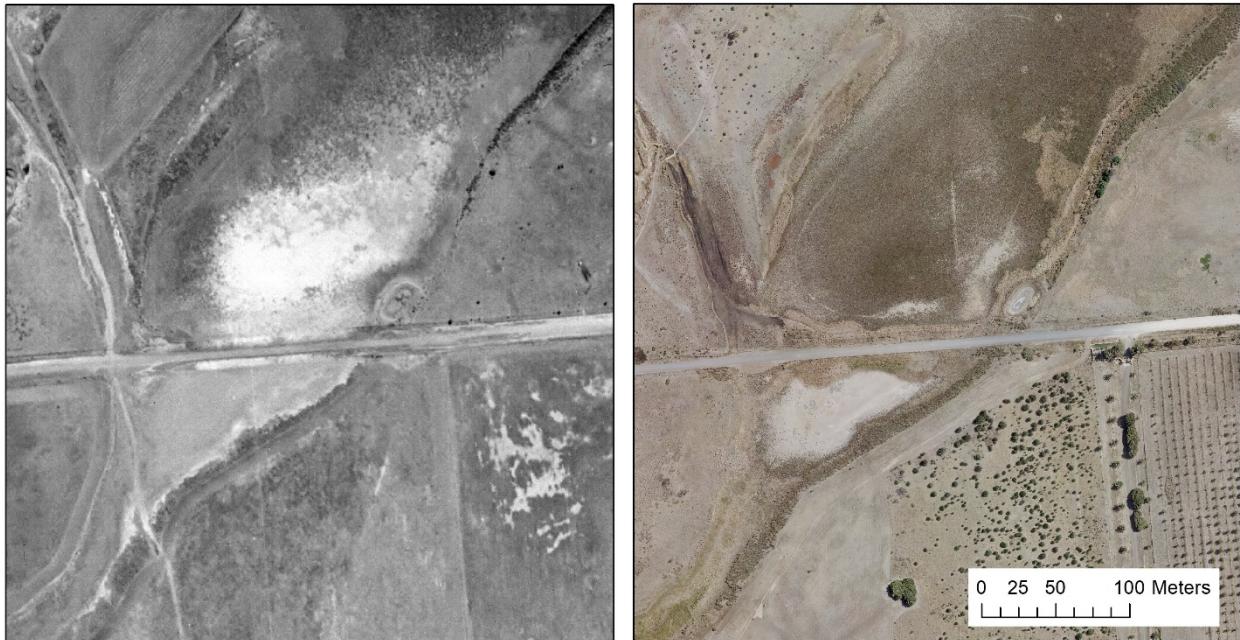
Figure 8. The Washpool in the vicinity of Button Rd in 1949 (left) and 2020 (right), showing displacement of open mudflats (white areas) by samphire (dark areas) in the intervening period.

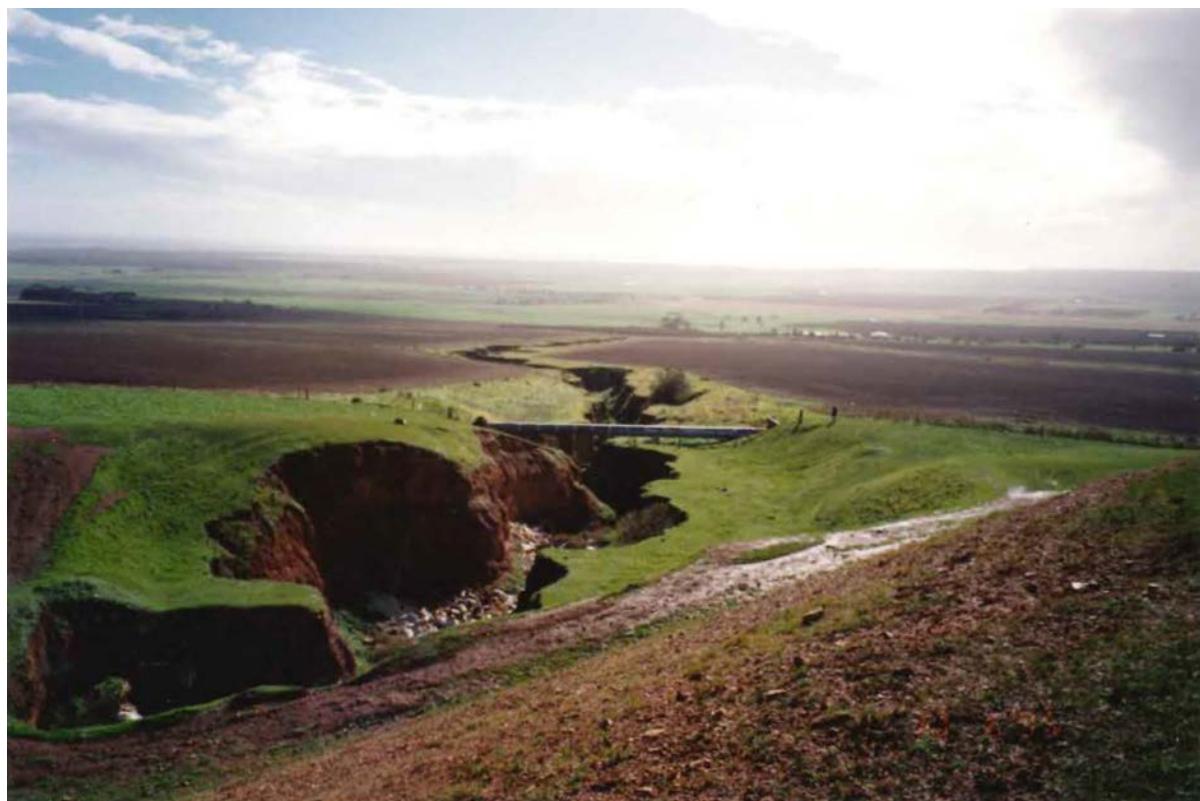
Figure 10. Erosion gully in the Washpool catchment (source: Wegener 1995).

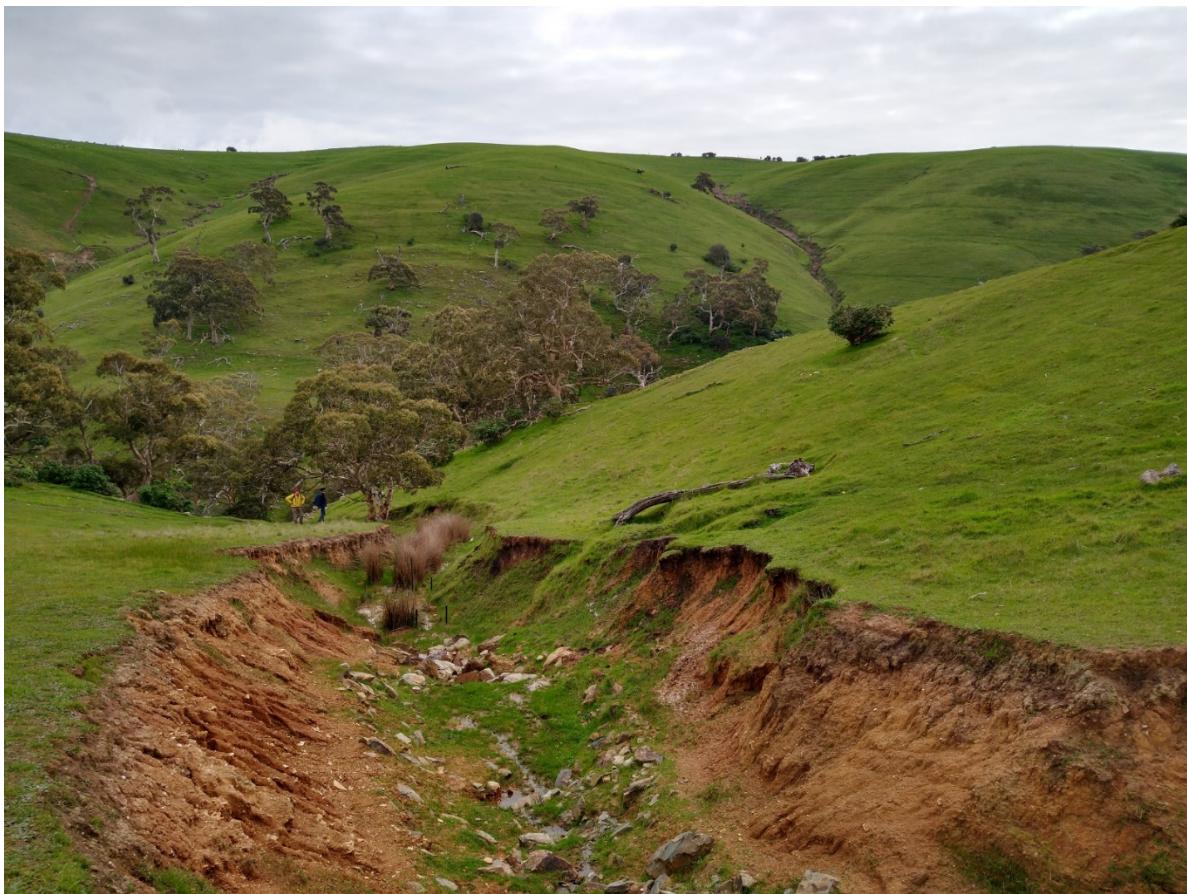
Figure 11. Erosion gully in the Washpool catchment near Louds Hill, July 2019 (photo Maarten Ryder, WHFLG).

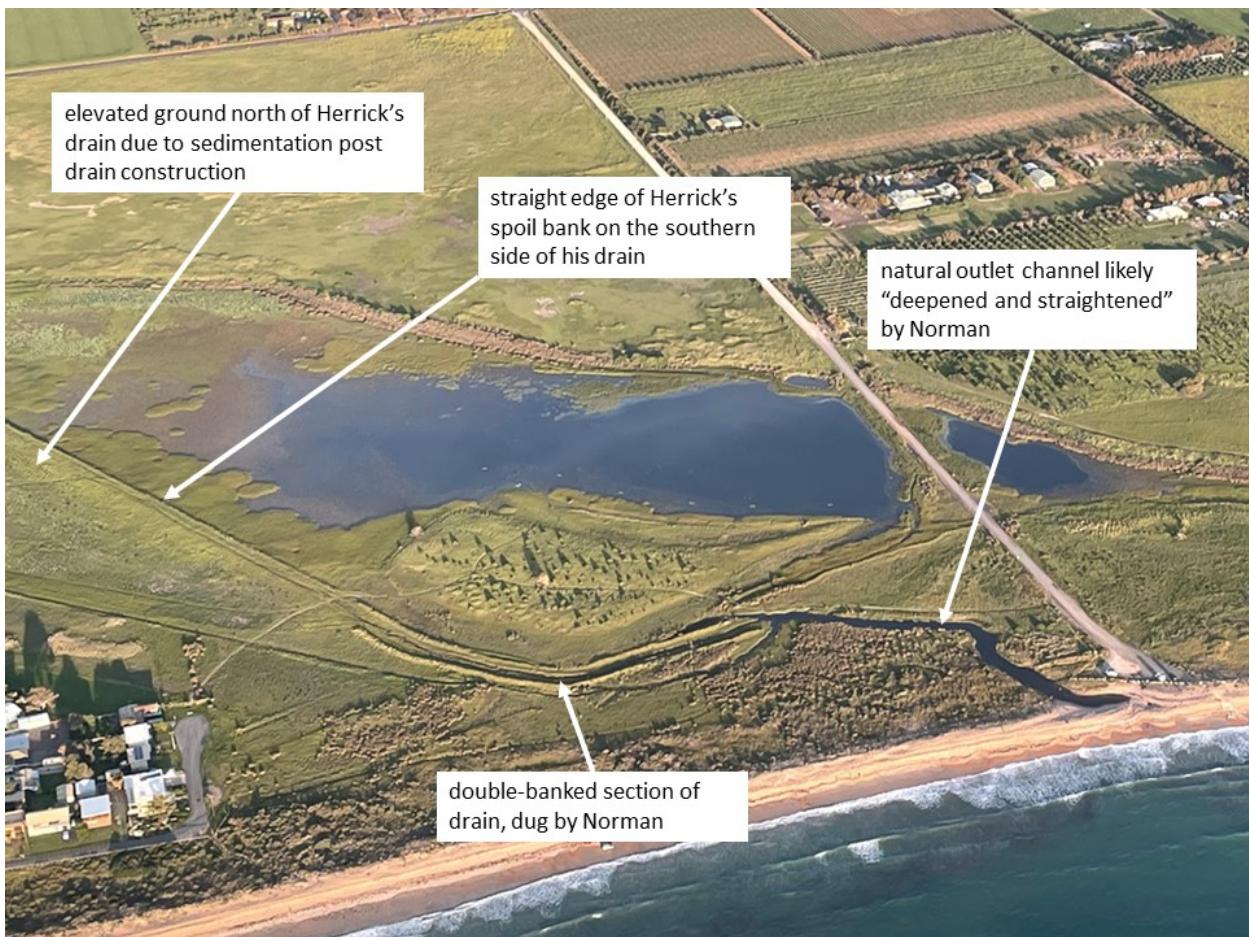
Figure 16. Oblique aerial image of the Washpool, 8th October 2021, with legacy effects of Herrick and Norman’s c.1950 drain highlighted (photo: Coast Protection Board / Coast and Marine Branch, DEW).

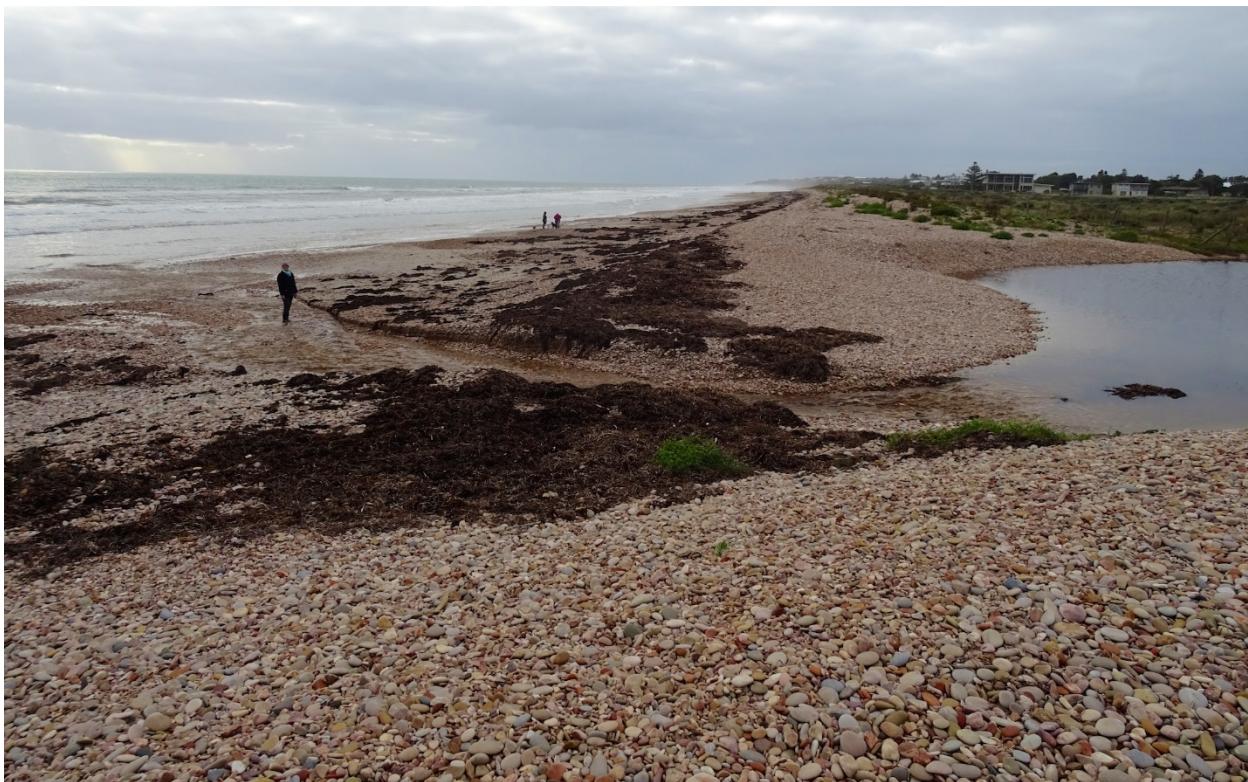
Figure 19. The Washpool outlet channel showing the pebble embankment lowered by a period of high outflows, 17th July 2017 (photo: Chas Martin (FoAS 2022)).

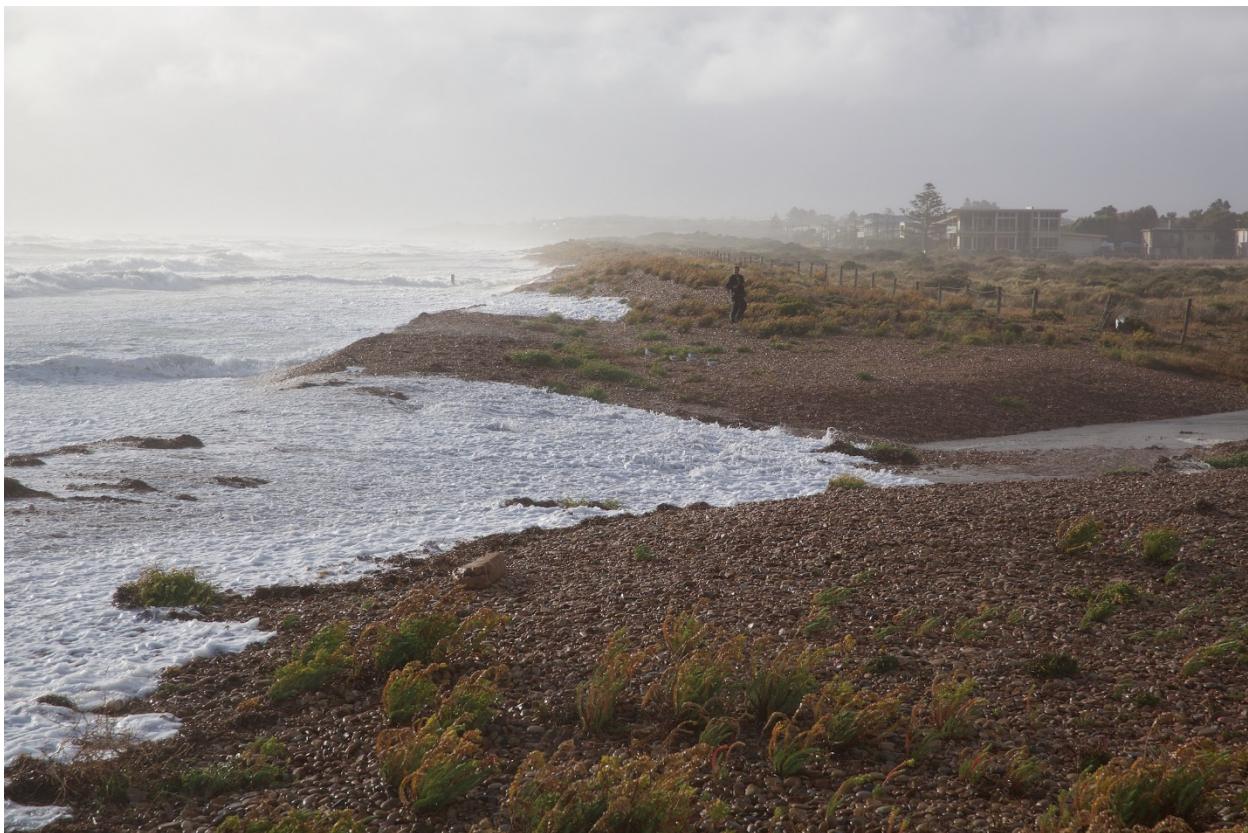
Figure 21. The Washpool outlet showing reverse flow of seawater into the outlet channel, 9th May 2016 (photo: Julie Burgher (FoAS 2022)).

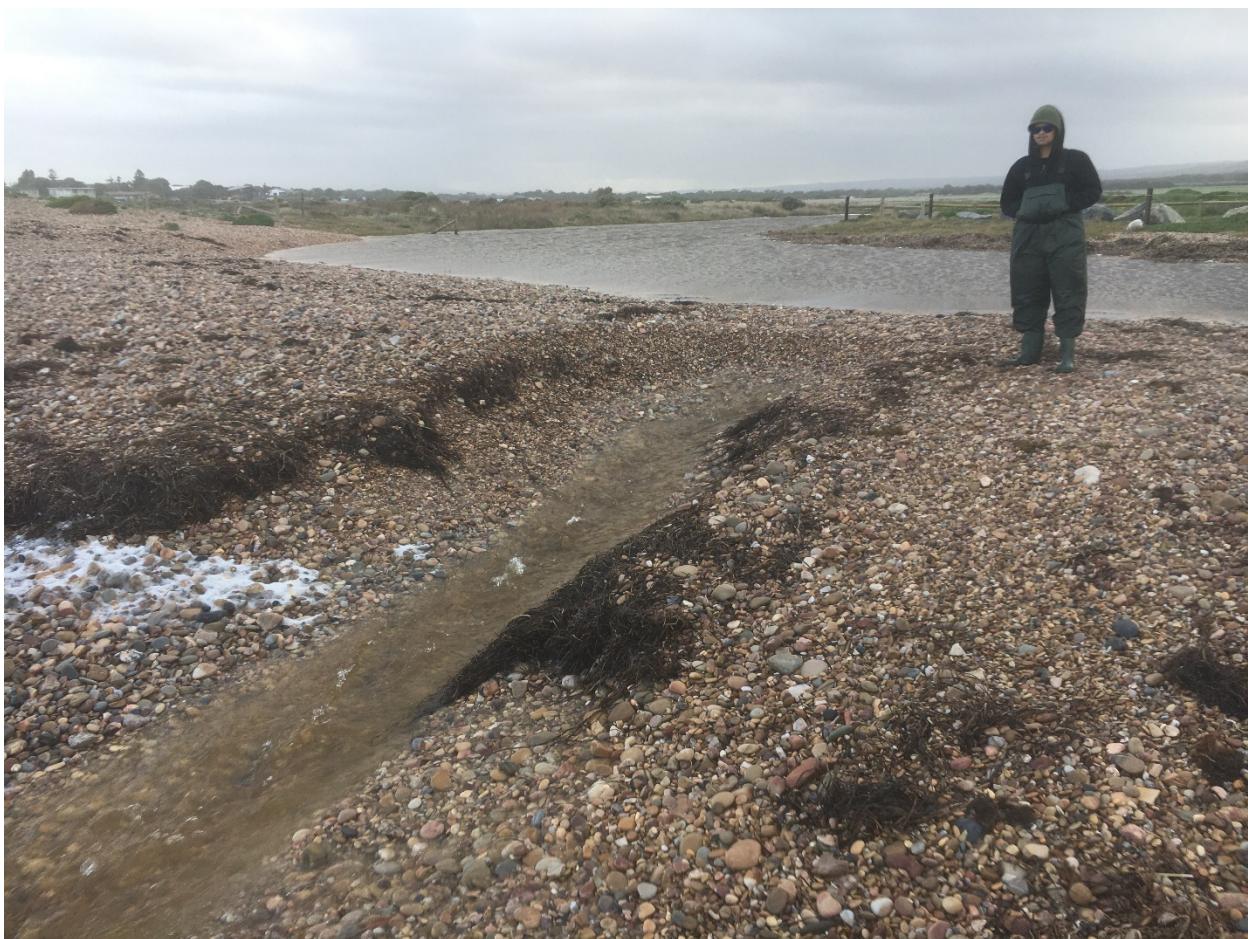
Figure 23. The Washpool outlet on 17th July 2021, looking upstream, showing the pebble embankment in place but leaking, with water re-emerging on its beach-facing side to form a fast flowing stream. Onlooker is Drew Kilner (photo: Ben Taylor).

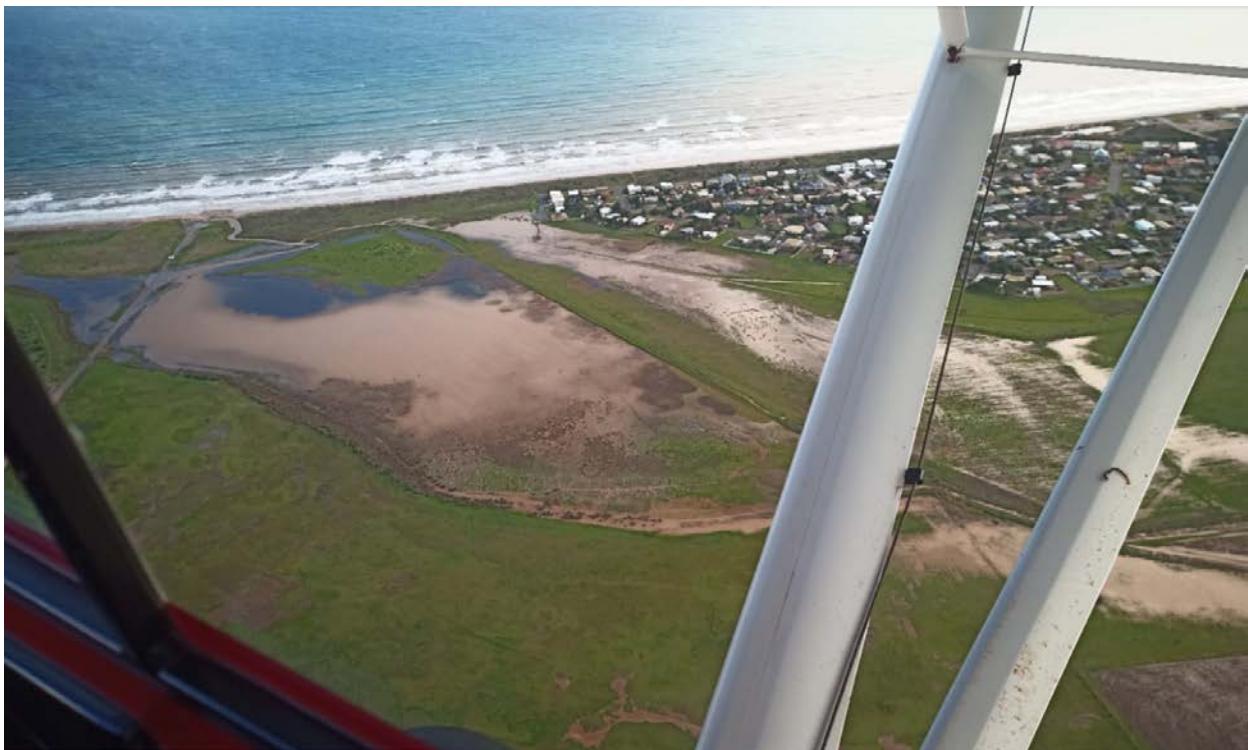
Figure 30. Highly turbid inflows to the Washpool displacing clear water, early afternoon 21st June 2020 (photo: Stewart Bond for Willunga Hillsface Landcare Group).

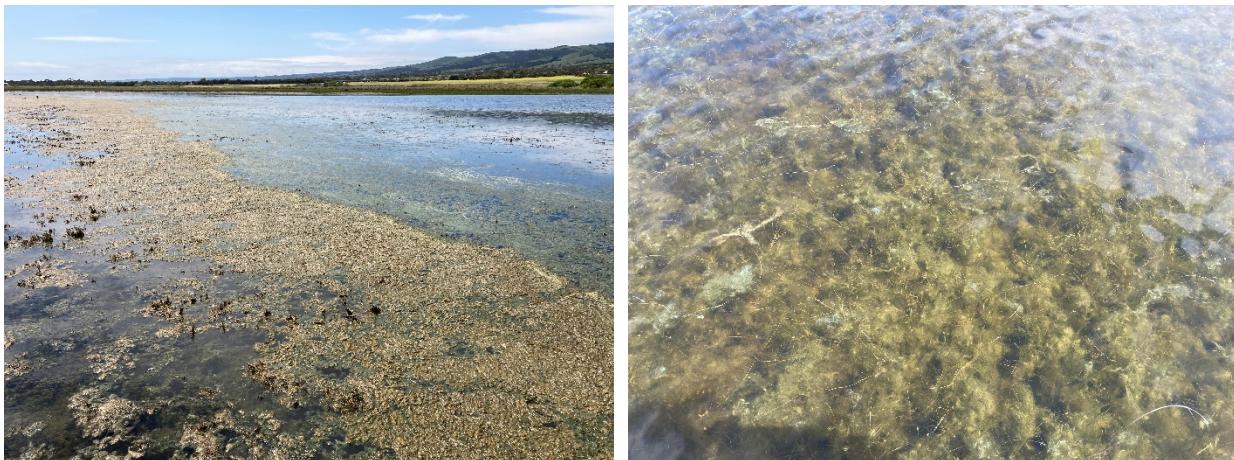
Figure 31. Dense coverage of filamentous green algae along the shoreline (left) and epiphytic algae on submerged aquatic vegetation (right) within the Washpool, 20th October 2022 (photo: Ben Taylor).

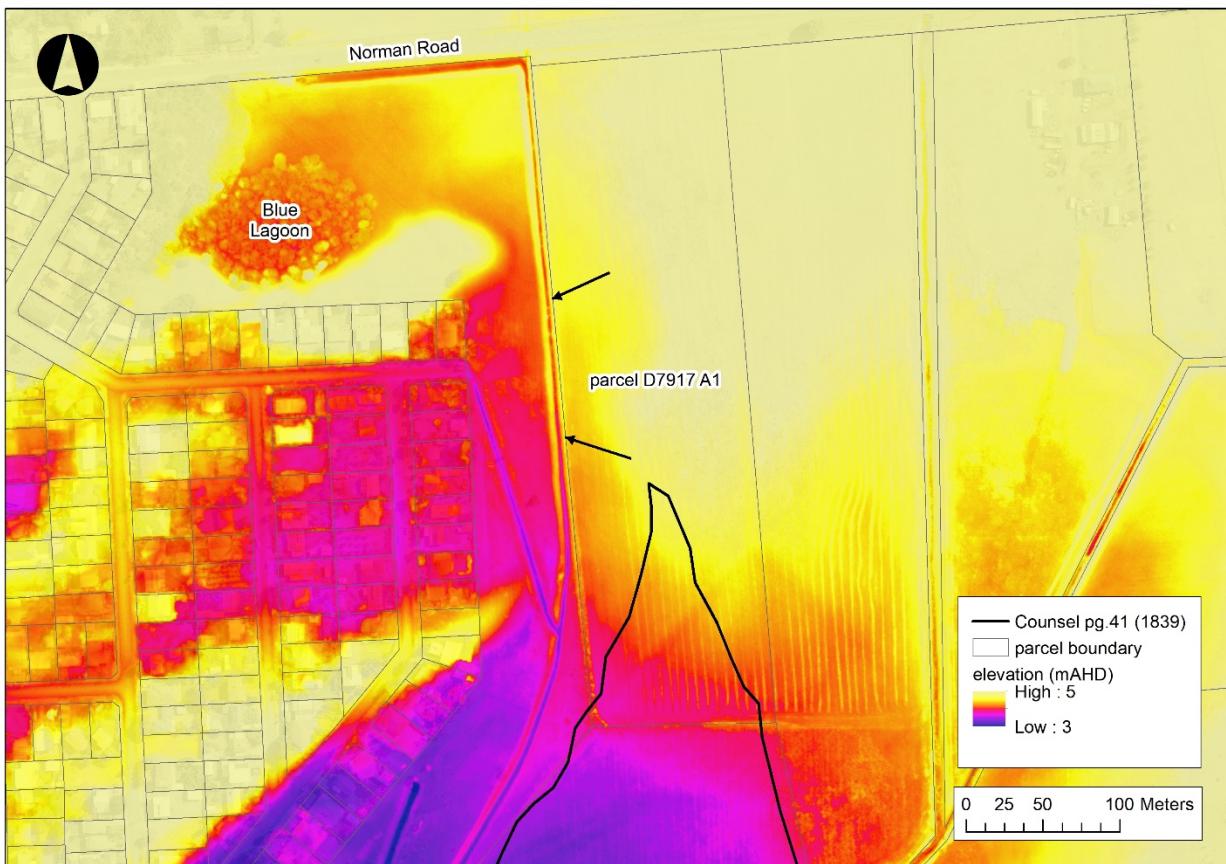
Figure 33. Topography suggestive of land reclamation within parcel D7917 A1 (indicated by black arrows). The area in question includes the northern arm of the Washpool as mapped in 1839.

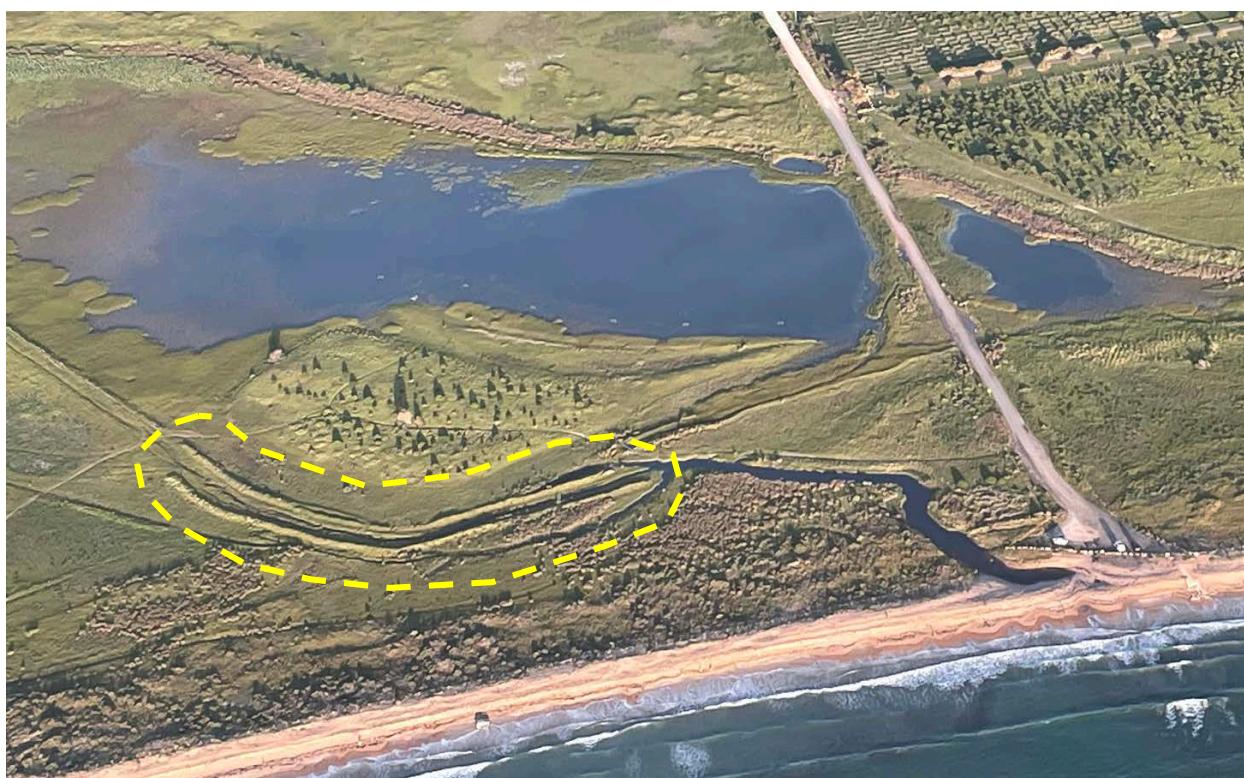
Figure 45. Oblique aerial image of the Washpool, 8th October 2021, with Norman's double-banked drain highlighted (yellow dashed line) (photo courtesy of Damian Moroney, DEW).

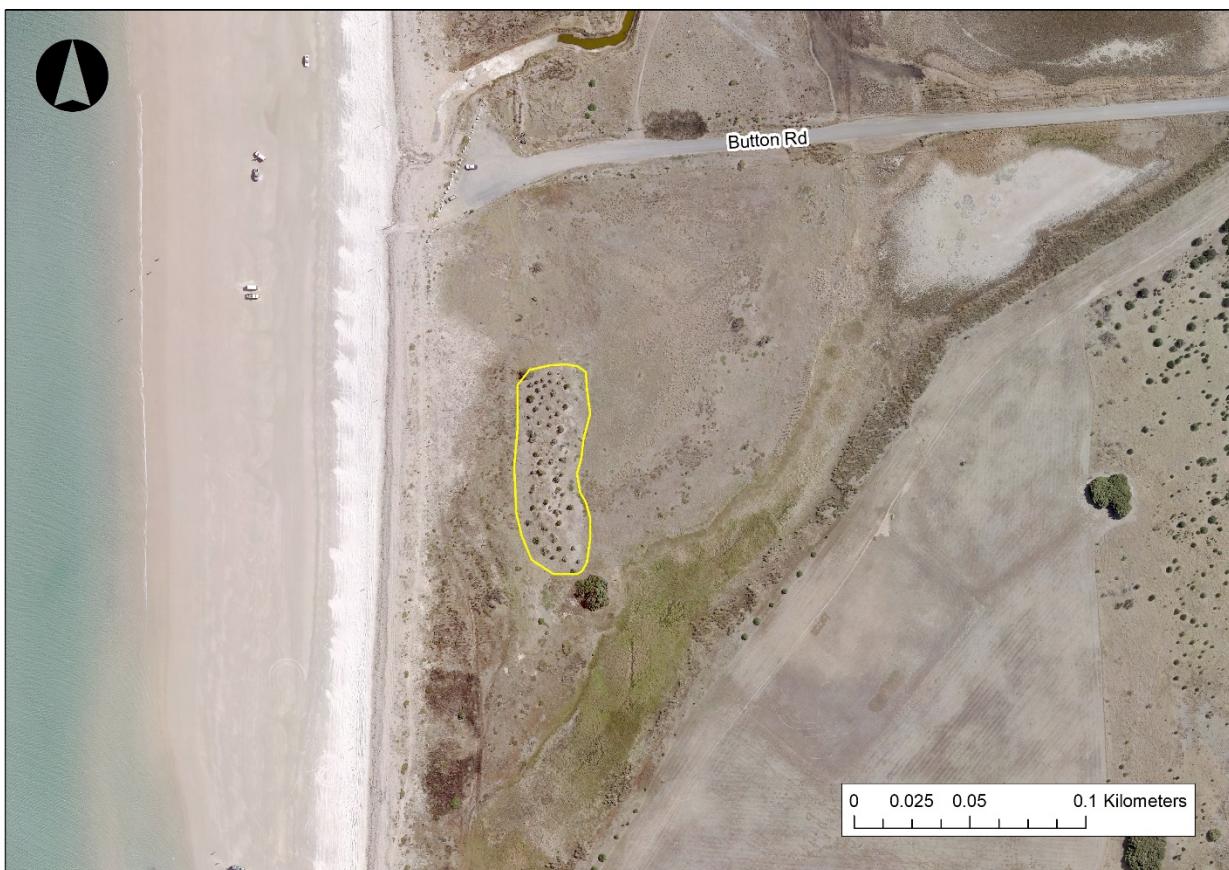
Figure 55. Approximate extent (yellow polygon) of dumped spoil in the vicinity of the Tjilbruke spring.
