Ecohydrological Restoration Assessment of the Aldinga Washpool

Report to the Green Adelaide Board

Ben Taylor, Tessa Roberts, Lachlan Farrington, Mark Bachmann and Sylvia
Zukowski

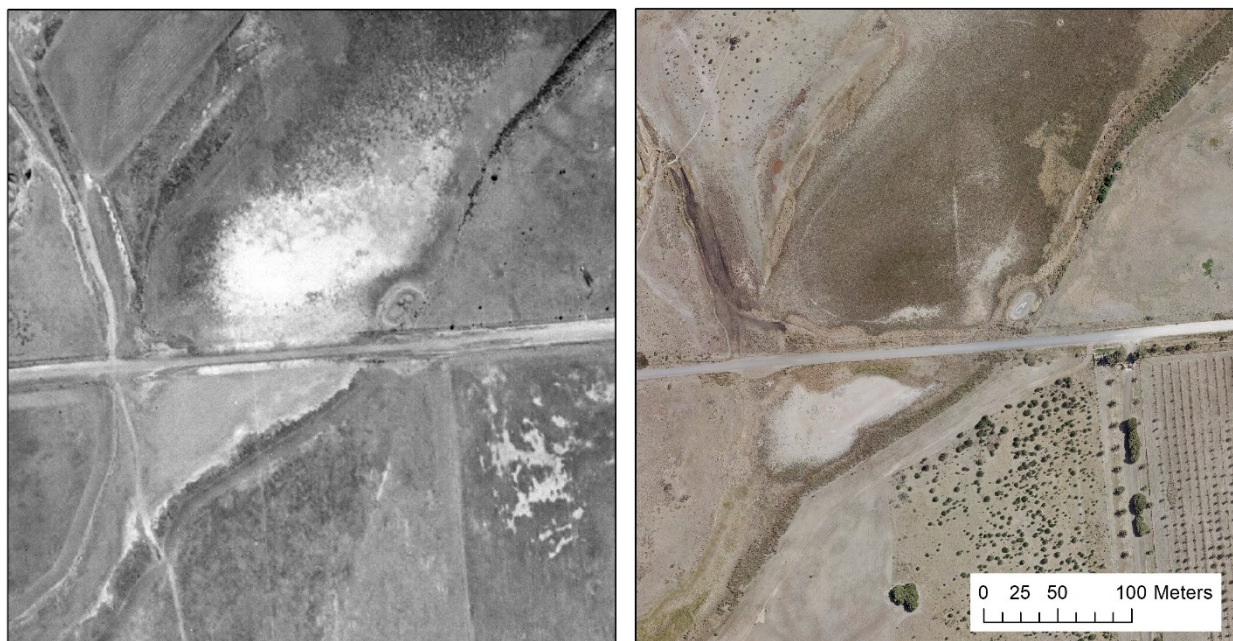
Figure 8. The Washpool in the vicinity of Button Rd in 1949 (left) and 2020 (right), showing displacement of open mudflats (white areas) by samphire (dark areas) in the intervening period.

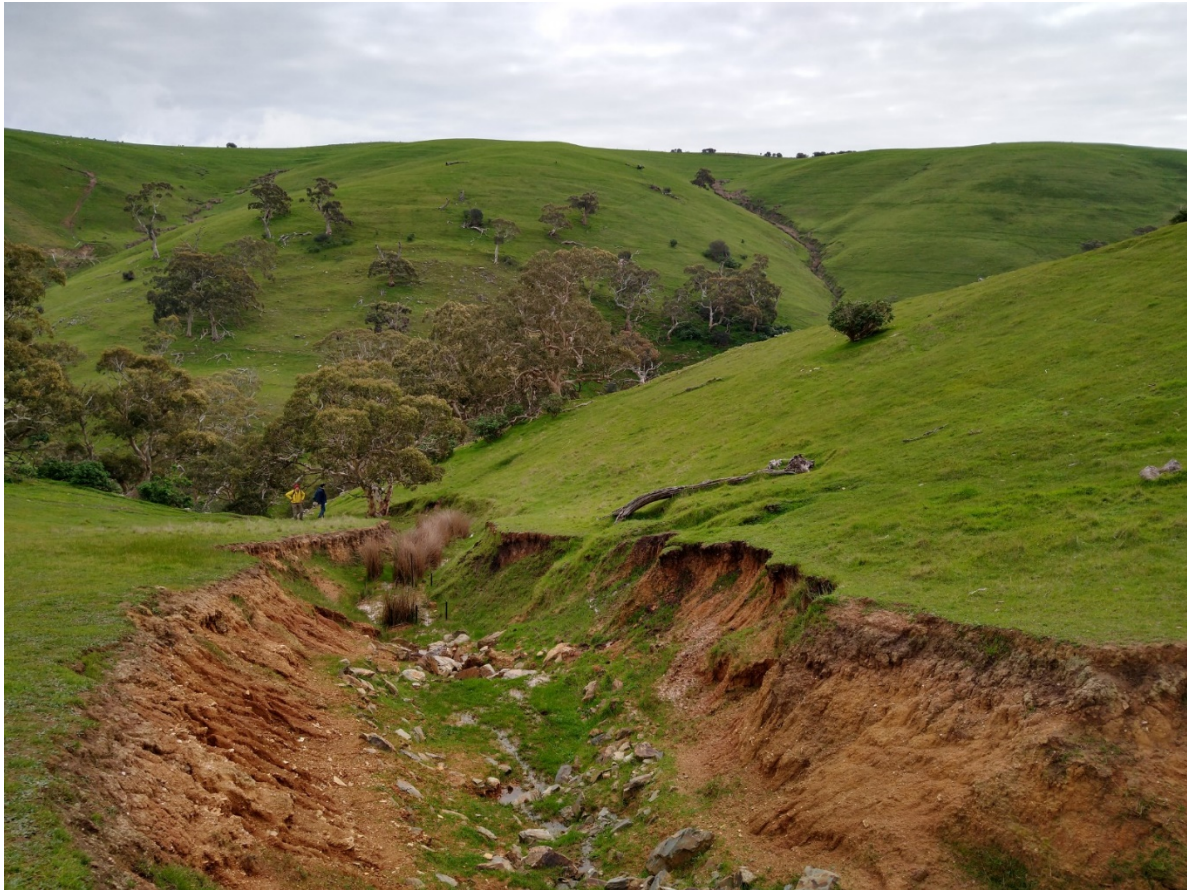
Figure 11. Erosion gully in the Washpool catchment near Louds Hill, July 2019 (photo Maarten Ryder, WHFLG).

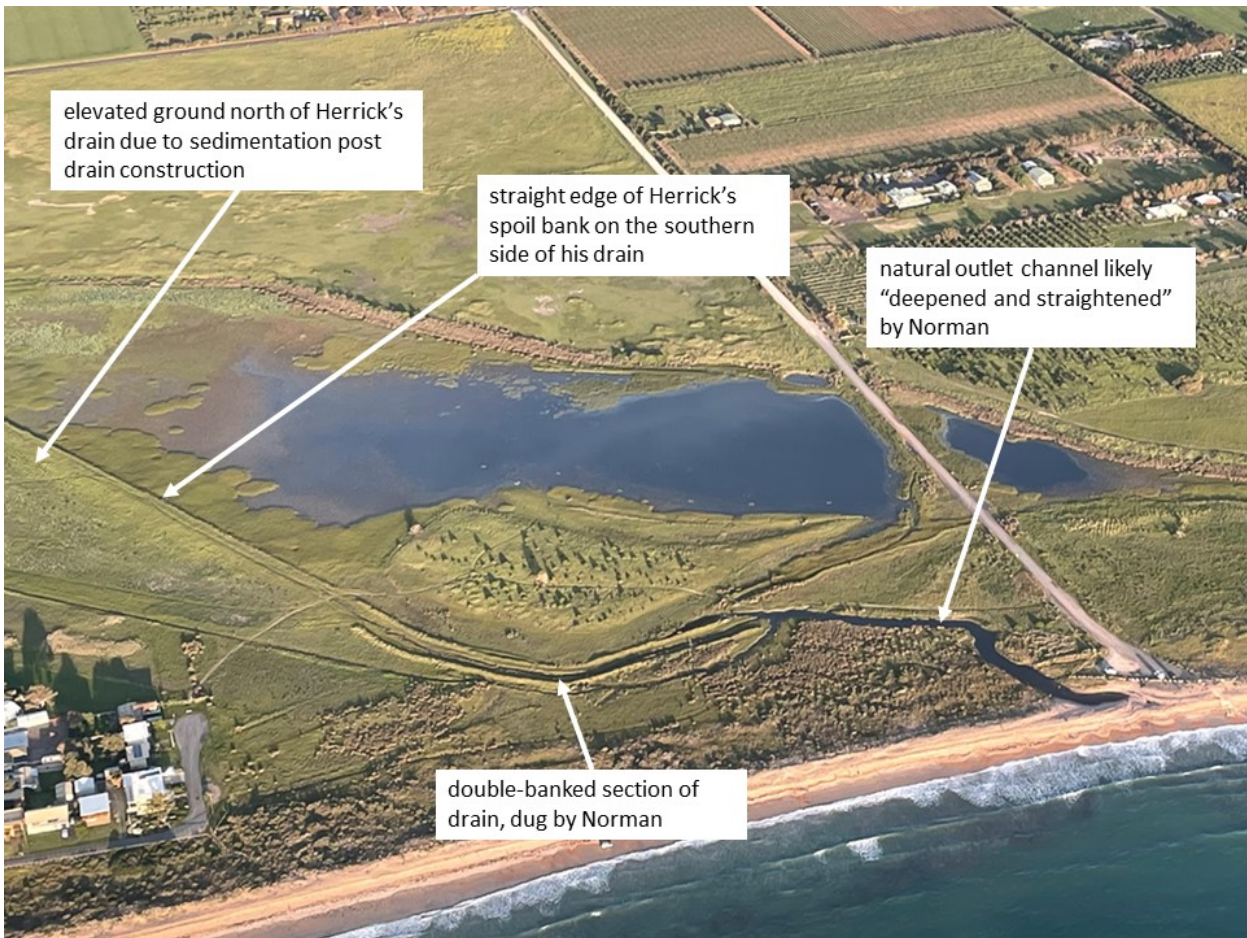
Figure 16. Oblique aerial image of the Washpool, 8th October 2021, with legacy effects of Herrick and Norman's c.1950 drain highlighted (photo: Coast Protection Board / Coast and Marine Branch, DEW).

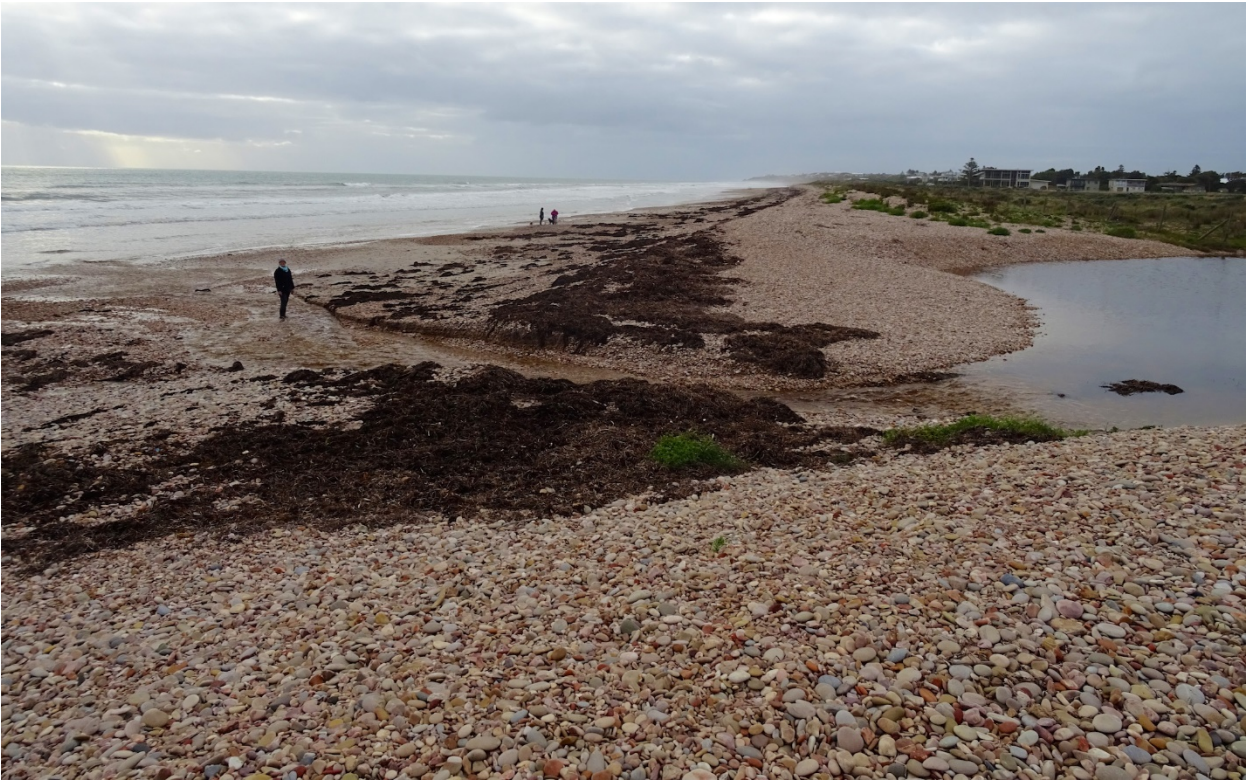
Figure 19. The Washpool outlet channel showing the pebble embankment lowered by a period of high outflows, 17th July 2017 (photo: Chas Martin (FoAS 2022)).

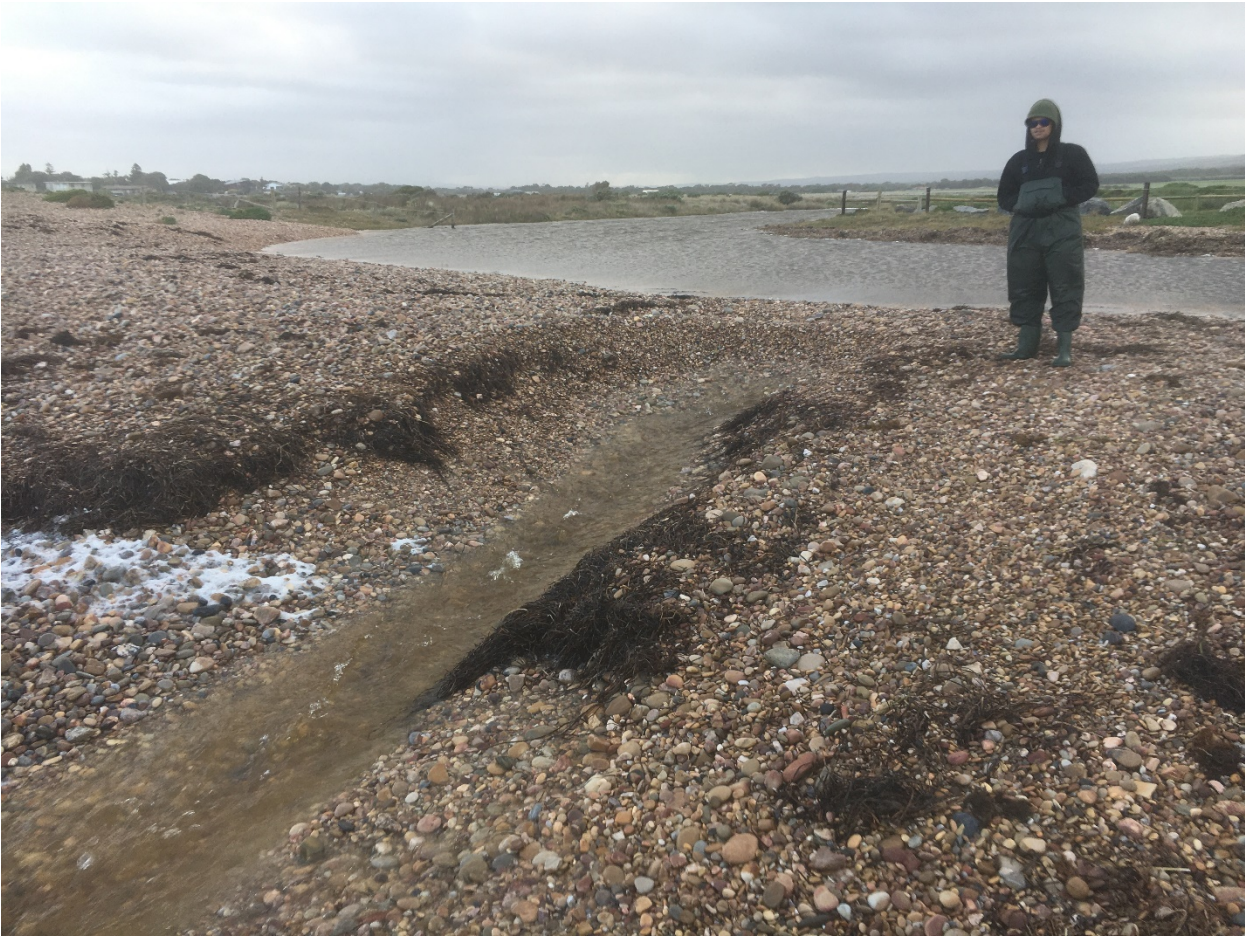
Figure 23. The Washpool outlet on 17th July 2021, looking upstream, showing the pebble embankment in place but leaking, with water re-emerging on its beach-facing side to form a fast flowing stream. Onlooker is Drew Kilner (photo: Ben Taylor).

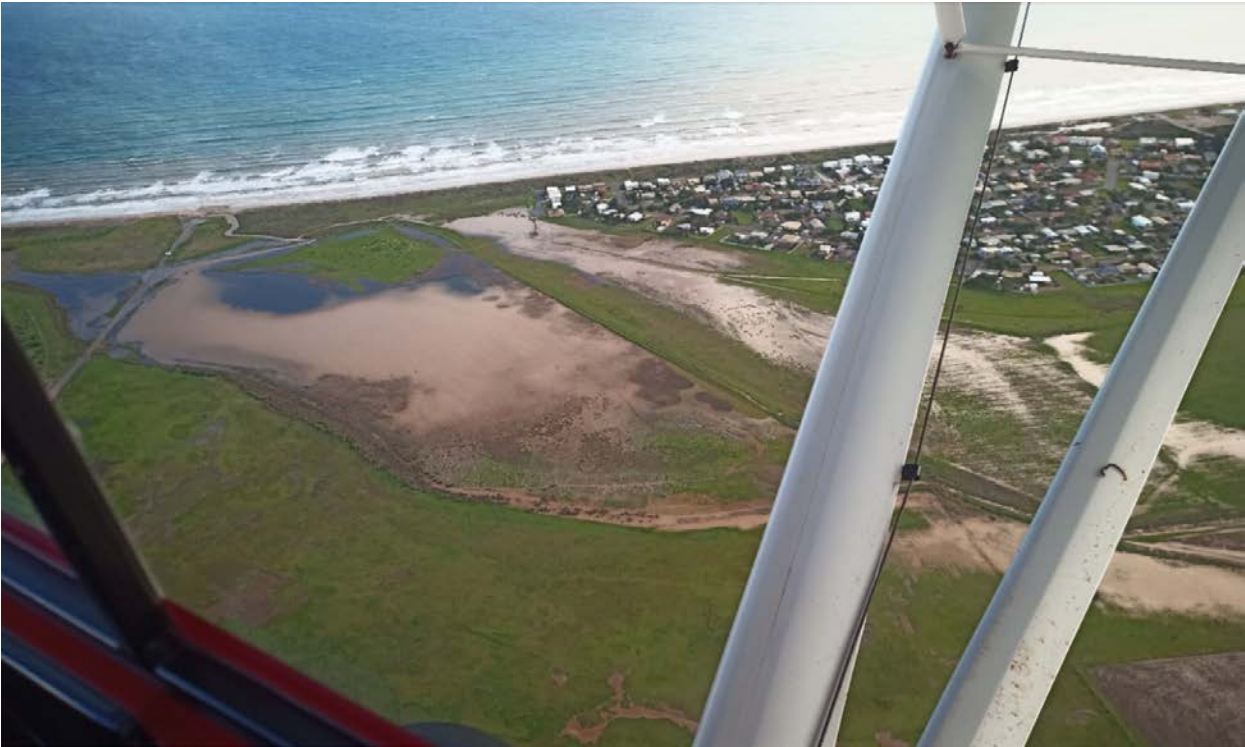
Figure 30. Highly turbid inflows to the Washpool displacing clear water, early afternoon 21st June 2020 (photo: Stewart Bond for Willunga Hillsface Landcare Group).

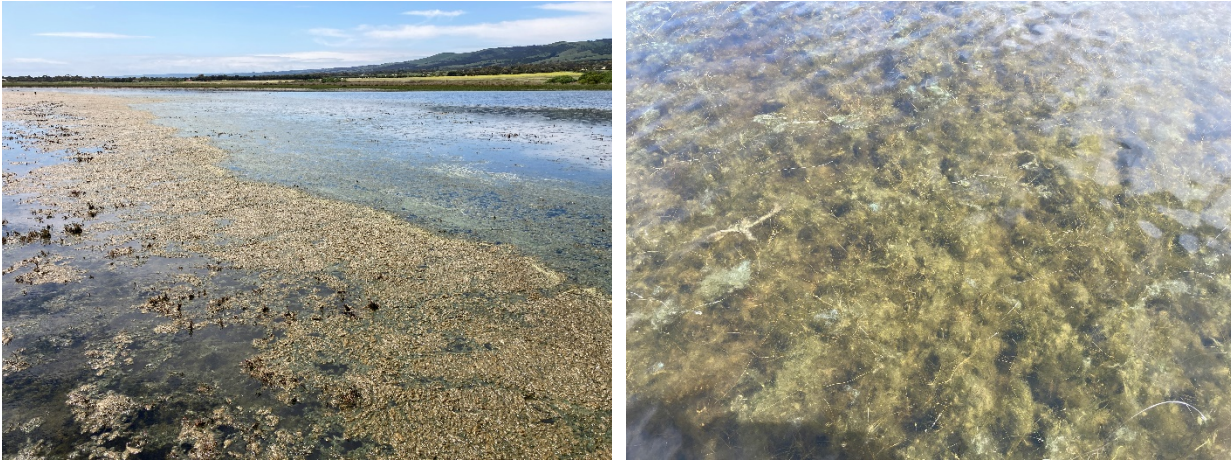
Figure 31. Dense coverage of filamentous green algae along the shoreline (left) and epiphytic algae on submerged aquatic vegetation (right) within the Washpool, 20th October 2022 (photo: Ben Taylor).

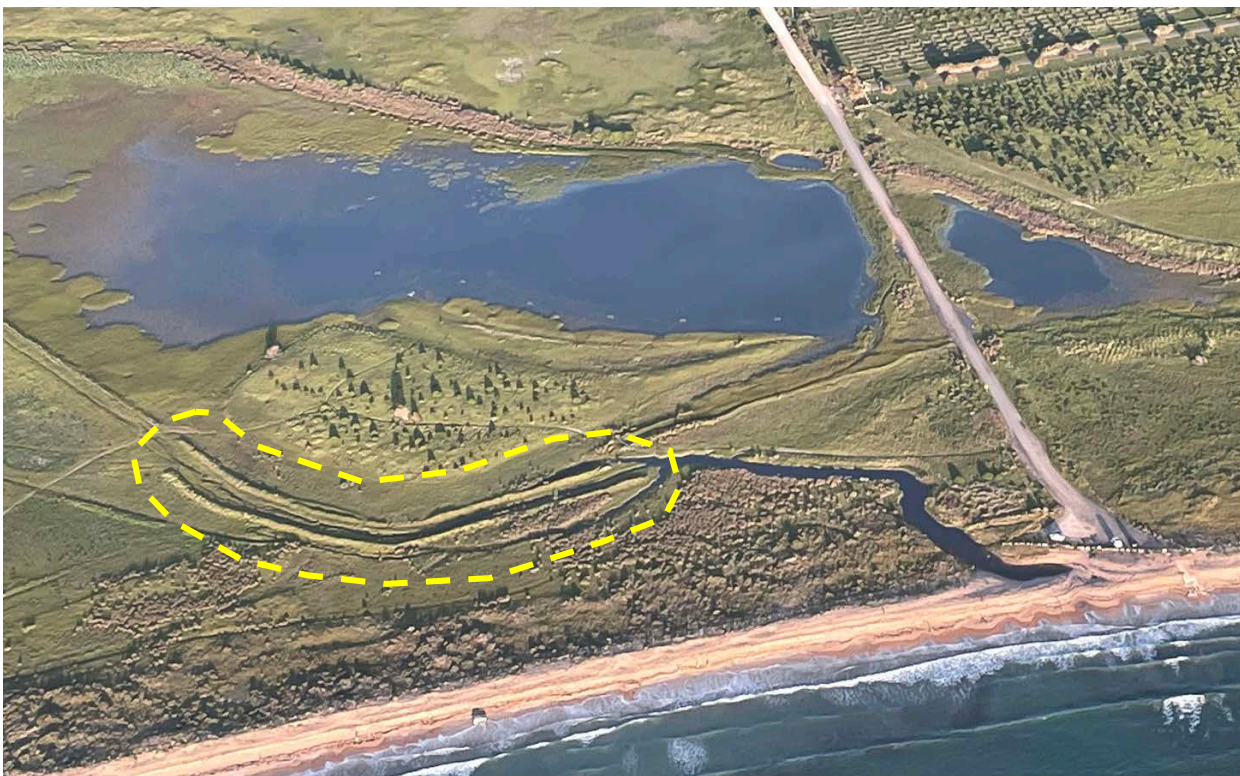
Figure 45. Oblique aerial image of the Washpool, 8th October 2021, with Norman's double-banked drain highlighted (yellow dashed line) (photo courtesy of Damian Moroney, DEW).

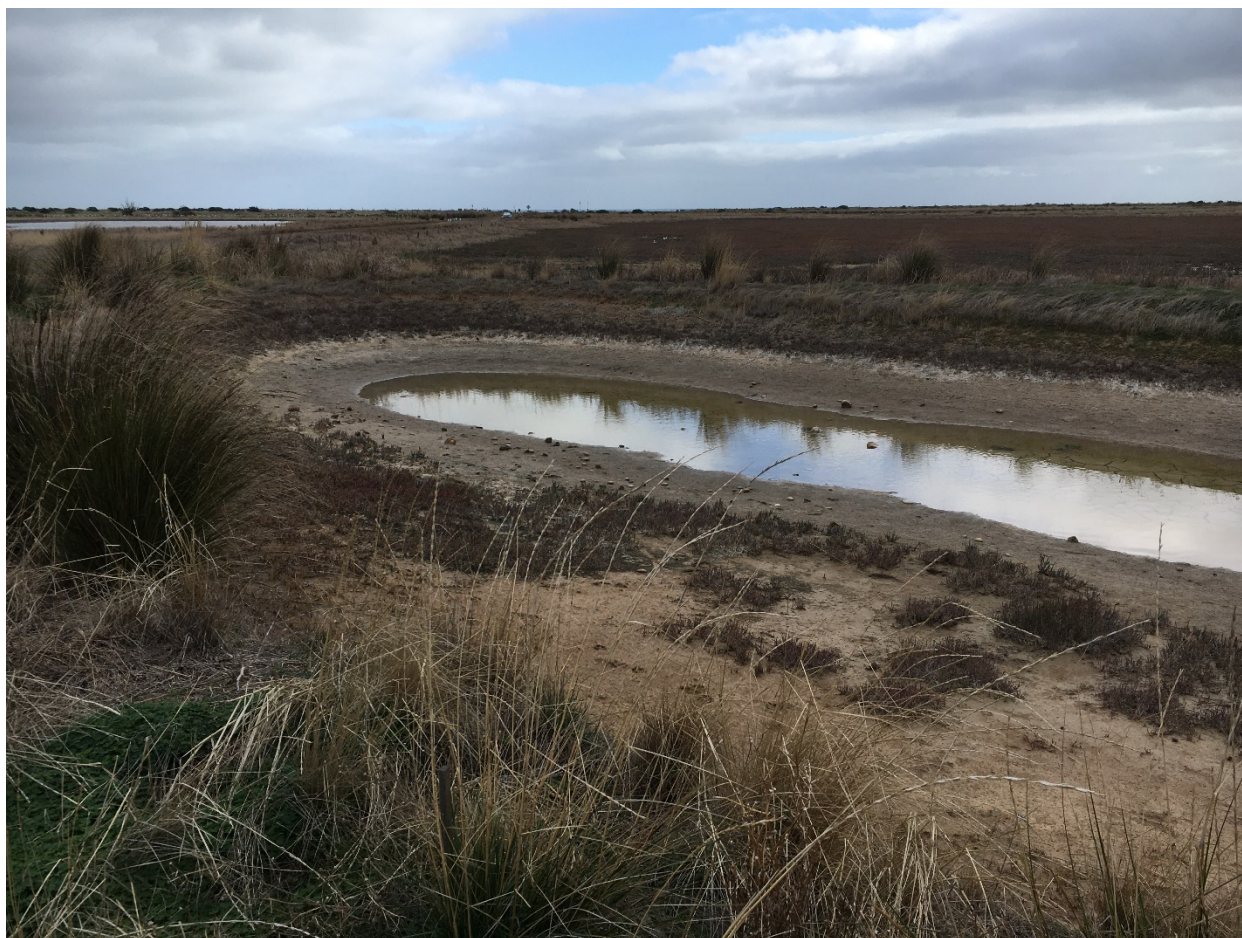
Figure 49. The old farm dam on the eastern edge of the Washpool just north of Button Rd, 10th June 2021.

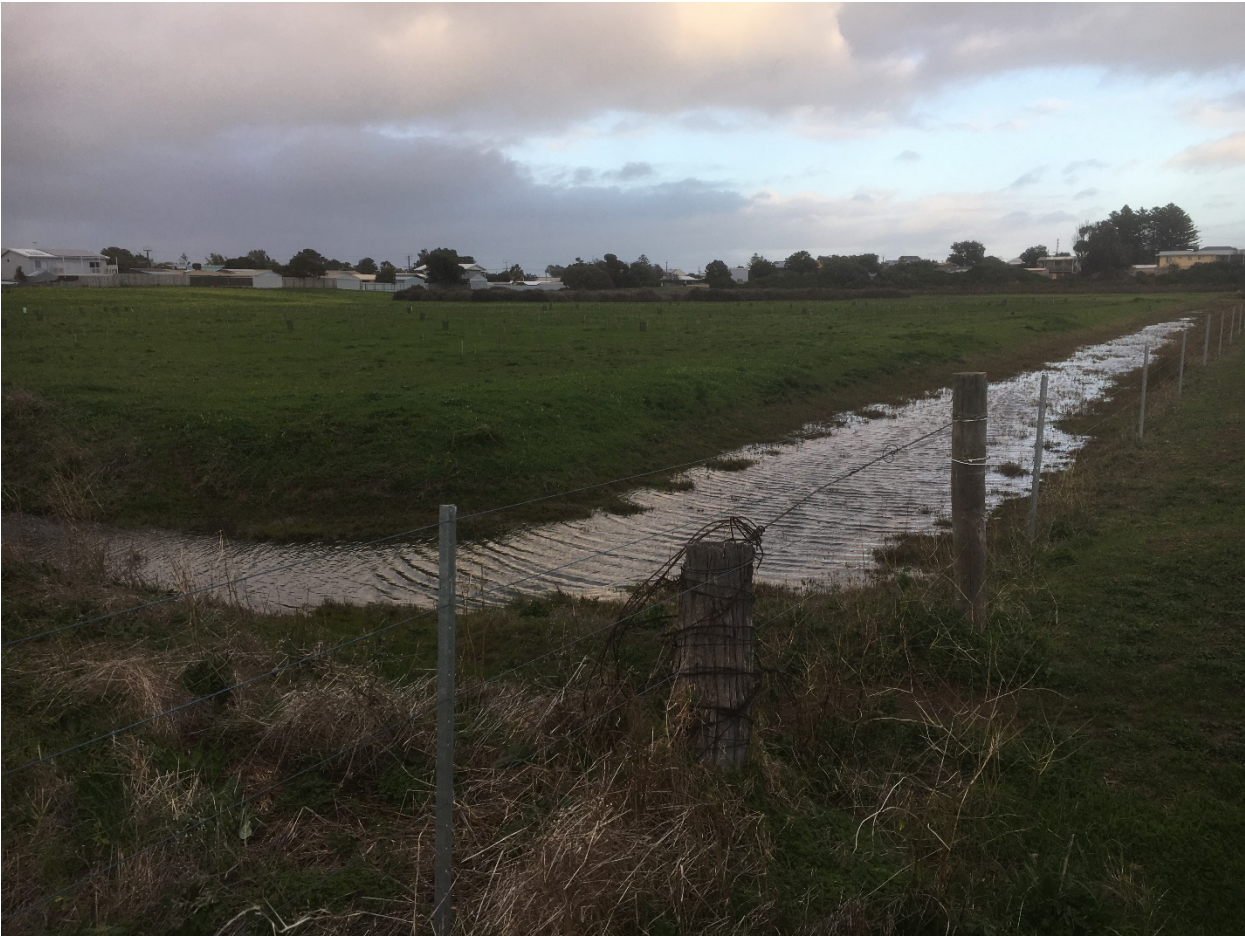
Figure 54. Drain near Blue Lagoon, 17th July 2021.

Figure 53. Section of drain near Blue Lagoon proposed for backfilling (white cross-hatching).

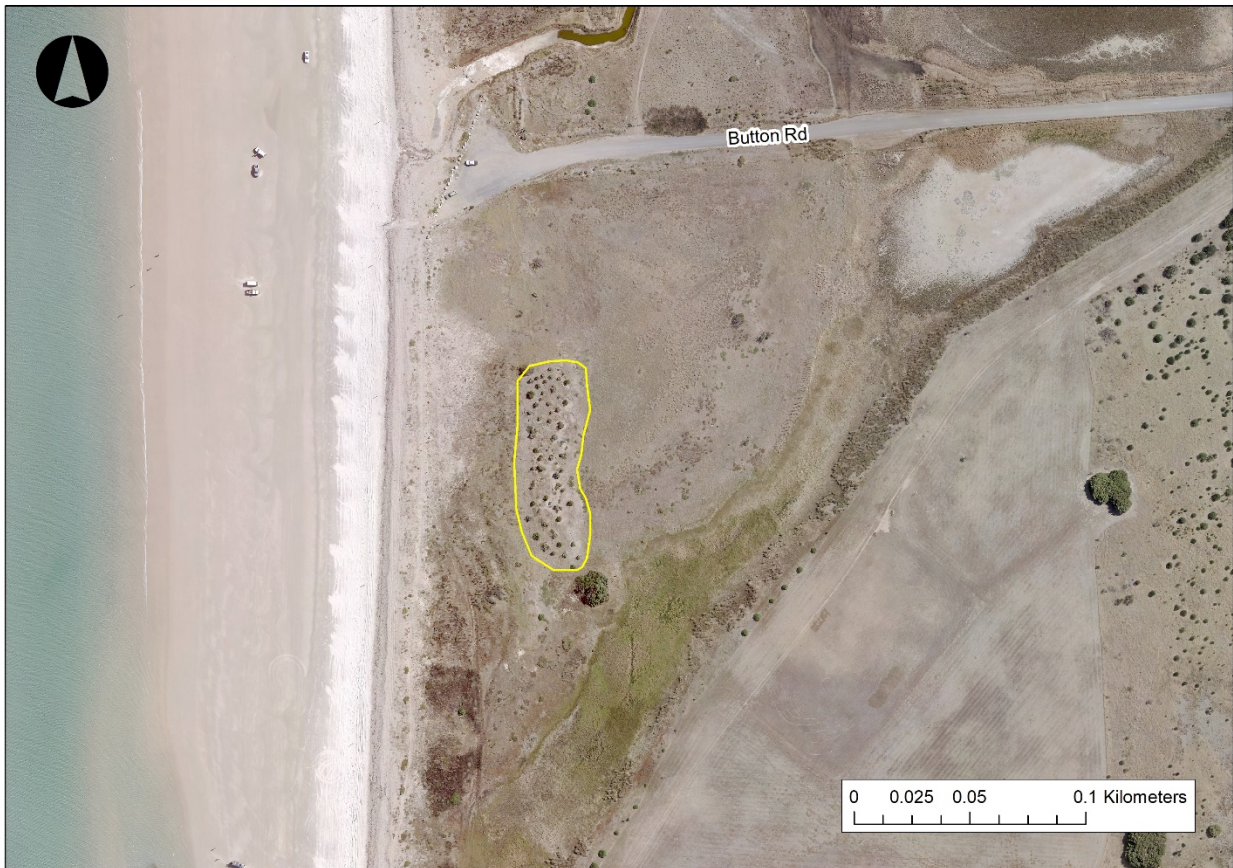
Figure 55. Approximate extent (yellow polygon) of dumped spoil in the vicinity of the Tjilbruke spring.
