# Conservation and Management of River Blackfish in Rodwell Creek, 2011-12

**Nick Whiterod & Michael Hammer**

*Aquasave Consultants, Adelaide*

Report to the Foundation for Australia's Most Endangered Species Inc (FAME), Goolwa to Wellington LAP and the South Australian Murray-Darling Basin NRM Board

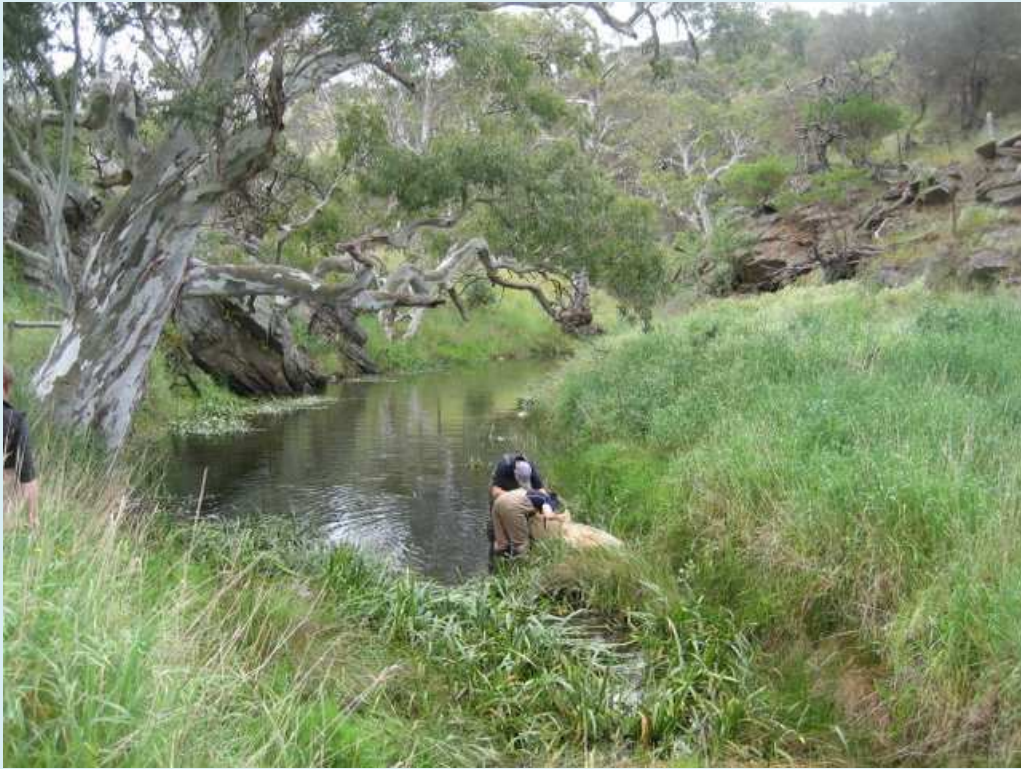
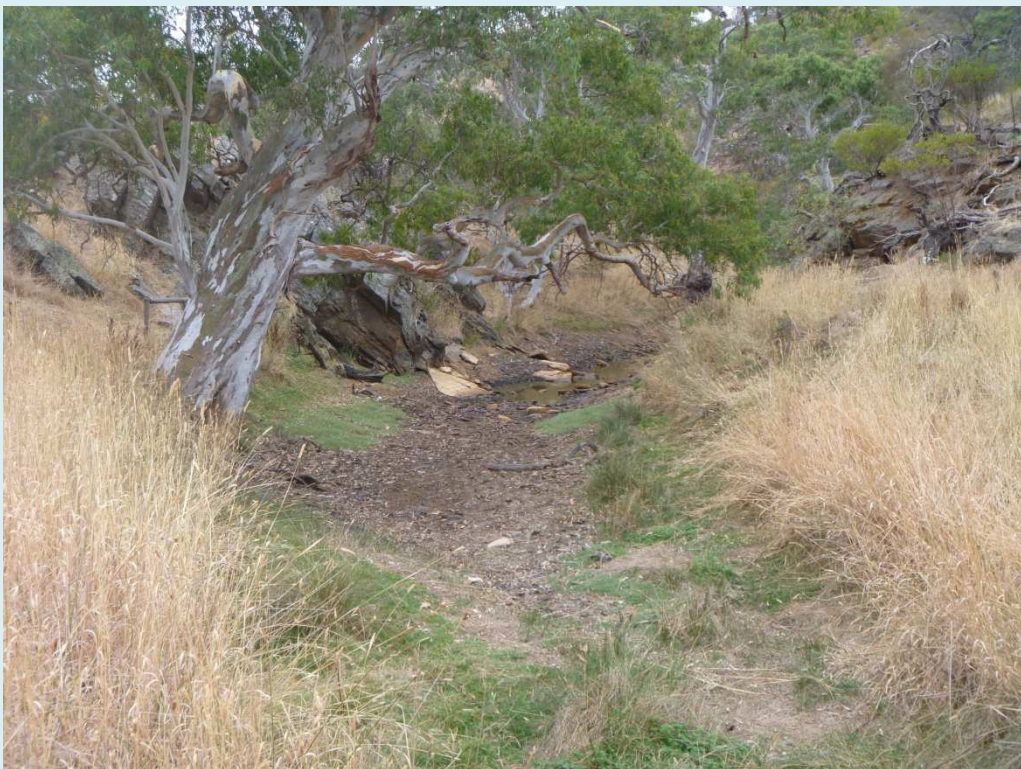
**Cover photos** Changes in the condition of pool 6 on Rodwell Creek between October 2011 (top) February 2012 (bottom).

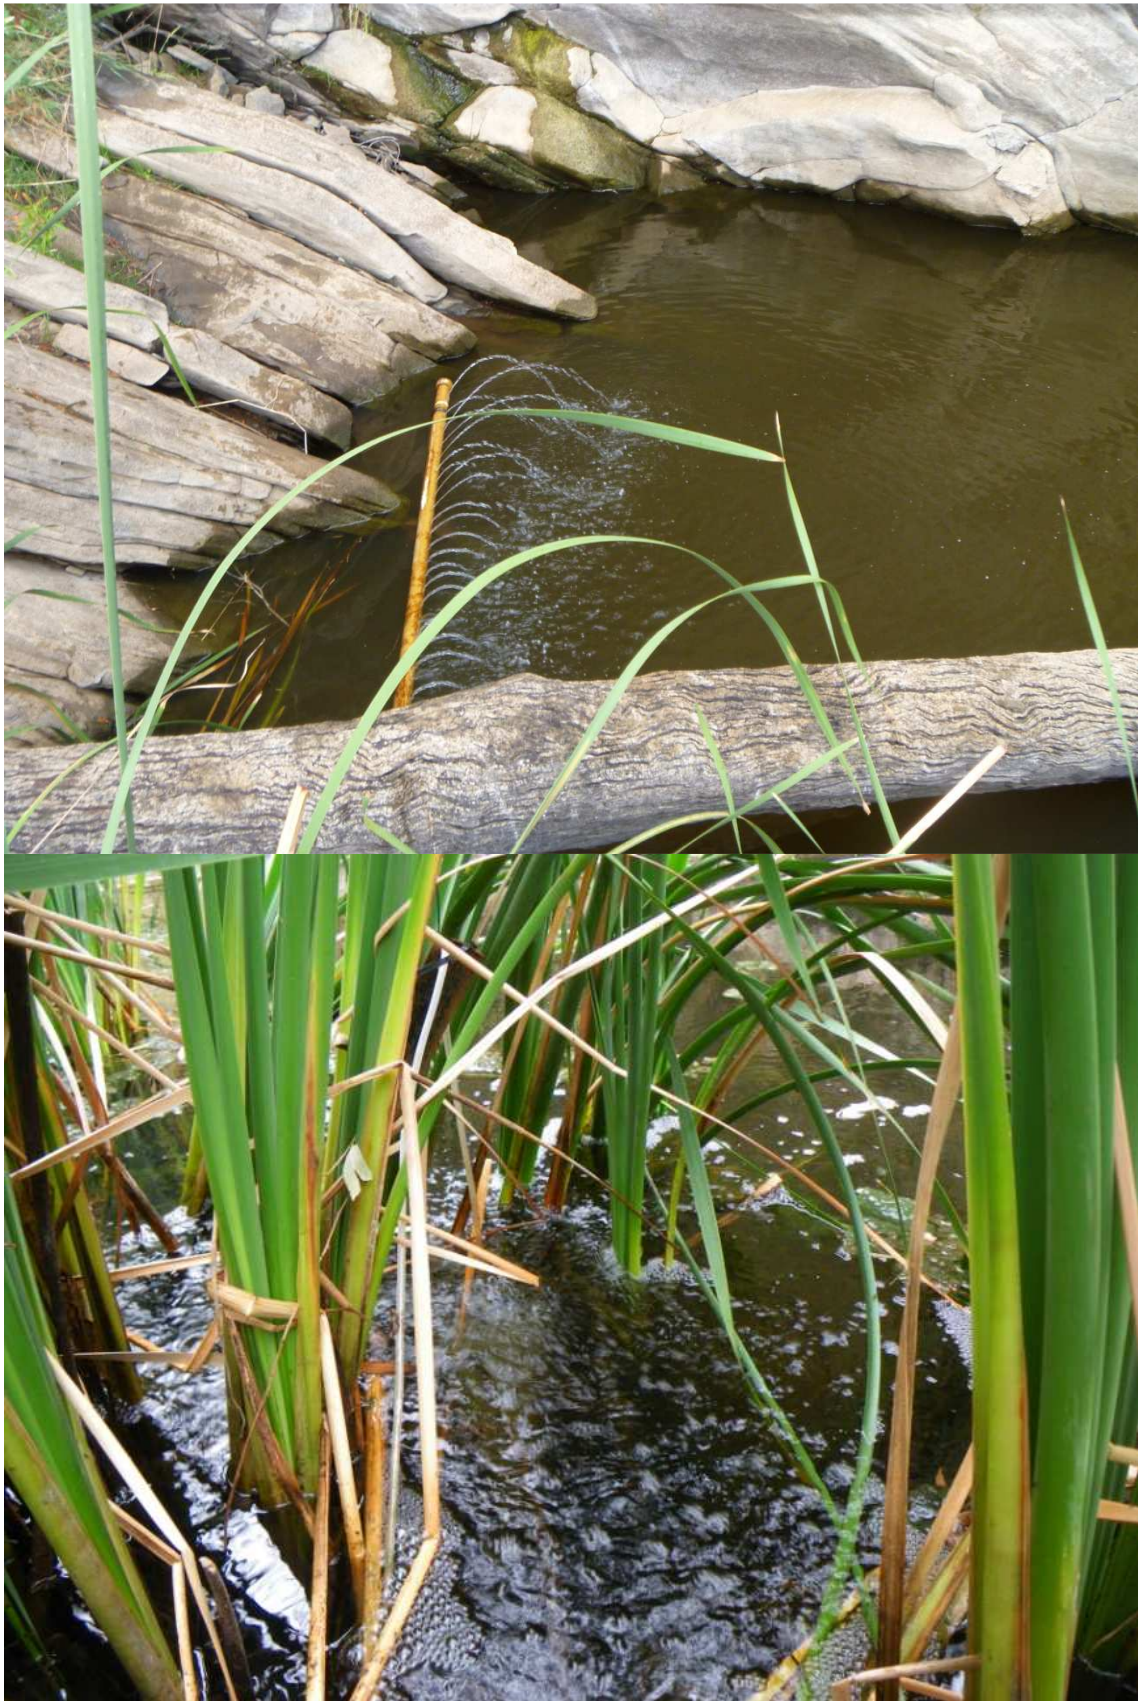
*Summary of the management inventions at Rodwell Creek: environmental watering (top) and aeration (bottom).*

Management intervention of the main pool was initiated when prevailing conditions reached alarm thresholds and involved aeration and environmental watering using pre-existing infrastructure and emergency fish transference (Hammer 2010). Environmental water is gravity fed from two rainwater tanks (total volume 30000L) via a spray bar at the top of the pool to reduce velocity and increase aeration. A water tanker delivers bore water with suitable water chemistry (low salinity, sulphides, and trace metals) to the rainwater tanks via a commercial supply. An aeration system was developed via a commercial pond aerator (Pond One 12000, 6600L hour<sup>-1</sup>) located at the property residence and piped to the pool some 400m through 12mm poly pipe carefully trenched and configured to avoid damage during property maintenance and by natural means. Delivery to the pond was to three large airstones at 0.5m depth tide to star pickets.

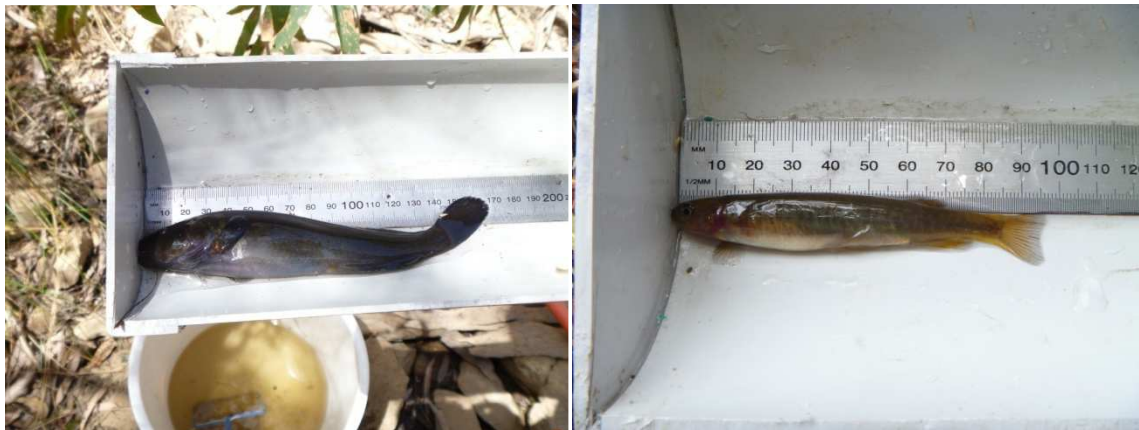
*River Blackfish and Mountain Galaxias sampled from additional pools*

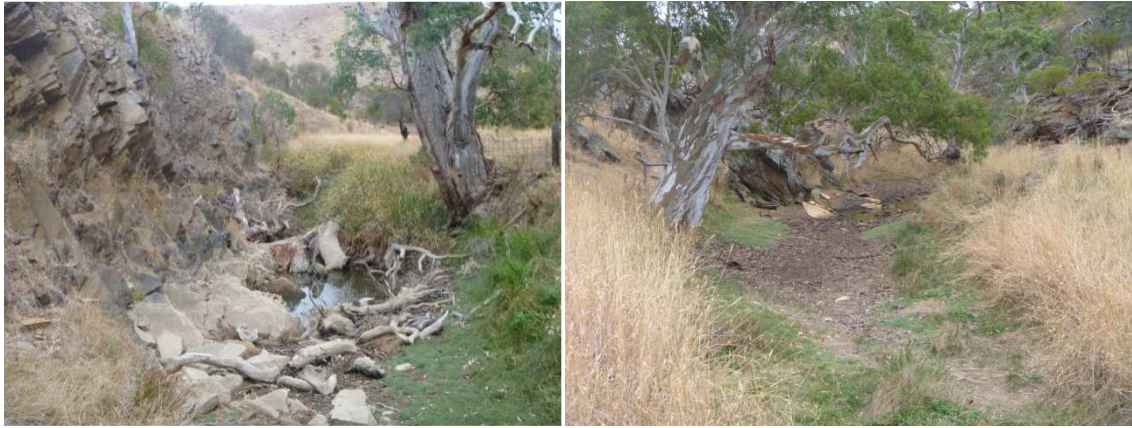
*Condition of pool 1 (left) and pool 6 (right) in Rodwell Creek by February/March 2012*

The deterioration of the known pools by the end of January 2012 prompted environmental watering (28000L) of the main pool and triggered the requirement for emergency transfer of individuals from pools 3 and 6 (Figure 7).

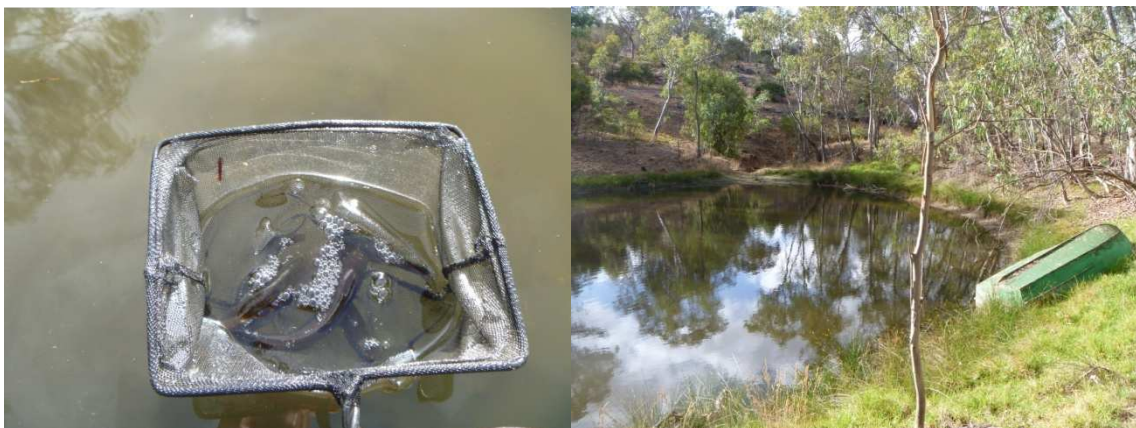
*Release of River Blackfish (left) into pool 16 on Rodwell Creek (right)*

It was decided to transfer these fish into (a) the main pool as it was being actively managed and (b) a refuge location (pool 17) further upstream to provide a medium-term safeguard and assist with the dispersal of River Blackfish above pool 7. Follow up assessment of the refuge locations revealed that pools 8-16 had dried and pool 18 was looking stagnant whilst pool 17 maintained its suitability. As such, overnight netting (31 January 2012) collected 82 fish from pool 3 and 6, which were transferred to the main pool (16 fish) and the refuge pool (pool 16, 66 fish, 110-250mm).

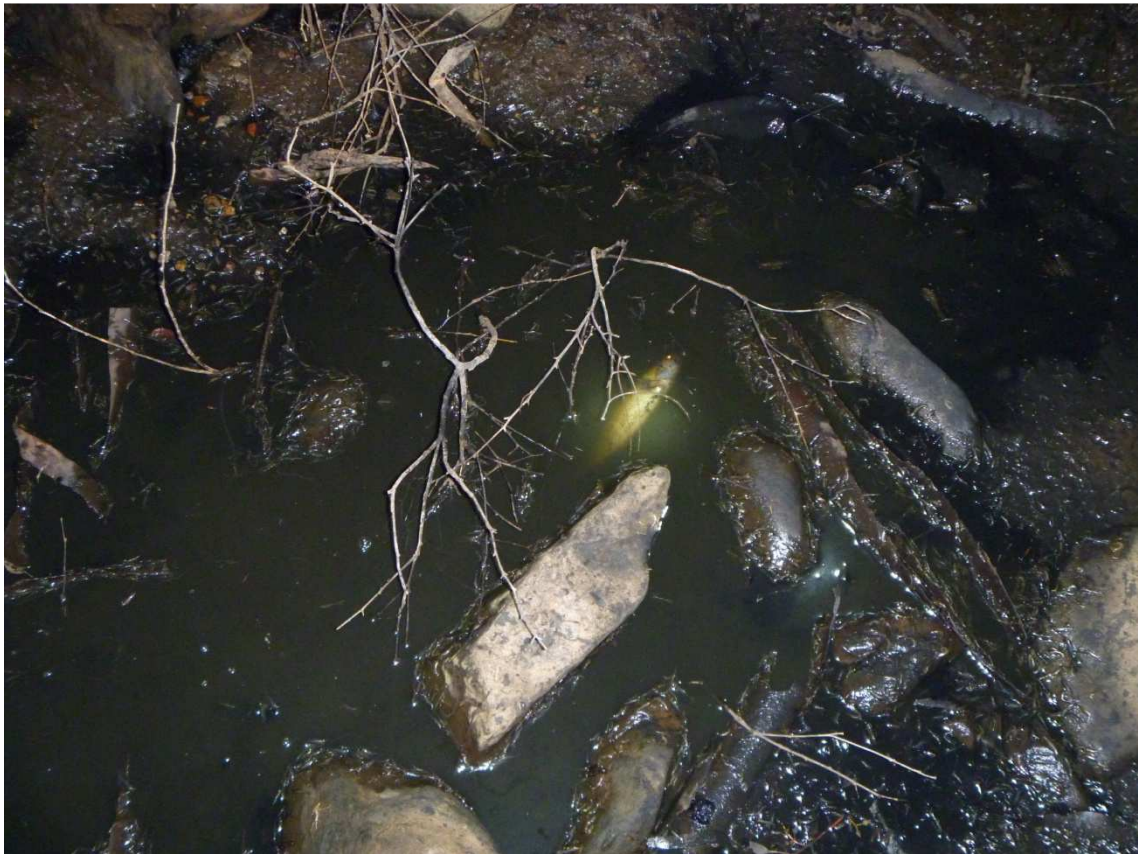
*The severe deterioration of pool 6 on Rodwell Creek showing dead River Blackfish spotlighted.*

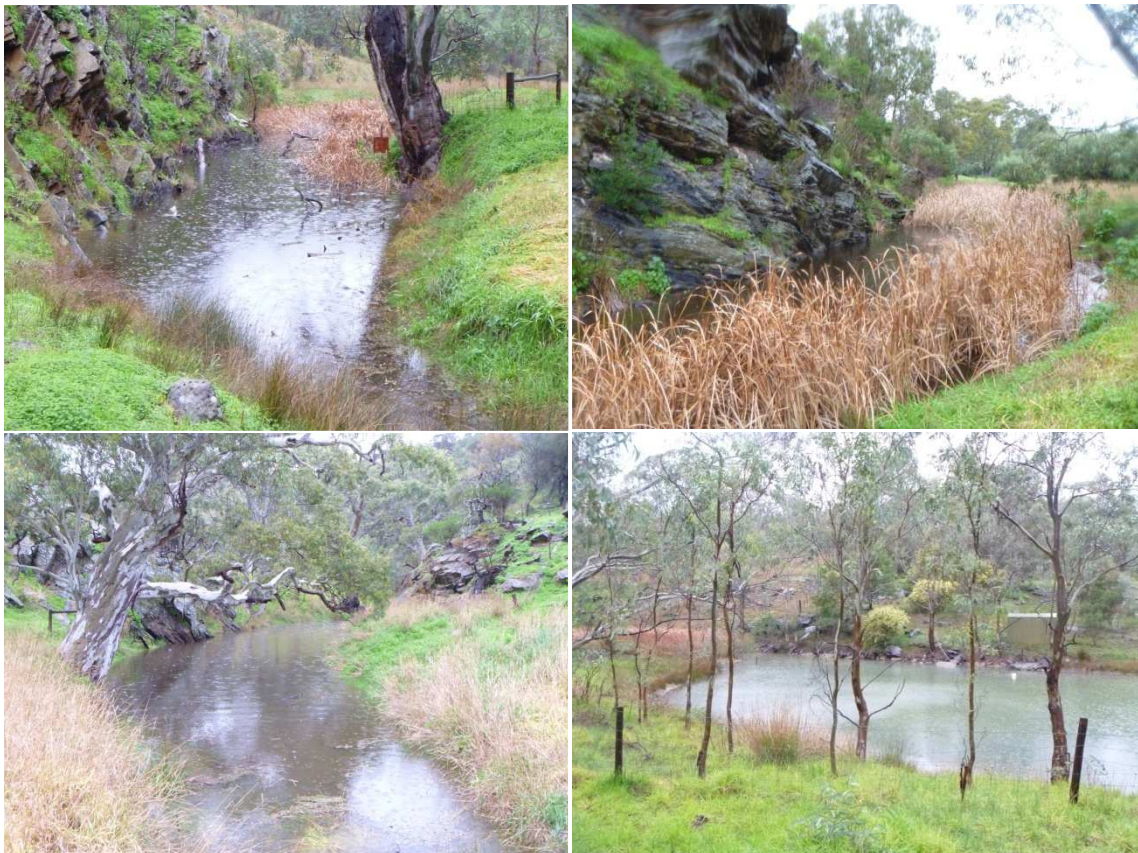
*Status of pool 1 (top left), main pool (top right), pool 6 (bottom left) and the refuge pool (pool 16, bottom right) on Rodwell Creek in June 2012.*

contrast to the main pool, the condition of the unmanaged pools (1, 3, 4, 5, 6) continued to decline over the critical period and by April 2012 conditions in pools 1, 4, 5, and 6 had collapsed. Indeed, pool 6 was almost dry and several dead River Blackfish were observed in the shallow, low DO and algal rich waters of pool 6 during fish monitoring in April 2012. Encouragingly, adequate conditions in pool 3 were maintained across the critical period. By June 2012, cooler weather and periods of high rainfall, and resultant creek flow, have acted to reset all pools in the section of Rodwell Creek with the main pool depth (1.76m), DO ( $7.5\text{mgL}^{-1}$ ) and EC ( $4.0\text{ mScm}^{-1}$ ) all at suitable levels.
