River Blackfish in Rodwell Creek, 2012-13 update

Aquasave – Nature Glenelg Trust

June 2013

Report to the Goolwa to Wellington LAP and South Australian Murray-Darling Basin NRM Board

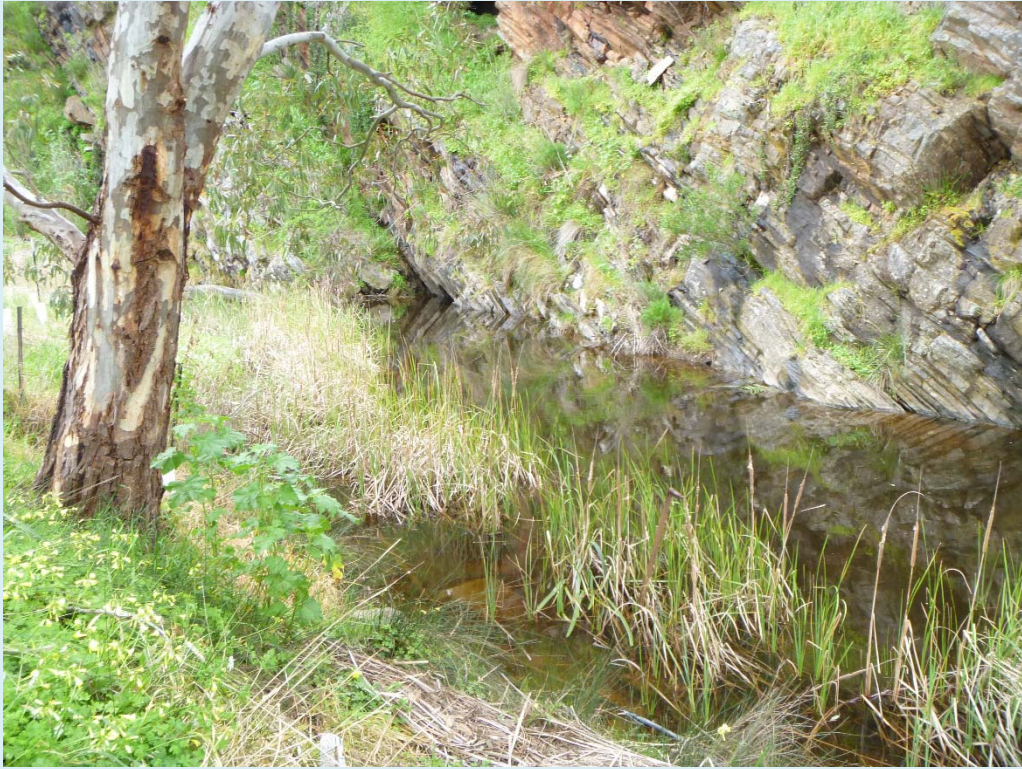
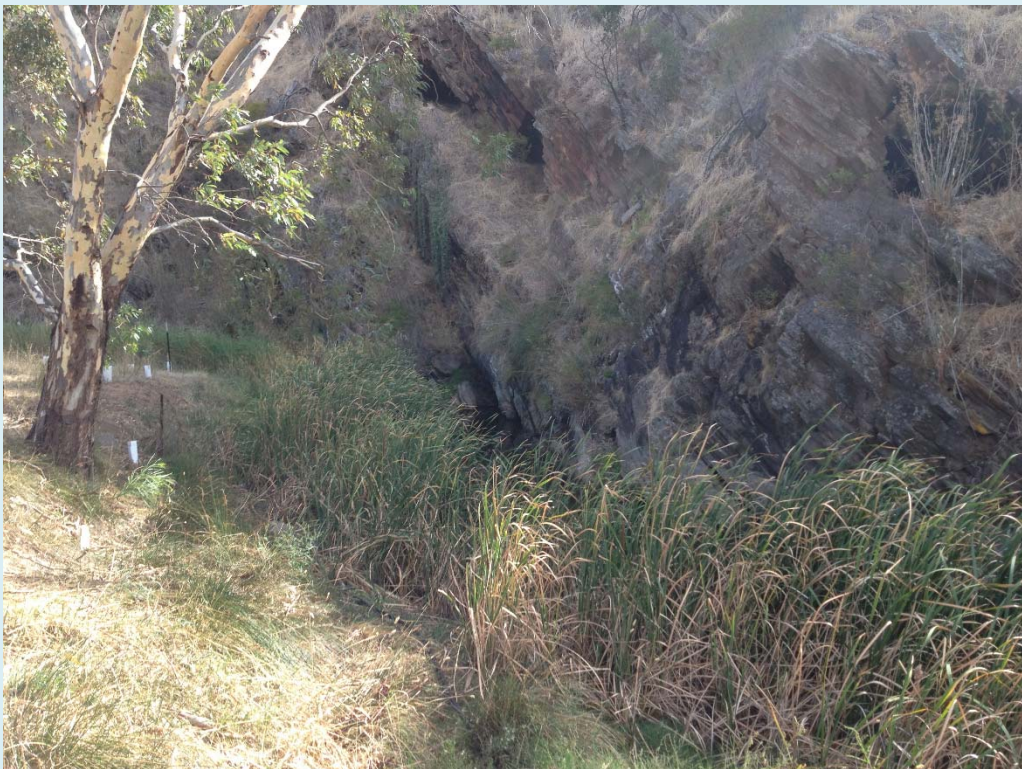
Cover photos Changes in the condition of the main pool on Rodwell Creek between October 2012 (top) and March 2013 (bottom).

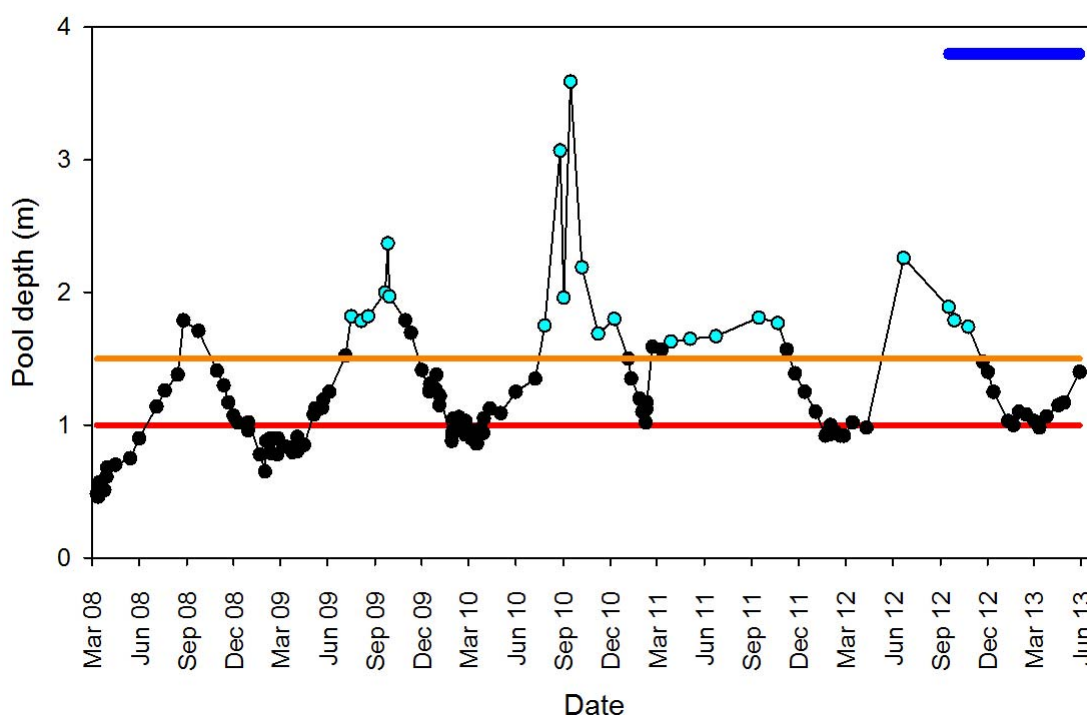
Figure 4 Pool depth at Rodwell Creek since autumn 2008 with 2012-13 sampling period (blue bar) and periods of creek flow (light blue dots).

The 2012-13 critical period in Rodwell Creek was preceded by slightly above average rainfall (Jan-Jun 2012) that contributed to moderate but short, winter flows in June 2012 (Figure 4). Consistent with previous years, the creek ceased to flow in October and water levels (1.74m) receded rapidly to 21 January 2012 (1m deep) but unlike 2011-12 suitable dissolved oxygen (7.1 mgL^{-1}) and EC (4.7 mScm^{-1}) were maintained – in fact dissolved oxygen and EC generally remained outside the alarm threshold range for the entire critical period (Figure 5). However, as the critical pool depth threshold was triggered emergency watering (30,000L) was initiated. In response to a subsequent drop in water level and in anticipation of the impacts of period of high air temperatures, emergency watering (30,000L) was repeated on 12 March 2013 (Figure 6), which helped to stabilise water level ($>1\text{m}$), improved dissolved oxygen ($>7\text{mgL}^{-1}$) and freshening the main pool (down 2.8 mScm^{-1}). The pool depth and water quality remained suitable until the end of the critical period.
