# Restoring wetlands of the upper Wannon River floodplain, south-west Victoria

Mark Bachmann, Nature Glenelg Trust

Following historic artificial drainage, wetlands are now bouncing back with the help of new partnerships and innovative wetland restoration techniques.

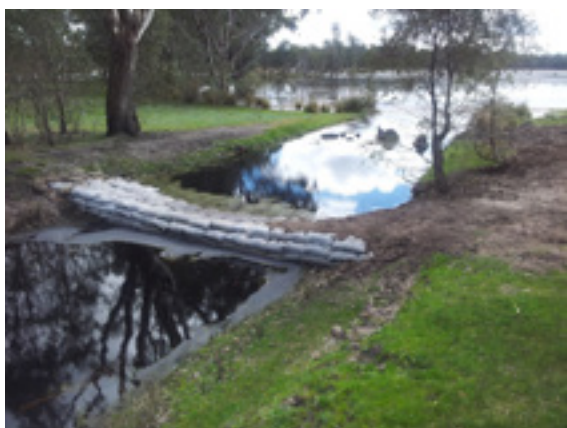
*The Gooseneck Swamp Restoration Trial Structure was installed in August 2013 and is situated in the artificial outlet drain from the swamp* (© Copyright, Mark Bachmann)

In a previous edition of *Wetlands Australia* (Issue 25, August 2014), readers were introduced to the initial results of a restoration trial undertaken at Gooseneck Swamp in the Grampians National Park, south west Victoria.

However, this wetland is just one of a series situated in the upper Wannon River floodplain that has been impacted by previous artificial drainage works. The early success of the Gooseneck Swamp Restoration Trial has led to a number of new partnerships across public and private land, resulting in some positive developments for other wetlands in this part of the catchment.

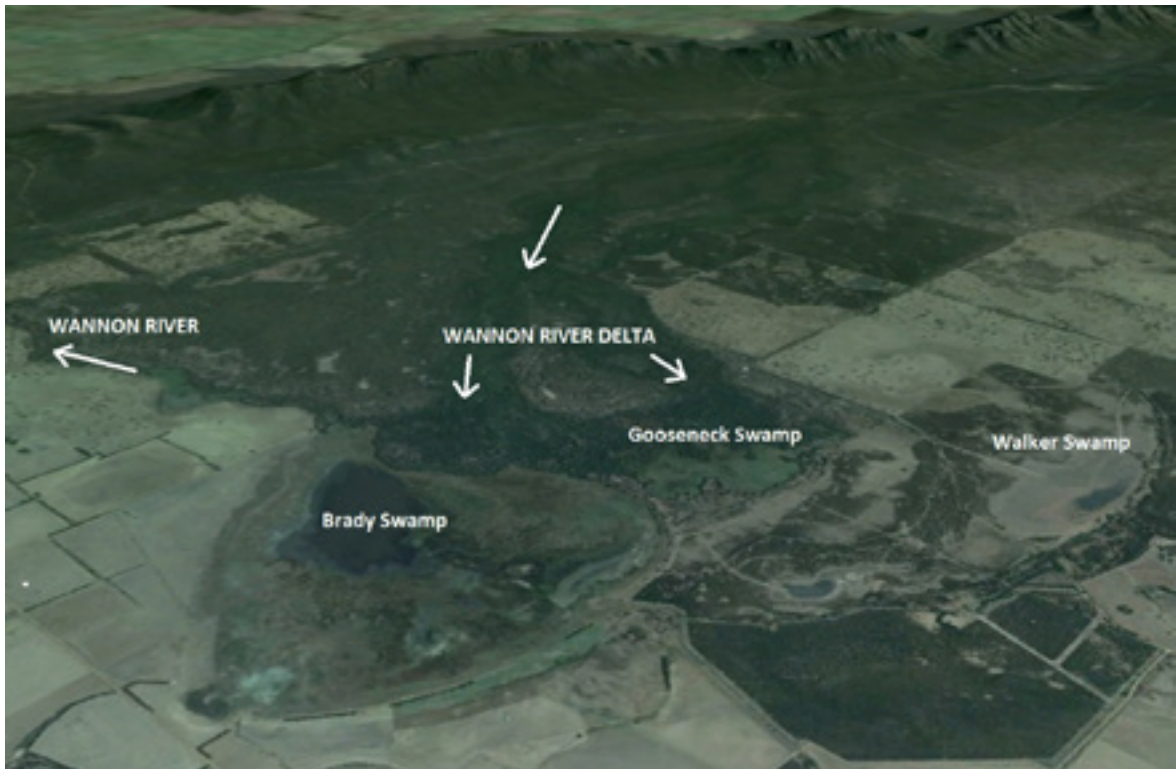
*Oblique view of the Upper Wannon River in Victoria, showing the wetlands associated with the floodplain and the direction of flow where the river exits the Grampians, before heading west towards Dunkeld (© Copyright, Mark Bachmann)*

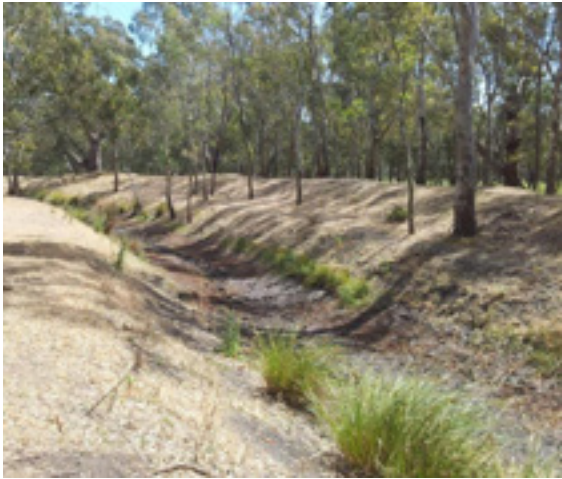
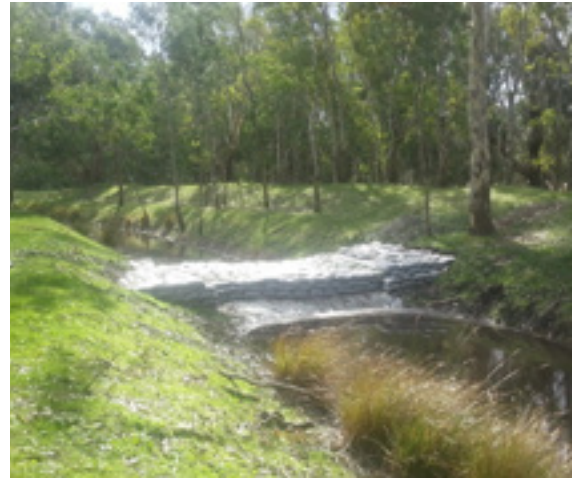
*A restoration trial structure was installed on the outlet from Brady Swamp in March 2014. The site is shown here before construction in March and with the trial structure operational in August 2014* (© Copyright, Mark Bachmann)

The structure at Brady Swamp was constructed in March 2014 with the support of 25 community volunteers. In spite of below average rainfall in the winter/spring of 2014, the structure is already having a positive impact on the hydrology of the wetland by increasing the retention level of water (and hence the duration of inundation) in the swamp, as well as re-invigorating flows in the adjacent natural Wannon River flowpath.

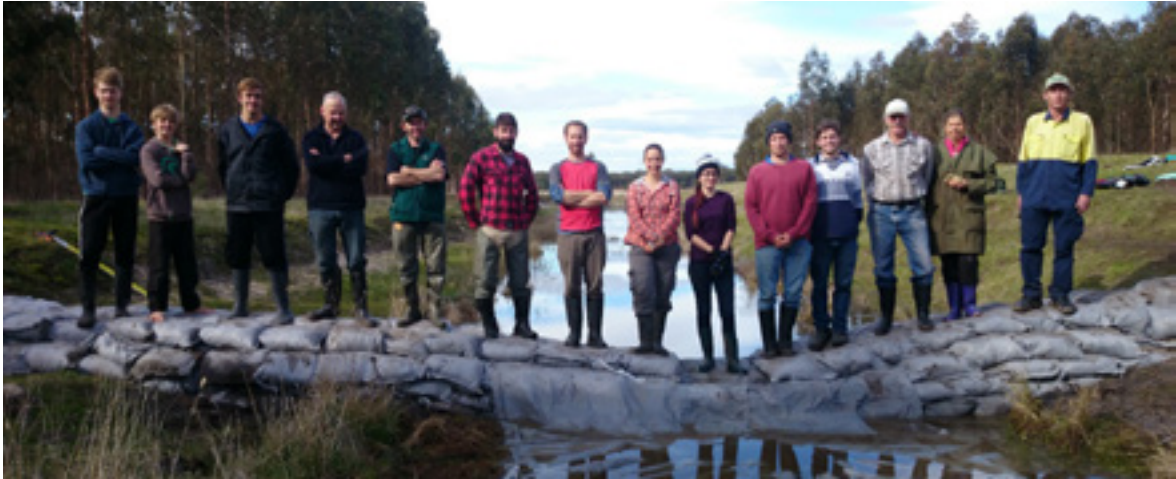
*The restoration trial structure at Walker Swamp, installed in August 2014* (© Copyright, Mark Bachmann)

The second trial at Walker Swamp commenced in August 2014, with another team of NGT staff and volunteers doing a fantastic job — only this time in flowing conditions. While this makes things a bit more logistically difficult, it does have the advantage of enabling us to make an immediate assessment of the structure operating in real time.

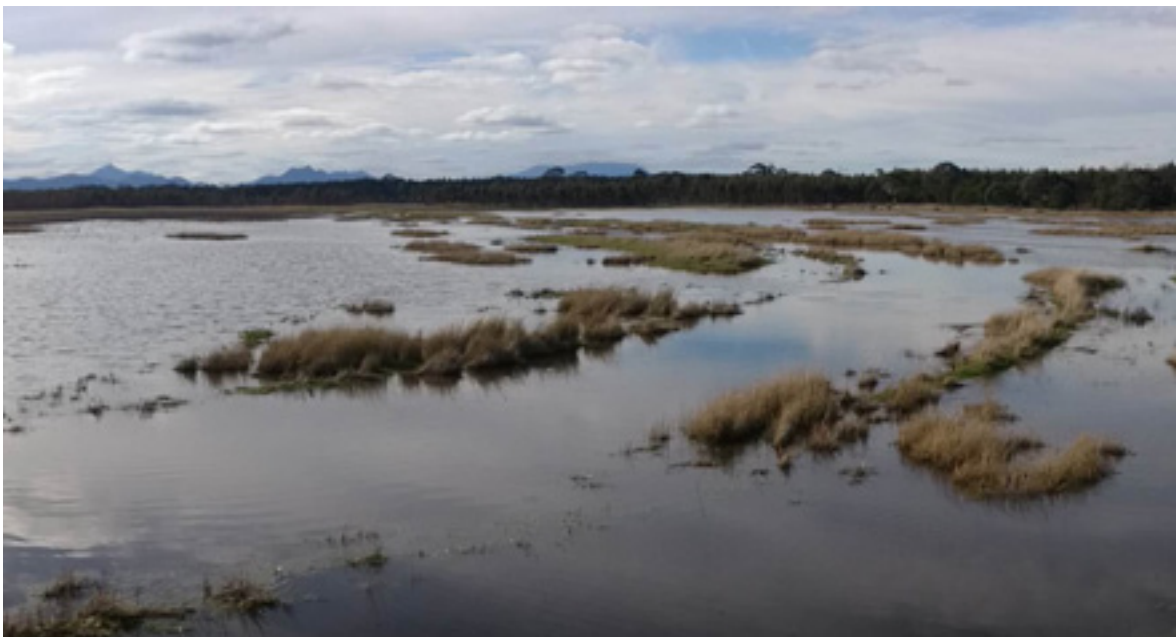
*The drain passing through the centre of Walker Swamp, August 2014* (© Copyright, Mark Bachmann)

Although Walker Swamp receives catchment inflows and still certainly looks and behaves like a wetland for a short period each year, the drain that passes through the swamp (constructed in the 1950s) has caused the swamp to drain down rapidly every year as soon as inflows cease. The restoration trial at this site is therefore designed to prevent the swamp from emptying prematurely, but still enabling water to exit the swamp at the spillway height set for the structure, as negotiated with the private landowner. Importantly, during the trial phase planned for this site over the next couple of years, the spillway height can be adjusted to reflect a range of operating conditions. In the dry spring of 2014, the design of the structure worked perfectly by significantly extending the duration of inundation in Walker Swamp, long after catchment inflows ceased.
