Hydrological restoration options for Square Waterhole Swamp, Hesperilla Conservation Park.

*A case study for Fleurieu Peninsula swamp restoration in the SA
Murray Darling Basin NRM Region.*

August 2017

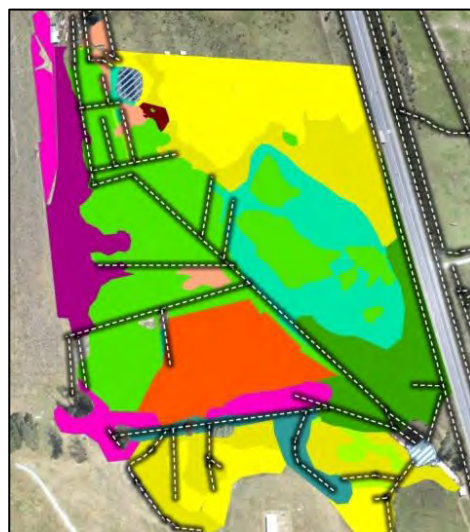
Despite the apparent obstruction to flow afforded by the road, active drains that pass through and around this remnant of the former swamp are still having an impact. Indeed a closer inspection of the drains and vegetation association maps together (right) clearly shows how the drains continue to shape the ecology of this wetland, as it has recovered after apparent subsidence. This relationship is not a coincidence; it is clear case of *cause and effect* and illustrates in detail

how manipulating flows over the long-term directly shapes and defines wetland floristics and ecology. It all starts with water regime – something that can be proactively managed into the future – and that is where the concept of wetland restoration through hydrological management comes into the equation.

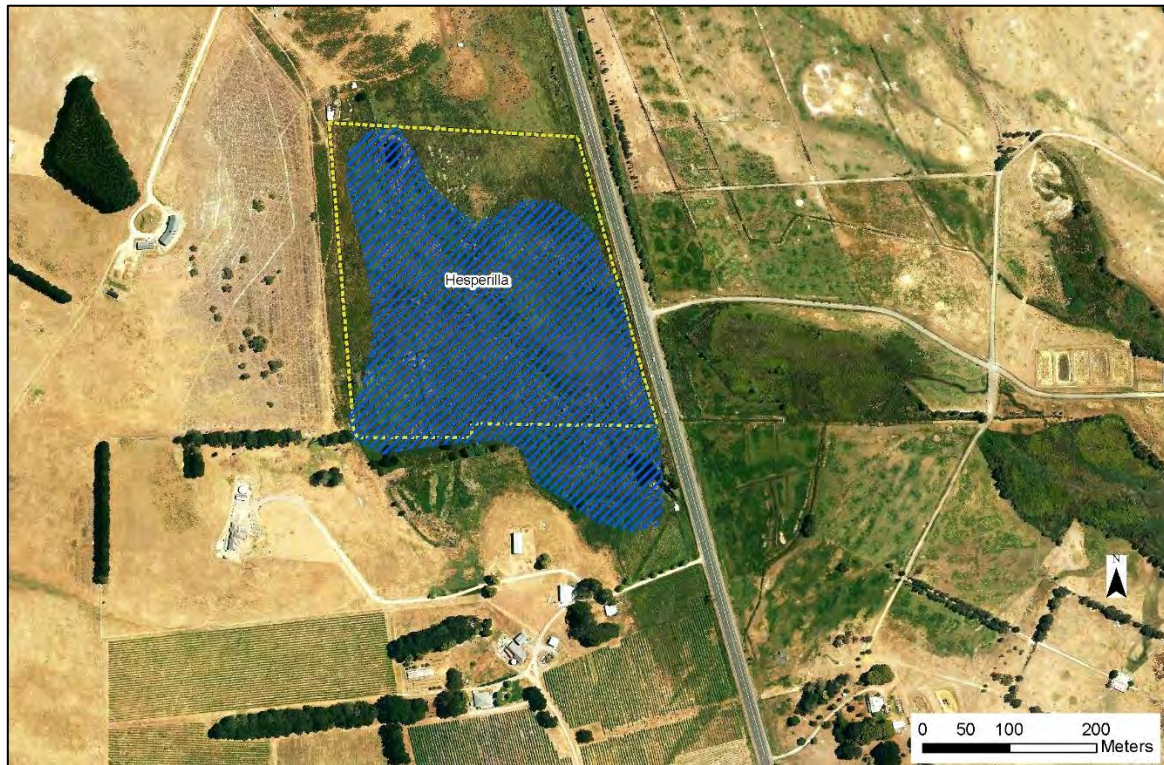
Figure 3.3: Hesperilla Conservation Park (outlined in yellow), showing the current mapped extent of Square Waterhole (blue shading) in the DEWNR GIS wetland layer.

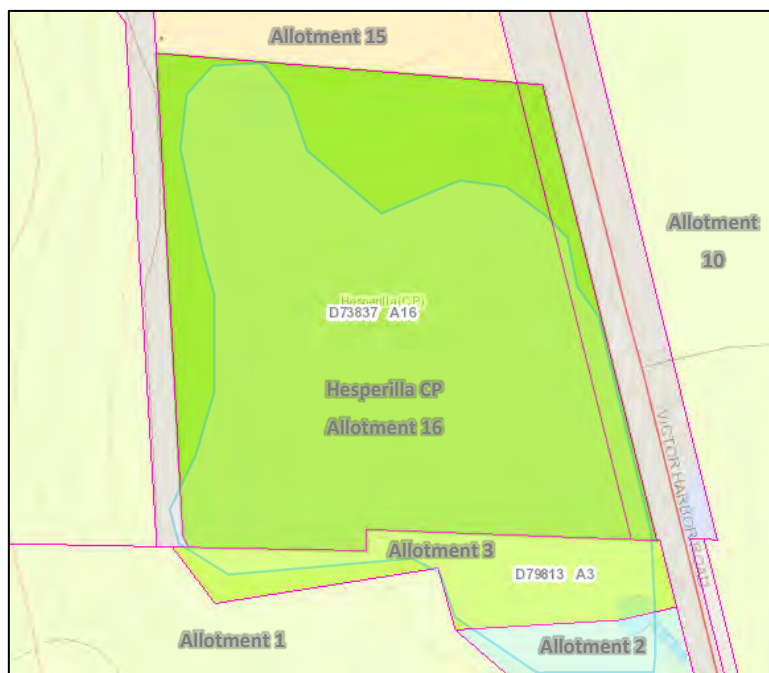
Figure 3.5: Topographic map showing cadastral boundaries and land tenure surrounding Hesperilla Conservation Park. DEWNR wetland polygon is lightly shaded.

Key: Dark Green – Hesperilla Conservation Park; Light Green – Local Government Reserve; Grey – Road Reserves; Other colours – Privately owned properties

1. **To its south** is an irregular shaped parcel (A 3) that has been a reserve vested under the care and control of Alexandrina Council since 2009 – marked light green in Figure 3.5. The creation of Allotment 3 resulted from a land swap negotiation between a previous private owner and the Council. The owner approached Council in 2005 after they discovered part of a building on their property had been constructed over the previous

2. **To the west** of the Conservation Park lies an unmade road reserve, under the care and control of Alexandrina Council – marked grey in Figure 3.5.
3. Finally, **to the east** of the Conservation Park is the main Victor Harbor Road from Mt Compass – also marked grey in Figure 3.5. This is a DPTI managed road, meaning that day-to-day management responsibilities are shared between the South Australian State Government (the road pavement and verge between the marker posts) and Alexandrina Council (the road reserve outside the marker posts).

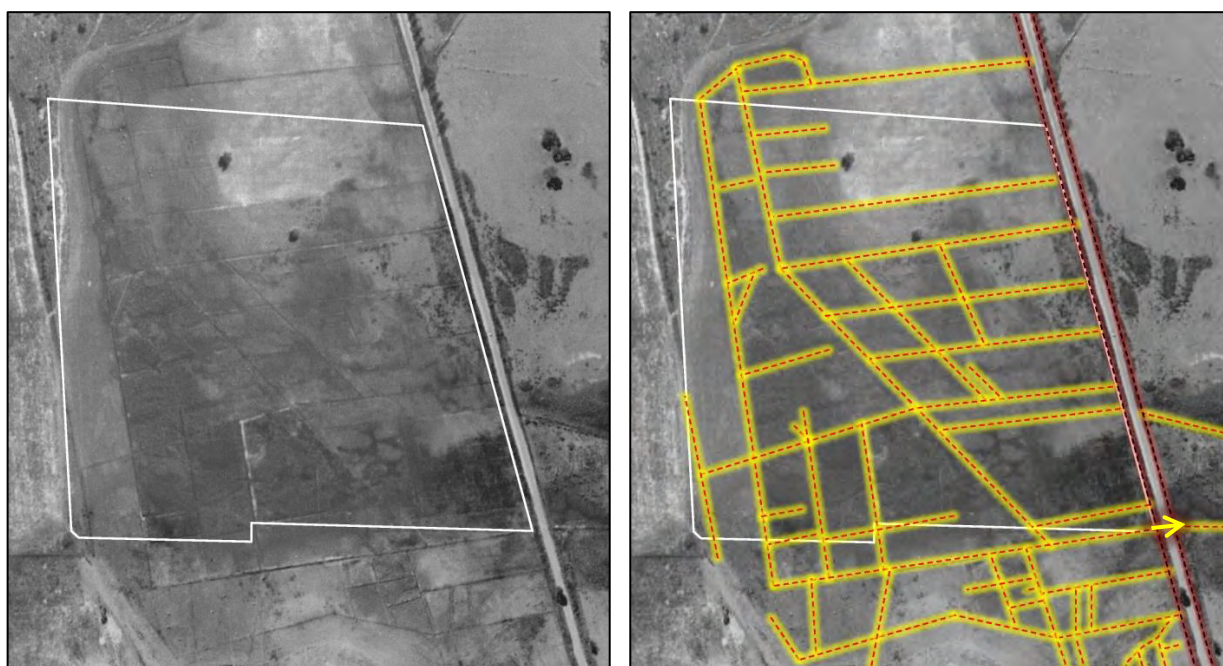
Figure 3.18: The isolated portion of Square Waterhole Swamp to the west of the main road.

Left: in April 1949, with the boundary of present-day Hesperilla CP is indicated in white.

We are fortunate that further insights of the time are possible, because a couple of years before this image was taken, an article appeared in the Chronicle (1947), after P. B. Angus Parsons made his property available for a field day on pasture development in the Mt Compass district (right). He also shared some interesting observations about the amount of water being carried away from the swamp by the drains at that time. The sheer amount of physical work involved in building those drains, can be appreciated upon closer inspection – a vast network for such a small area, directing flows to the main drain culvert under the Victor Harbor Road, at the south-eastern corner of the present-day park. For an accurate representation of the number of drains constructed across the site in the 1940s, please see the before and after images in Figure 3.18.

It is also worth reminding ourselves when viewing the 1949 image in Figure 3.18, that the swamp encountered and further drained by Keith Blakely in the 1940s was already modified. It had been partially drained at least twice previously (when the road was built in the 1860s and again sometime after 1893 but prior to 1903), and had been also subjected to sheep grazing since the 1890s. Beyond comprehensive drainage from the 1920s (and completed in the 1940s), as a result of the subsidence process previously described, over his tenure Keith Blakely had the drainage network periodically maintained, extended or deepened, consistent with farming practices where peatlands have been drained for agriculture (T. Blakely, pers. comm.).

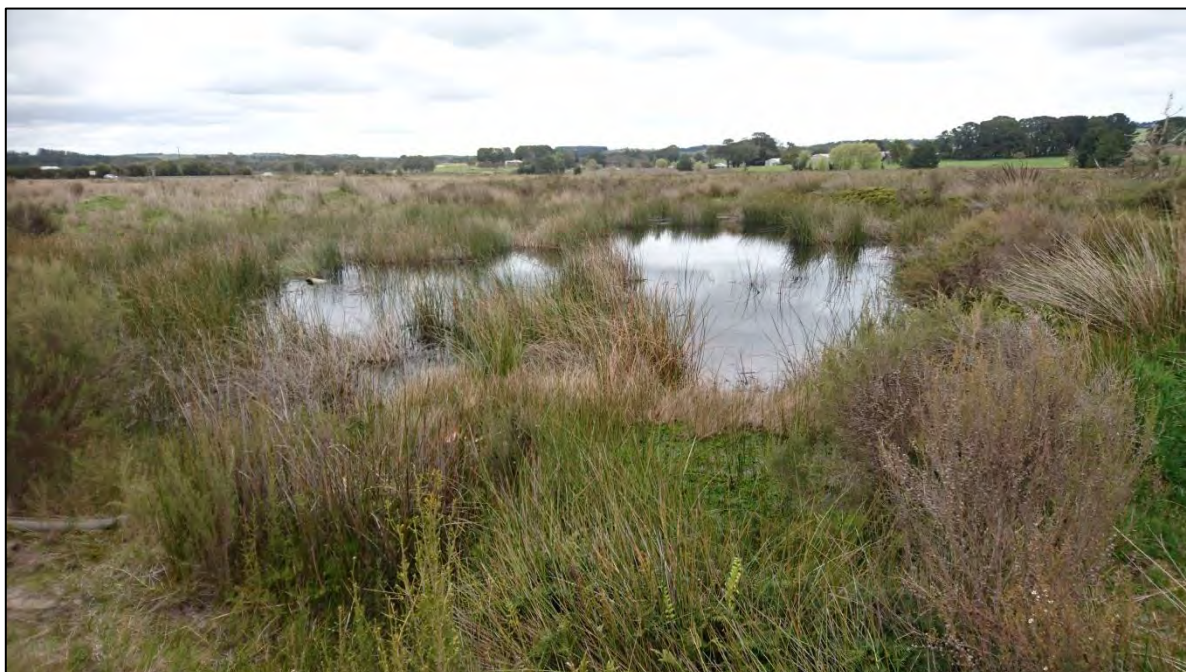
Figure 3.24: The current appearance of the dam in the north-western corner of Hesperilla CP

The current appearance of the dam and what appears to be a concrete foundation for the former pumping station on the bank next to it, are shown in Figure 3.24 and Figure 3.25 respectively.

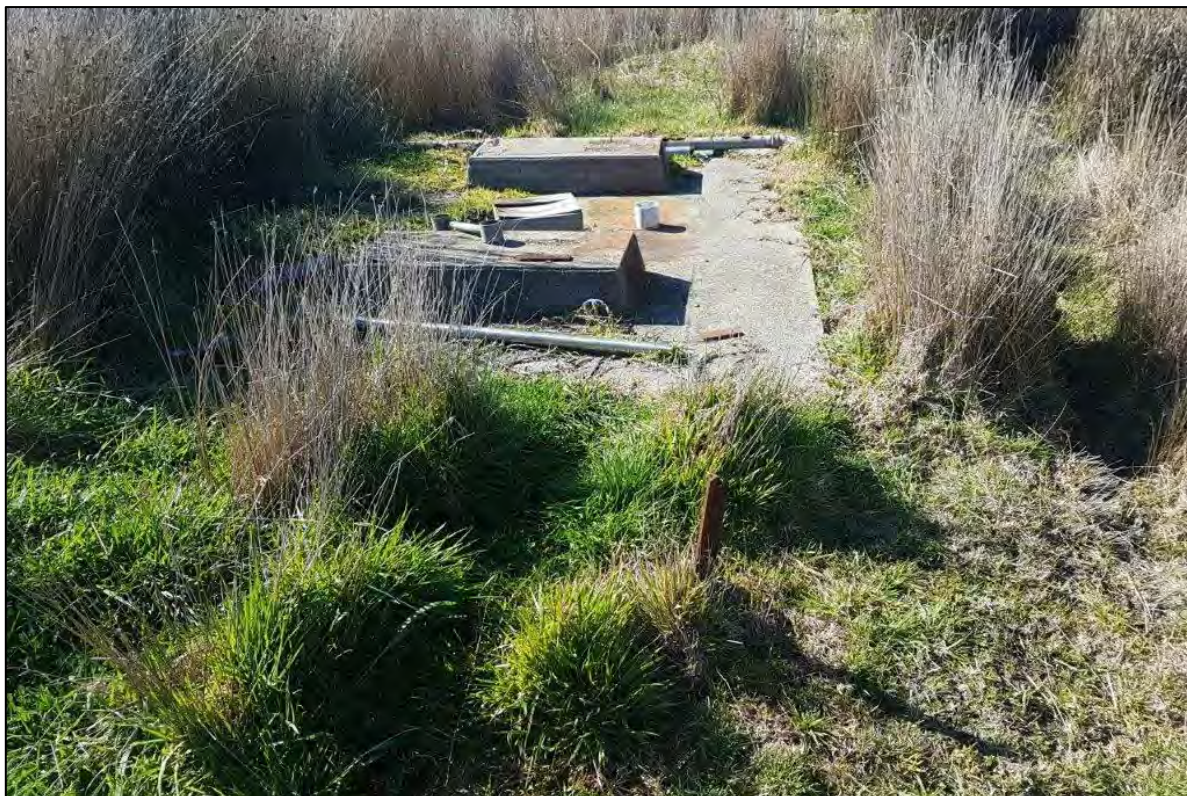
Figure 3.25: A concrete foundation still remains of what appears was the former pumping station

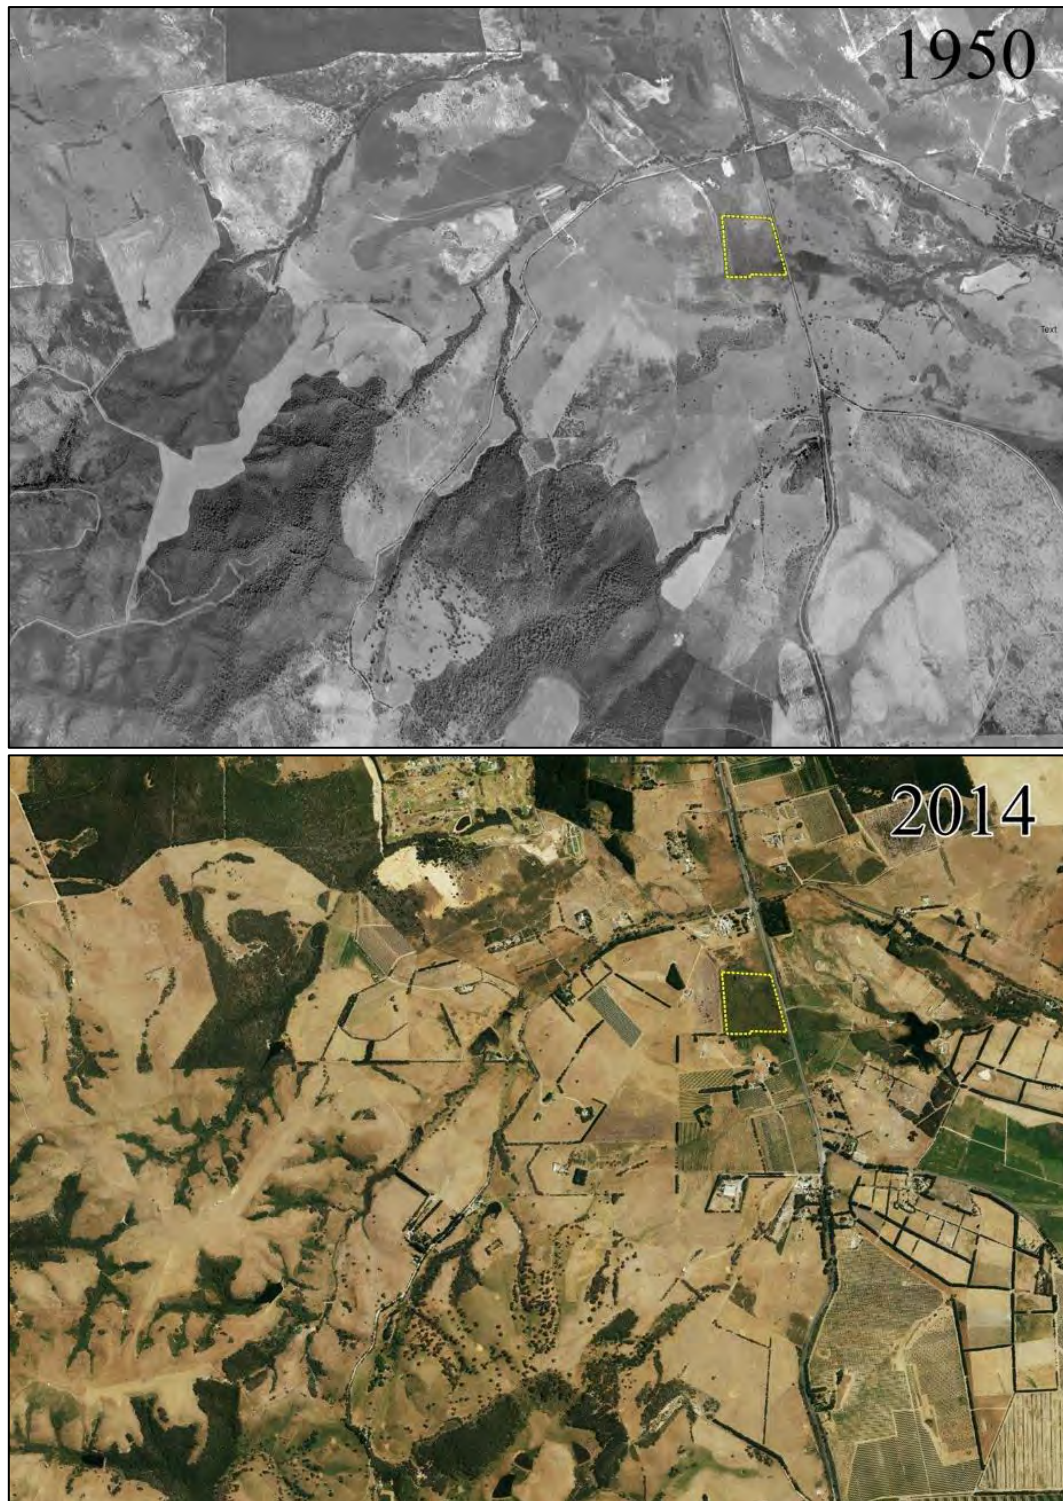
Figure 4.2: An aerial view of the greater catchment adjacent to Square Waterhole, showing areas of vegetation clearance from 1950 to present.

Imagery from 1950 reveals that vegetation clearance had already occurred through much of the catchment around Square Waterhole prior to 1950. However, a comparative view of the wider catchment area around Square Waterhole, using 1950 and 2014 aerial imagery (Figure 4.2) shows significant vegetation clearance in the vicinity of Mt Jagged, an area from which surface and groundwater flows towards Square Waterhole originate.

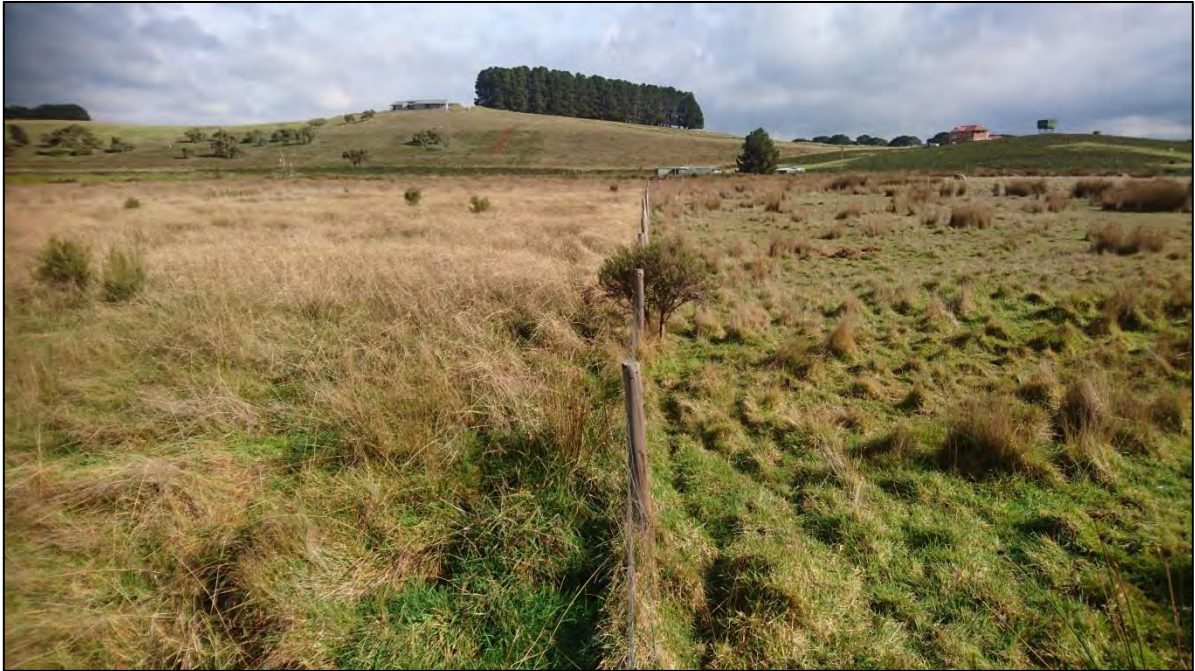
Figure 4.11: Looking west along the northern boundary of Hesperilla CP (ungrazed, left of fence) – this boundary was created as part of the sub-division that resulted in the creation of the park.

Consistent with community feedback received during our consultation process for the project, there is clear evidence that this more elevated, upslope zone of the former saturated swamp margin (Figure 4.11) was still being cut for hay shortly before the park was

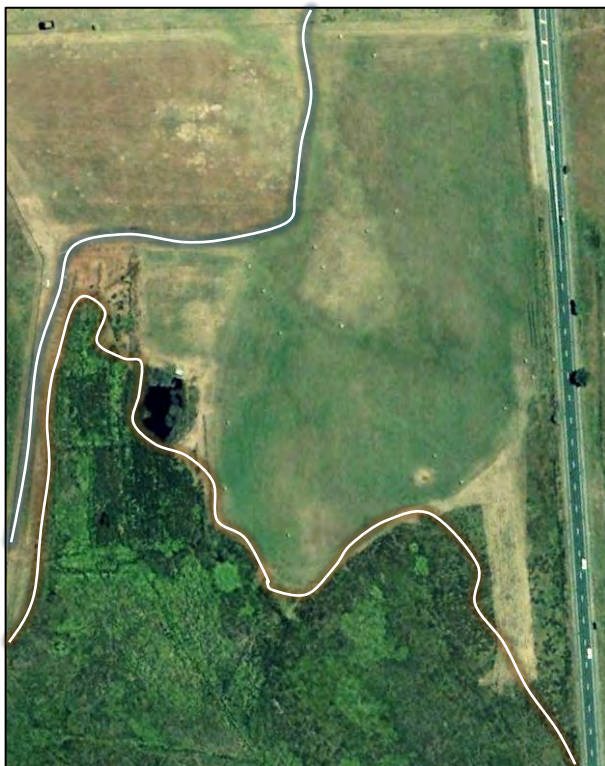
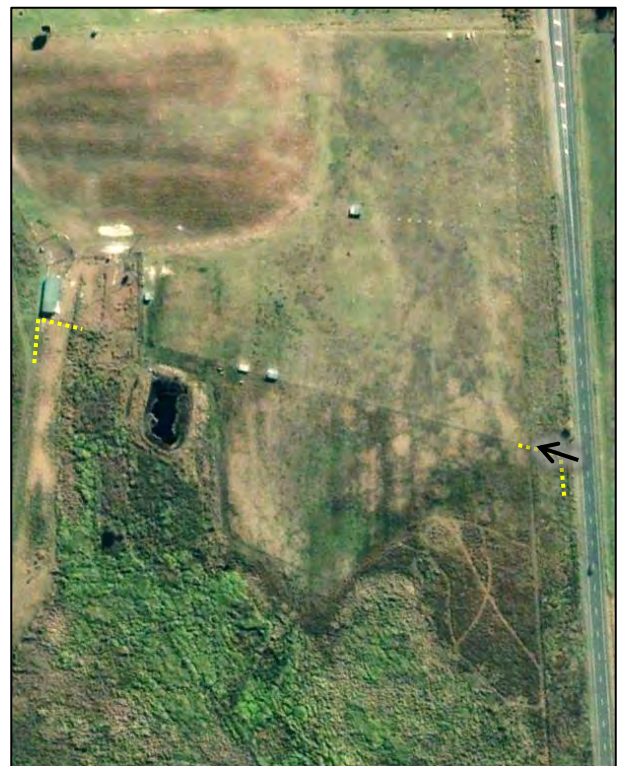
31st Dec 2004 – still being cut for hay
Blue line was the swamp margin in the late 1800s
Orange line was swamp margin in 2004

12th May 2007 – the Park boundary in place
Dashed yellow lines are corners of the park
Arrow is the location of the photo in Figure 4.11

Figure 4.12: The northern boundary zone of Hesperilla CP between 2004 and 2007

created. Hay bales are actually visible in the aerial imagery of the area in December 2004, and the new boundary fence is in place 2½ years later in 2007, as shown in Figure 4.12.

This substantial area of what was originally mapped as swamp vegetation, clearly associated with an area of upslope saturation and seepage, provides a clear reminder of just how much this portion of the wetland has changed since it was mapped in the late 1800s. It also illustrates the process of downward migration of the saturated swamp margin after drainage (also represented later, in Figure 4.25).

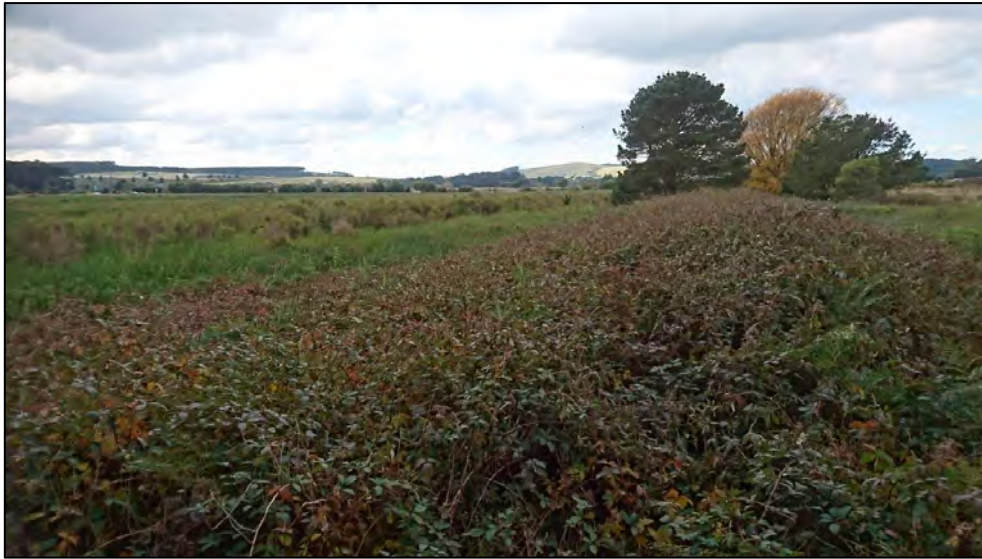
Figure 4.16: Looking east along a large Blackberry covered spoil bank to the south of the Conservation Park (which is in the left of the image)

When considering the whole remnant swamp area beyond Hesperilla CP, including surrounding public and private land, Blackberry (*Rubus spp.*) is probably the most significant introduced woody weed threatening the values of the swamp. The species is particularly dominant on the elevated, well-drained spoil banks associated with the large, deeper drains situated on both the public (local government reserve) and private land south of the Conservation Park, given past investment in control by the GWLAP within the park. This area is mapped in Figure 4.14 and an image representative of this zone is shown in Figure 4.16.

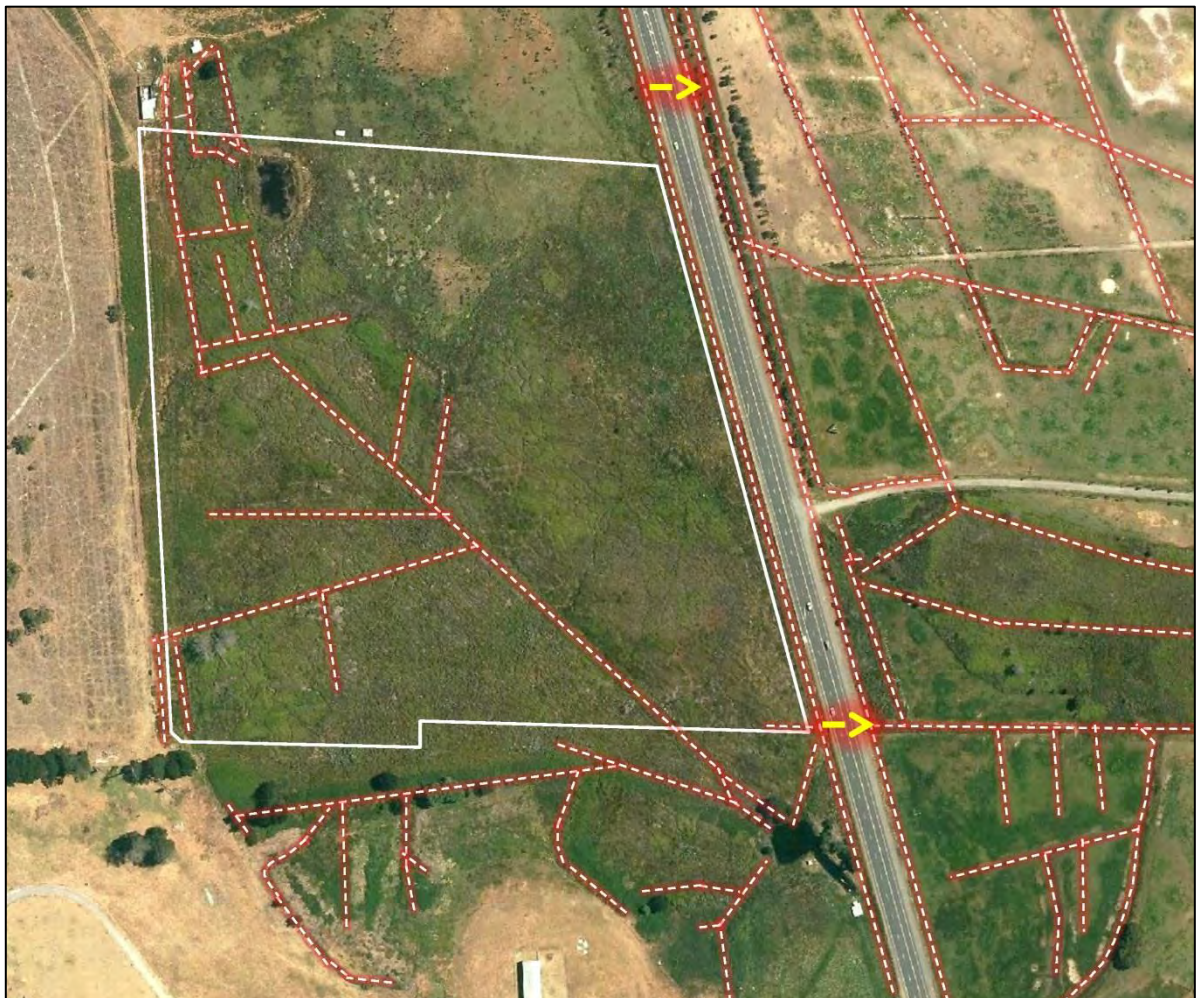
Figure 4.20: Highlighting the most significant drains still impacting upon the hydrology of the site. The arrows indicate culvert locations.

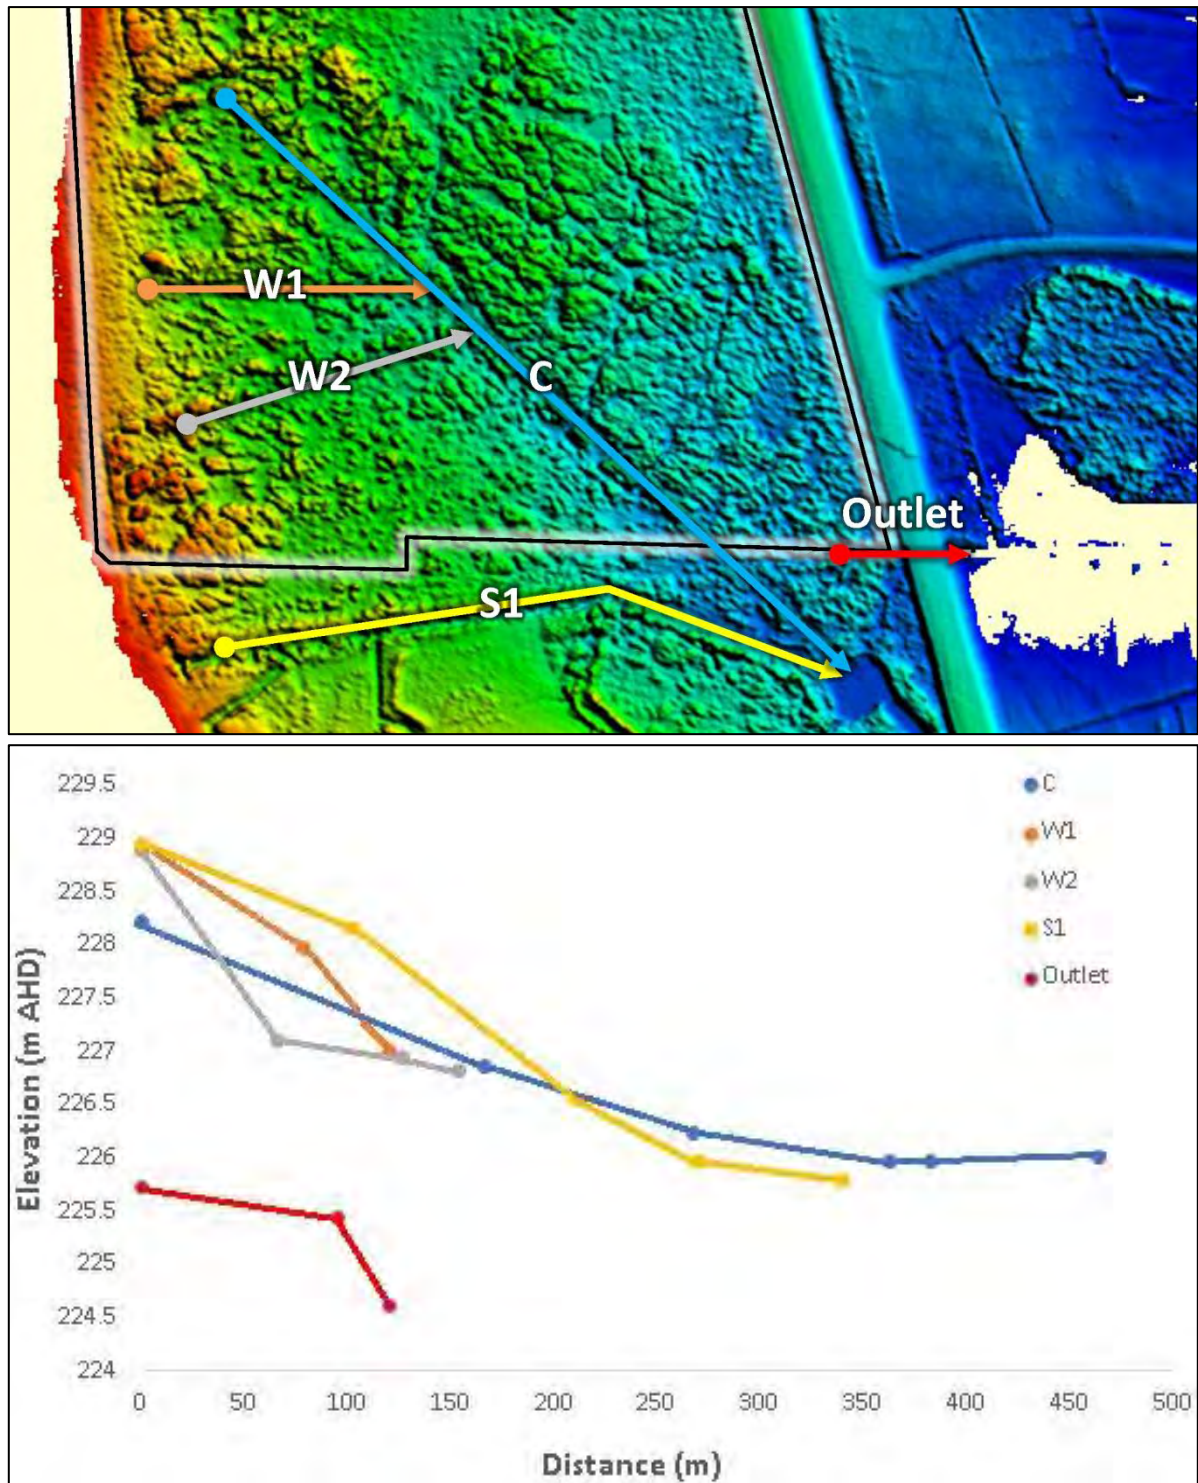
Figure 4.22: Digital Elevation Model and inferred drainage gradients

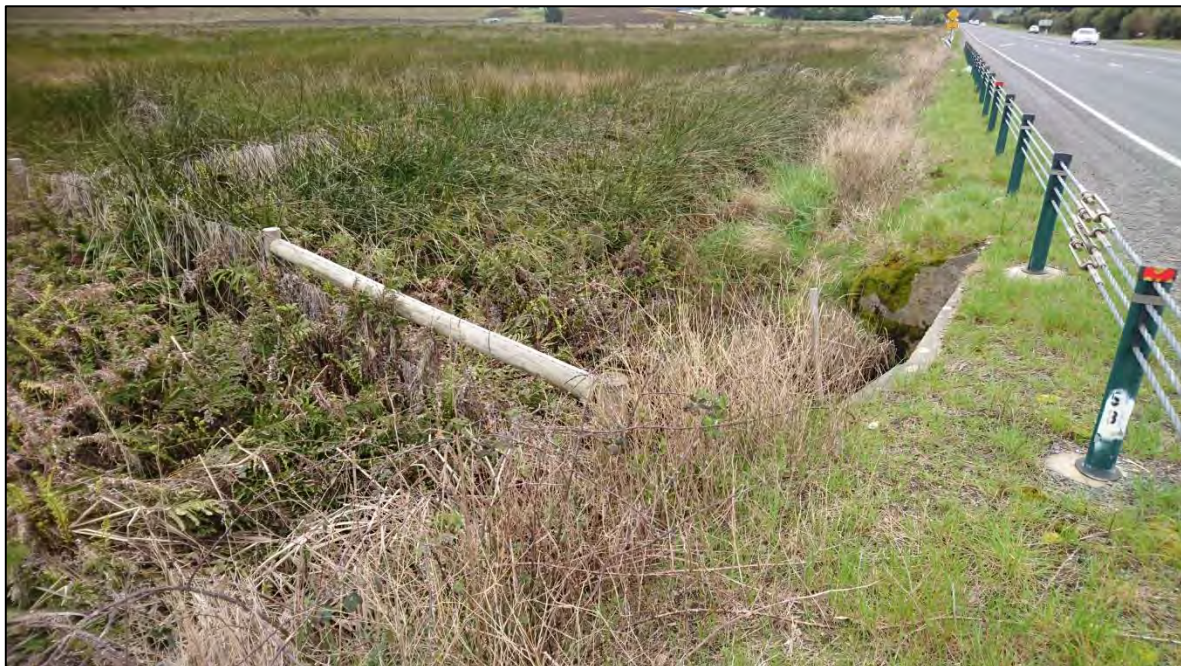
Figure 4.30: Looking north along the Victor Harbor Road and across the swamp to the north-west, from the location of the main drain culvert outlet (the SE corner of Hesperilla CP)

that the site itself has a significant natural lateral west-east gradient across it. This is not a 'wetland basin' feature with a fixed sill level (or static inundation height) – rather, it is more like a sloped 'sponge' of peat that had built up slowly but uniformly over time, kept saturated by its relationship to a groundwater supply that originally passed more slowly through all of it, all the time. As soon as that pattern of hydration and water movement was changed, then changes in eco-hydrological character were inevitable. To highlight this point, consider that between the current saturated western edge of the swamp, the break of slope (groundwater discharge zone) of the hills, is approximately 3m higher than the elevation of the swamp next to the road (Figure 4.29). Further, the elevated roadway itself sits around 1m above the drained peat immediately to its west, as shown in Figure 4.30.

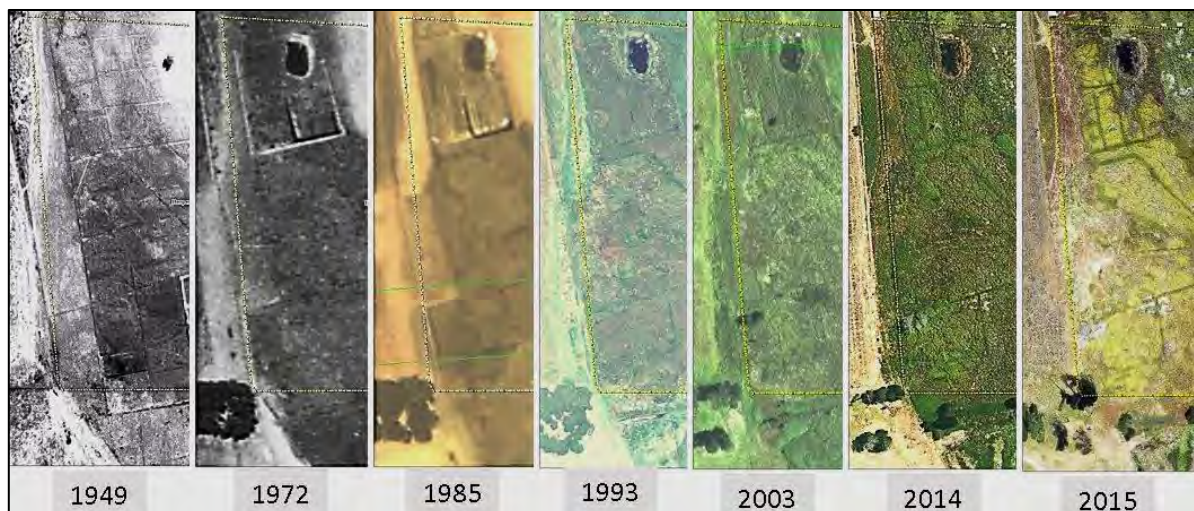
Figure 5.2: Vegetation change in Zone B1 over time.

These sub-zones experienced significant development pressure when the site was first developed, but have also undergone substantial spontaneous native vegetation recovery, despite the number of drains present and active (for example see Zone B1 in Figure 5.2). A small number of the N-S drains in Zone B1 actually straddle the boundary and continue up a relatively steep slope into the adjacent private land.

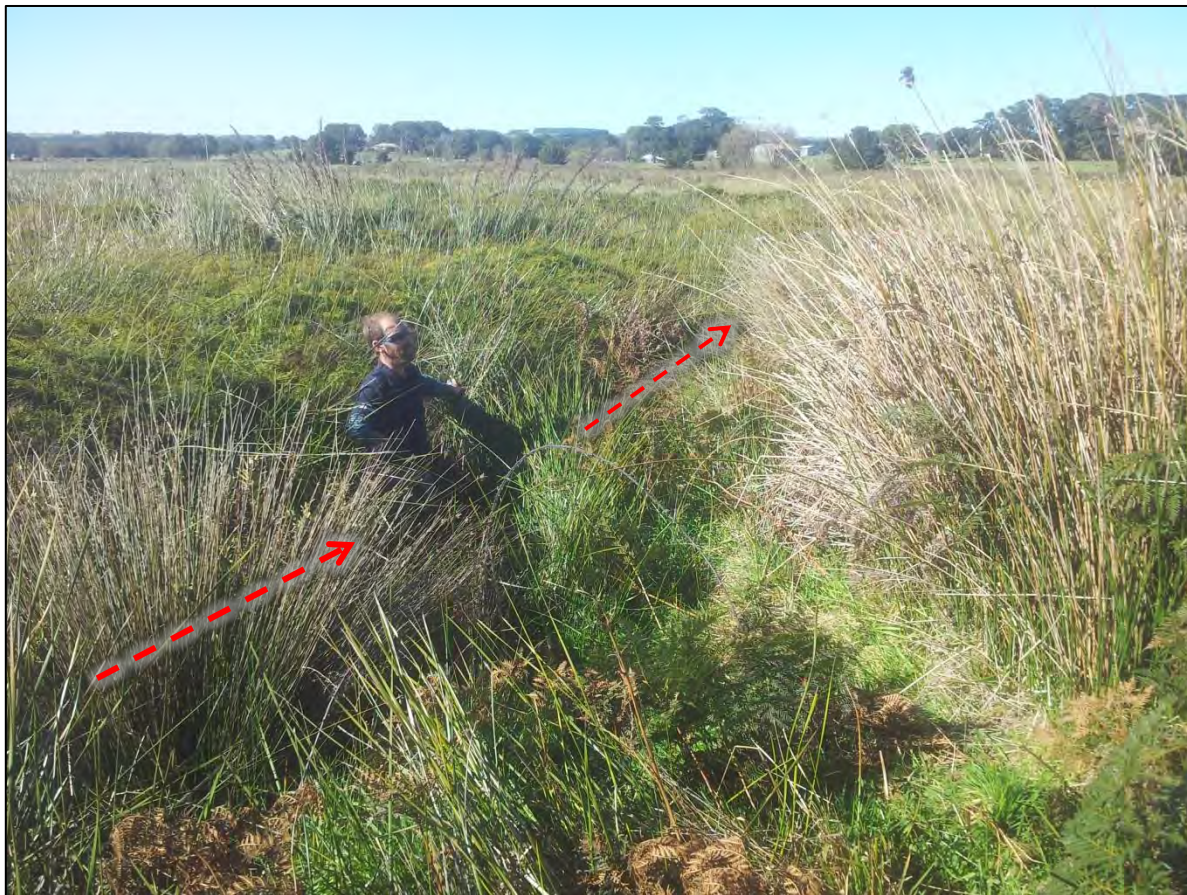
Figure 5.3: Lachlan standing in the bed of the western-most drain in sub-zone B1, which runs along the break of slope. The drier upslope bank is in the right and foreground of the image, while the recovering swamp vegetation can be seen behind. Image taken facing south-east.

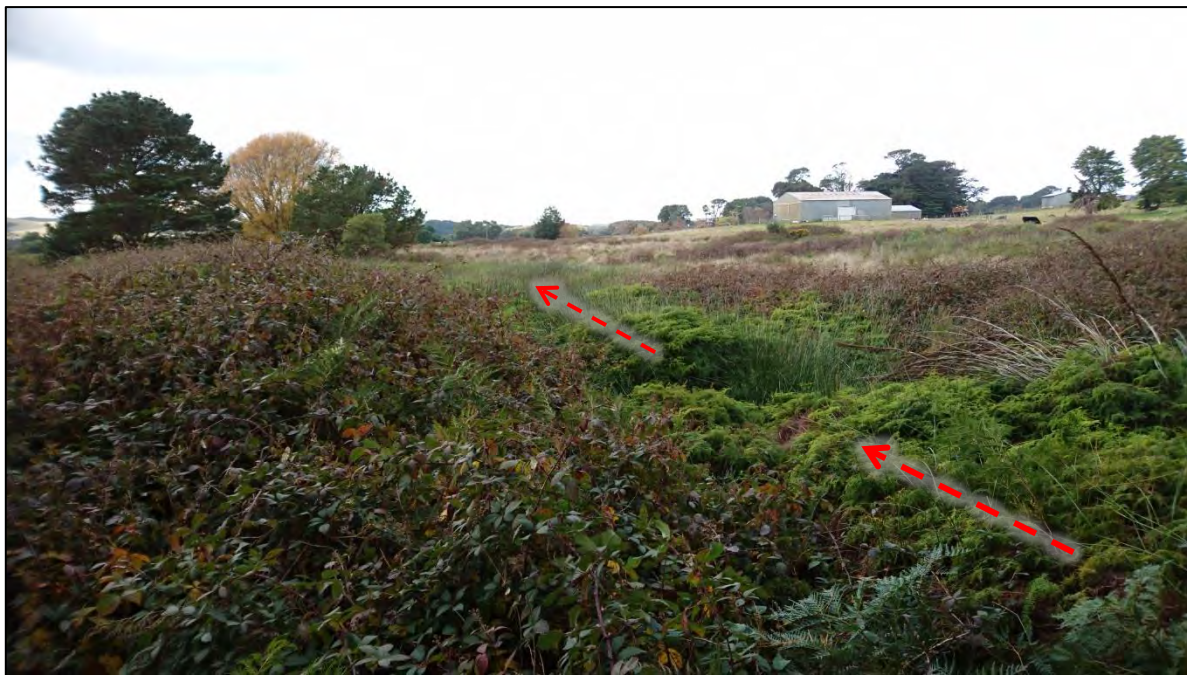
Figure 5.4: Looking east along the major drain in sub-zone B3, showing how the large spoil banks either side have become completely infested by blackberry thickets.

This has created conditions perfect for blackberry to establish and thrive, as the species is particularly well suited to well-drained soils with access to sub-surface permanent moisture – meaning that many of the spoil banks in this sub-zone are heavily infested. This impact is shown in Figure 5.4.

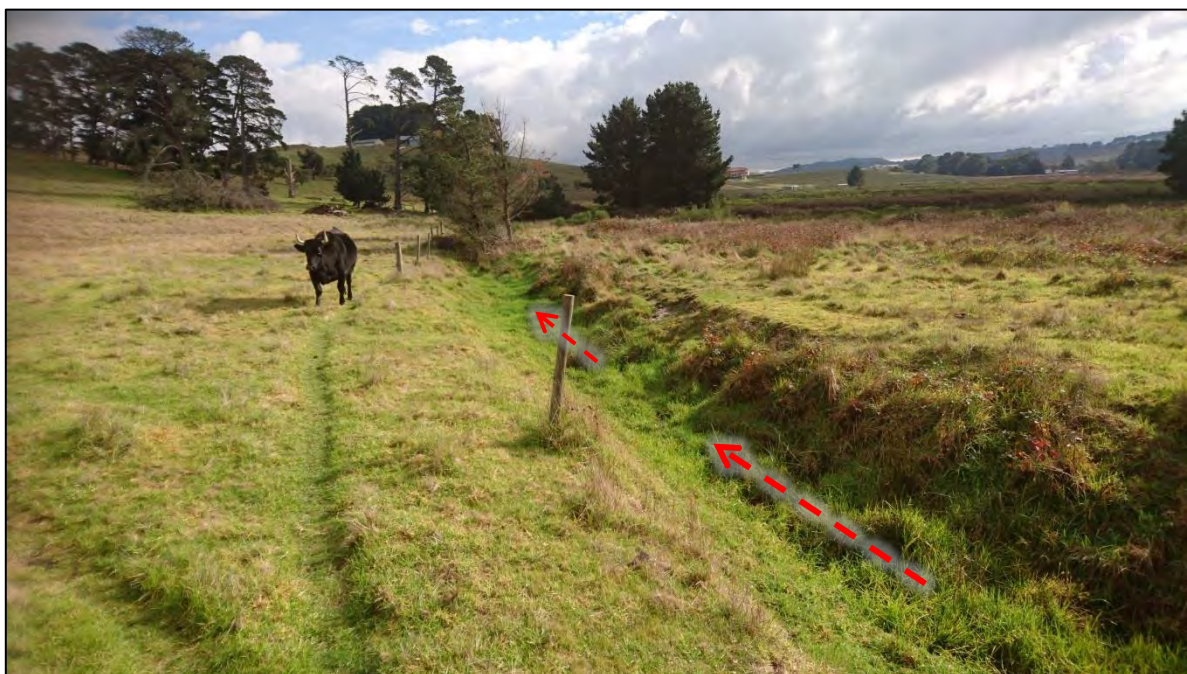
Figure 5.5: Looking north along the south-western most break of slope drain in in sub-zone B3, a more elevated area of dehydrated former swamp still utilised for grazing. This image illustrates what more of Square Waterhole Swamp would look like, if drainage had been successful. Hesperilla CP is in the middleground, right of image.

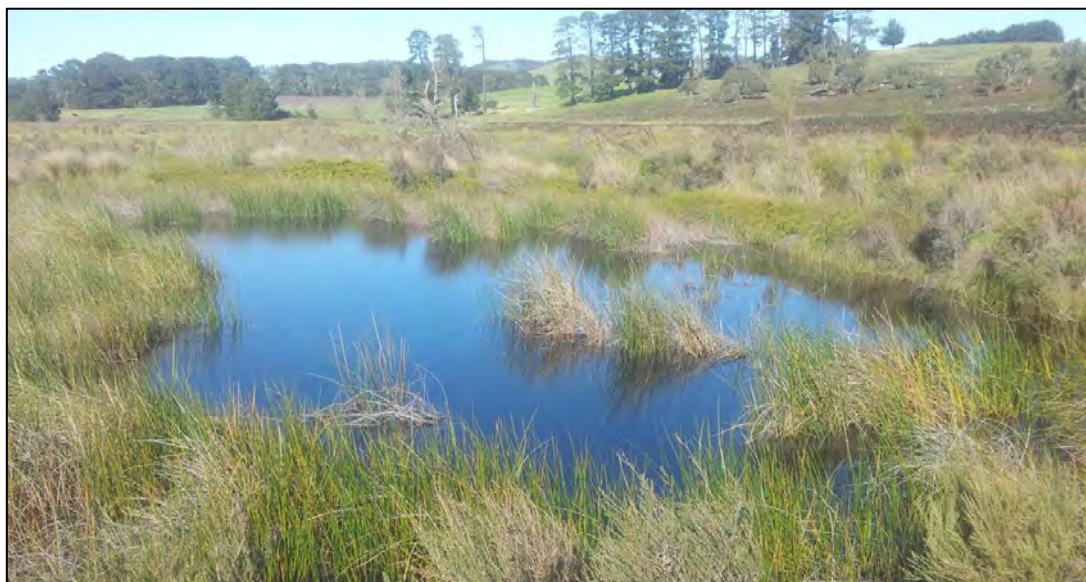
Figure 5.6: Looking south-west across the dam in D1, of 1960s construction.

Dam 1 (D1), as previously explained, was constructed in the early 1960s to supply water to the former milk products factory to the north of the swamp. The dam is essentially a window on the water table under that part of the swamp, and ironically is sustained by the very same water source that agricultural drainage activities were concurrently trying to remove from the site. Aside from a couple of minor feeder drains (in Zone B1) that appear to connect them with this feature via surface flows, the dam is otherwise isolated and land-locked by dense swamp vegetation (Figure 5.6).

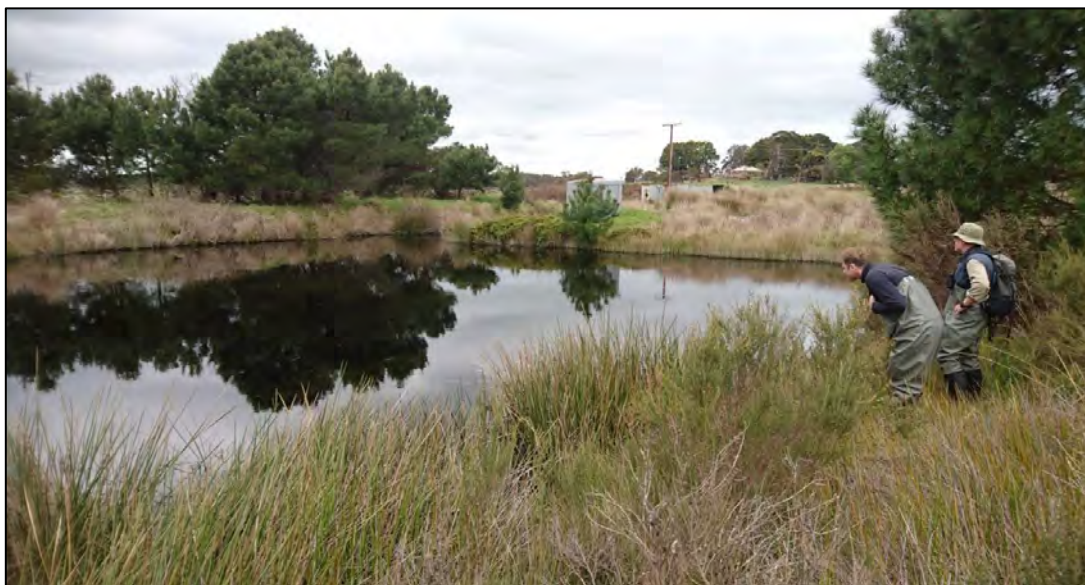
Figure 5.7: Looking south-east across the dam in D2, of 1950s construction.

Dam 2 (D2) was constructed in the 1950s to supply water to the property to the south of the swamp, when the Victor Harbor Road was upgraded. Like D1, site D2 captures surface flows and exposes the groundwater table (Figure 5.7).

However, unlike the other dam, D2 is situated much lower in the elevation gradient of the site. In fact, as shown in the LiDAR imagery earlier in the report, it is one of the lowest points in the swamp before water exists under the Culverts at C2. It is also the present terminus for almost all artificial drainage coming out of the swamp, before permanently spilling towards C2.

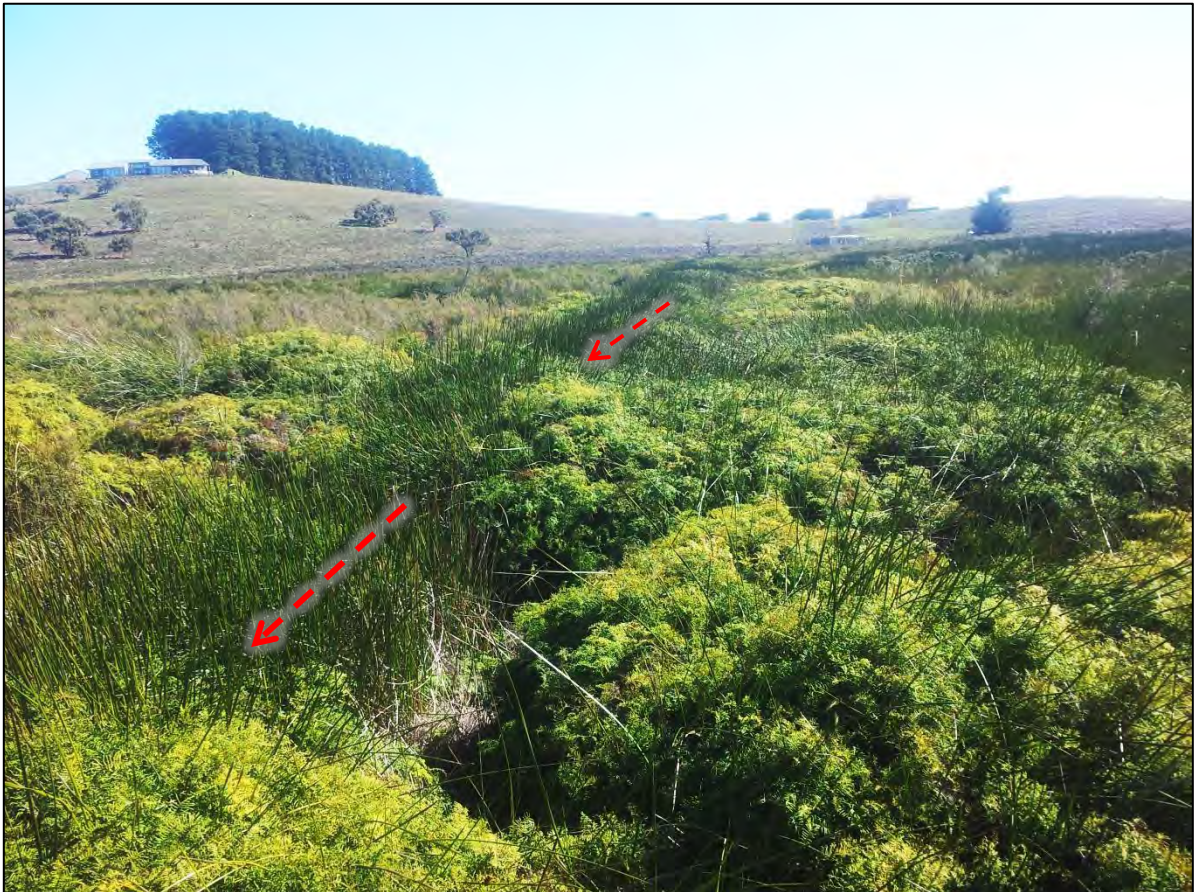
Figure 5.9: Looking north-west up the main diagonal drain (sedges) and spoil bank (covered in coral fern). Note the prickly tea-tree dominated vegetation community to the left (south-western side) of the drain, and the sedgeland to the right (north-eastern side).

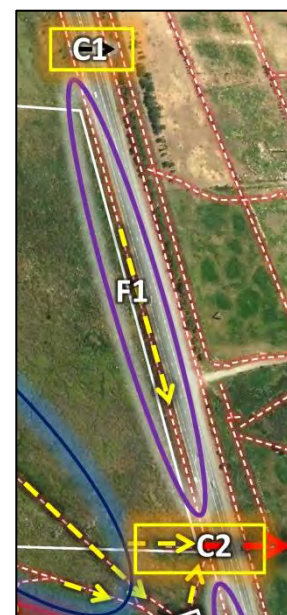
Figure 5.10: Looking east across the Victor Harbor Road – single pipe culvert, C1. Seasonal catch drain flows enter this culvert from the north.

The first, C1 (Figure 5.10), is a minor, single pipe culvert that doesn't carry permanent flows and is situated significantly higher in the elevation gradient. It is adjacent to the portion of the former swamp that was cleared and more recently used as a paddock for cutting hay. Parts of this area situated outside of the Conservation Park are still used for grazing (see Figure 4.11).

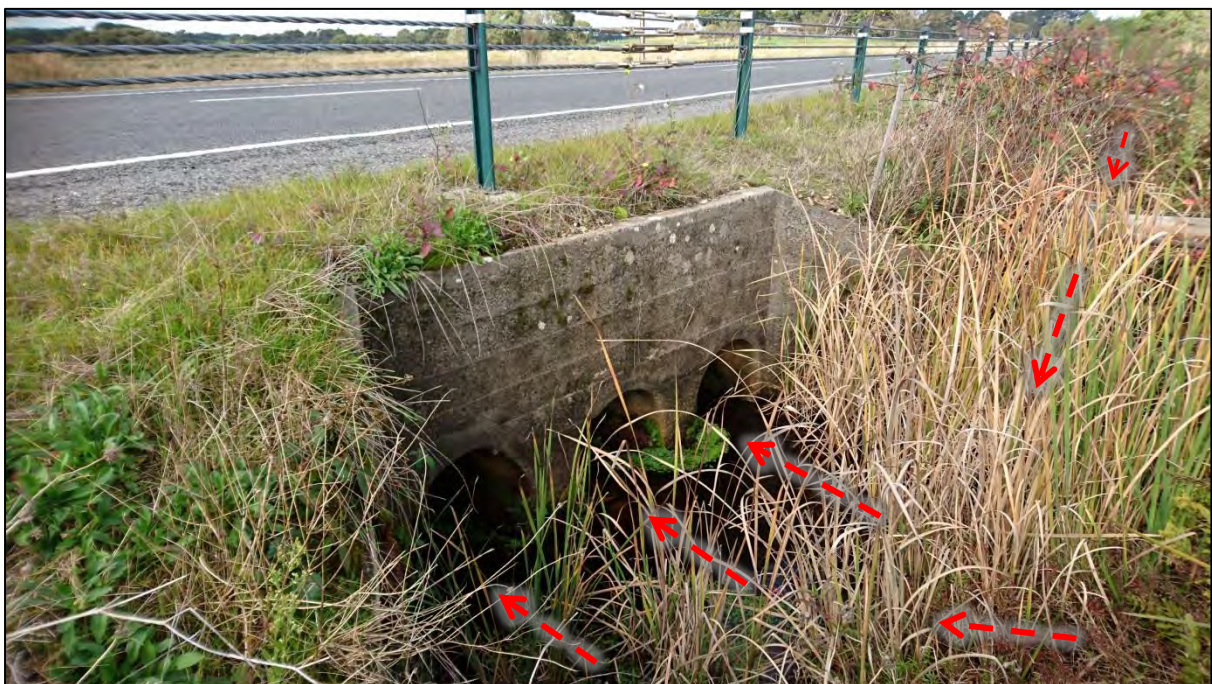
Figure 5.11: Looking south-east across the Victor Harbor Road – triple pipe culvert, C2. Permanent discharges enter this culvert, especially from the south-west and west. Additional seasonal road catch drain flows also reach this exit point from the south and north.
