Hydrological restoration options for Square Waterhole Swamp, Hesperilla Conservation Park.

*A case study for Fleurieu Peninsula swamp restoration in the SA
Murray Darling Basin NRM Region.*

August 2017

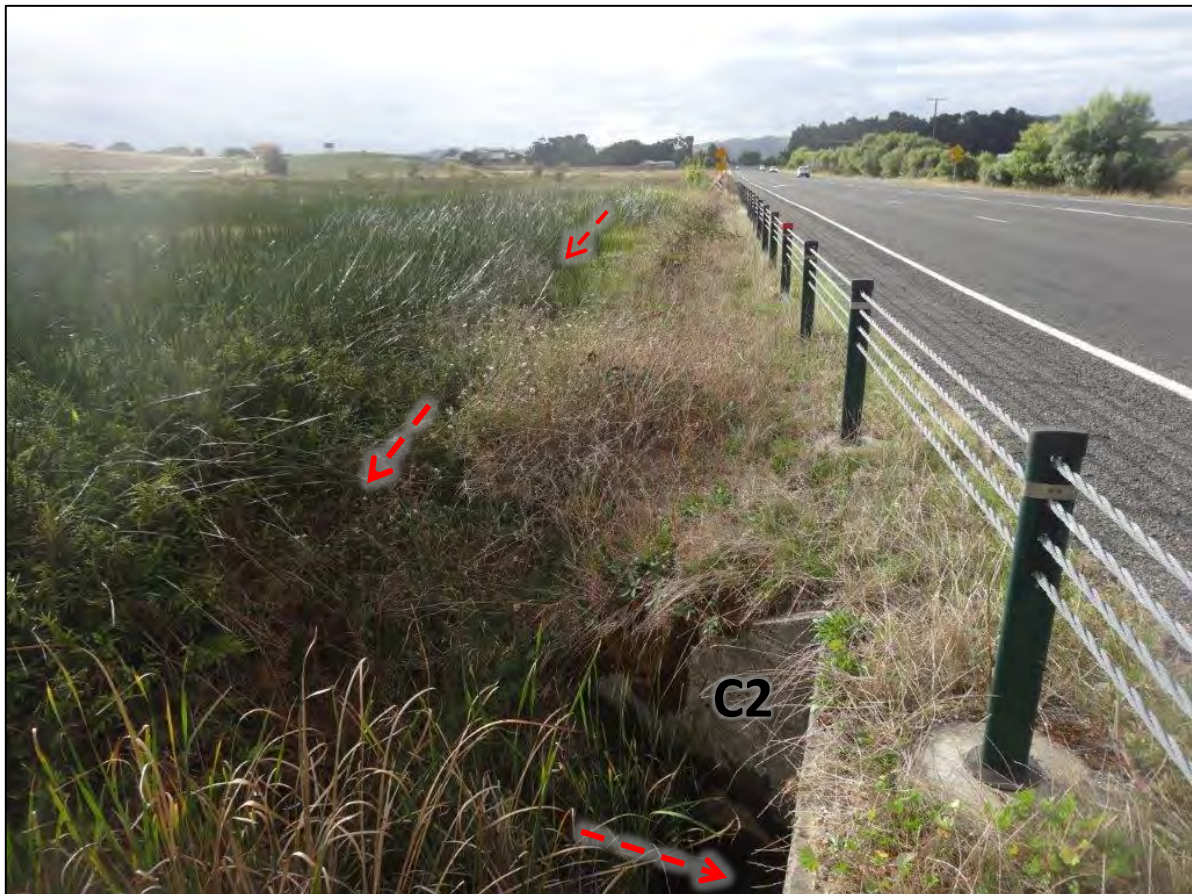
Figure 5.12: Looking north from C2 up the western verge next to the Victor Harbor Road.

The effects of catch drain F1 are predominantly local, only conveying flows from between the two culverts (C1 and C2), as shown in Figure 5.12.

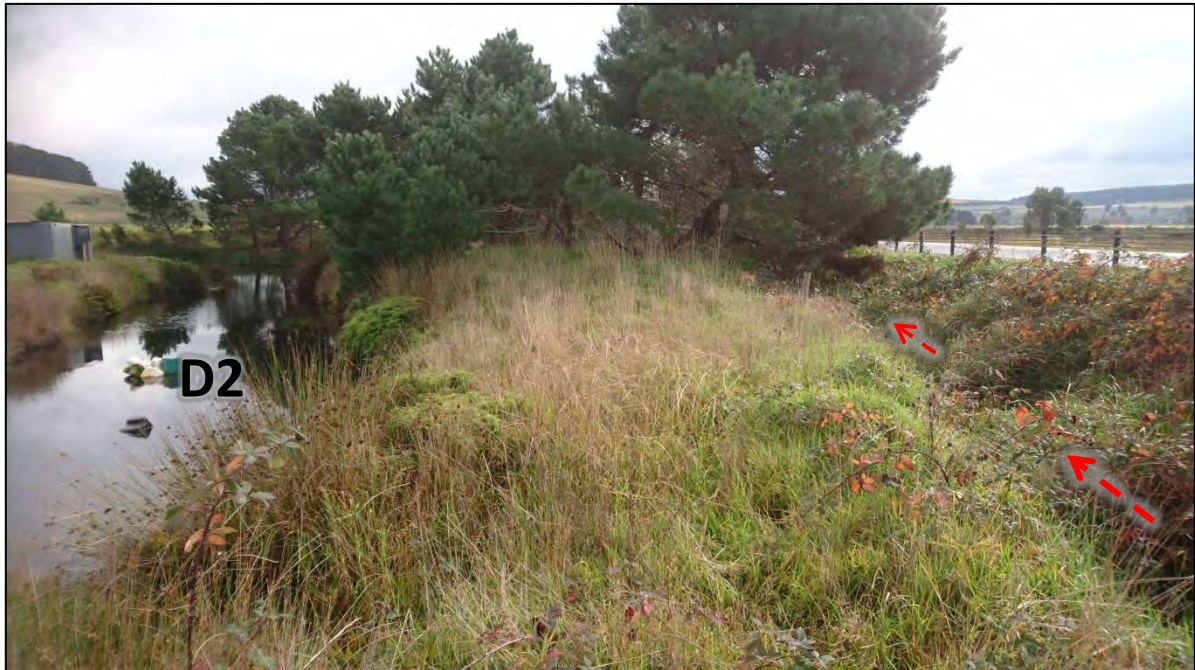
Figure 5.13: Looking north from the bank between D2 and F2, next to the Victor Harbor Road. Culvert C2 is further north, behind the trees.

Figure 5.13 shows where this channel passes the dam at D2, on its way to the main drain outfall and culverts at C2.

The channel at F2 is especially deep as a result of being required to carry additional flows and maintain effective drainage of the corner of the swamp surrounding the dam (D2). The terms of agreement with the landholder who owns D2, and the inundation regime that is acceptable for this part of the swamp, would determine the specific design solutions that can be proposed at this location to manage the additional inflows in the F2 catch drain.

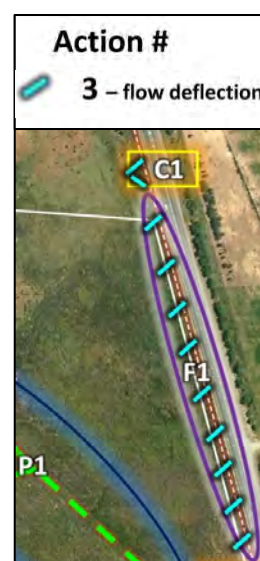
The road embankment has been sufficiently 'built up' as a causeway through this section of formerly continuous swamp and, in combination with the maintenance of outflows from the wetland (at culvert C2), proposed works would never threaten to cause flooding of the road surface. Such works would however capitalise on the fact the road is there, using this key infrastructure to the advantage of the future hydrological management of the site – and turning what is currently a potential threat into a self-sustaining and self-regulating restoration solution.

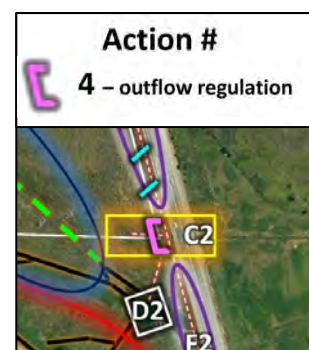
A relatively inexpensive, impermanent and adjustable option for initially trialling these works prior to committing to more permanent infrastructure, would be to install a three-sided geo-fabric sandbag spillway at this location. To ensure outflows through the culverts are not compromised, the structure would be set back and tied into the road embankment either side of the concrete wings of the culvert. Building a structure external to the culvert itself, up to the current bed level of the wetland, would allow the drain to spill at a higher level and still drain through an open culvert. This would ensure that high flow events were still catered for without any changes to this existing fixed infrastructure but, crucially, ensure that permanent groundwater baseflows would be regulated, increasing hydrological retention time in the swamp prior to discharge.
