Restoring flows to Glenshera Swamp after 70 years of drainage

Mark Bachmann, Nature Glenelg Trust (NGT)

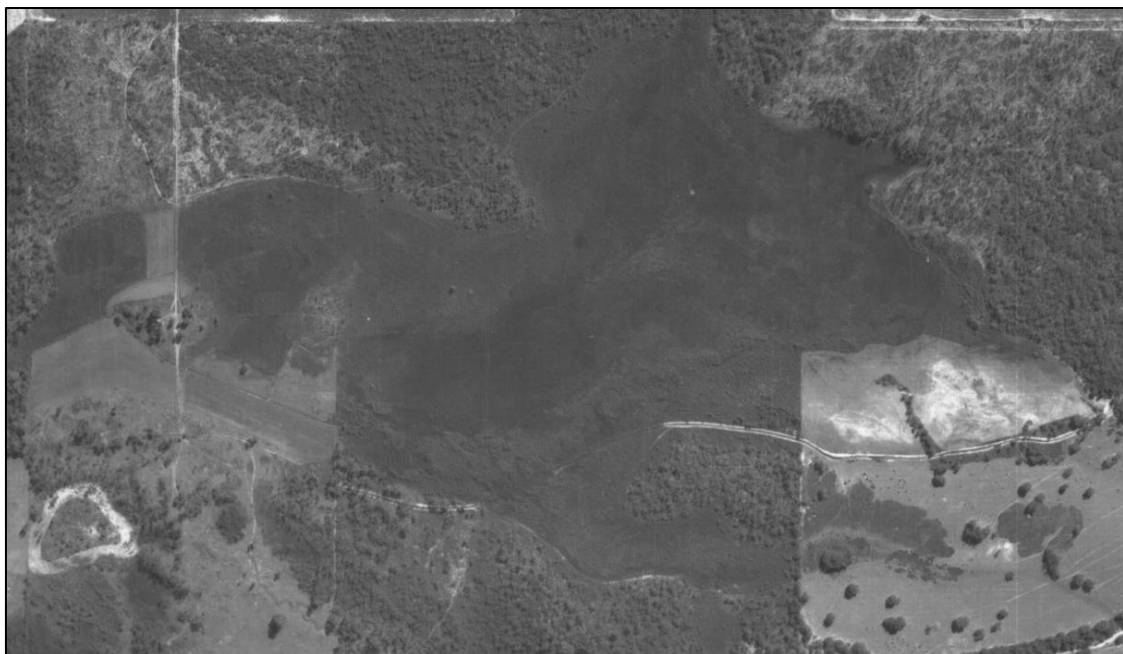
April 1949 aerial photograph of Glenshera Swamp

Glenshera Swamp, situated six kilometres west of Mount Compass, was first mapped in detail when the area was surveyed in February 1899, and remained largely intact when the first aerial photograph was taken in April 1949. In addition to early clearance, the main change by that time was the diversion of surface flows.

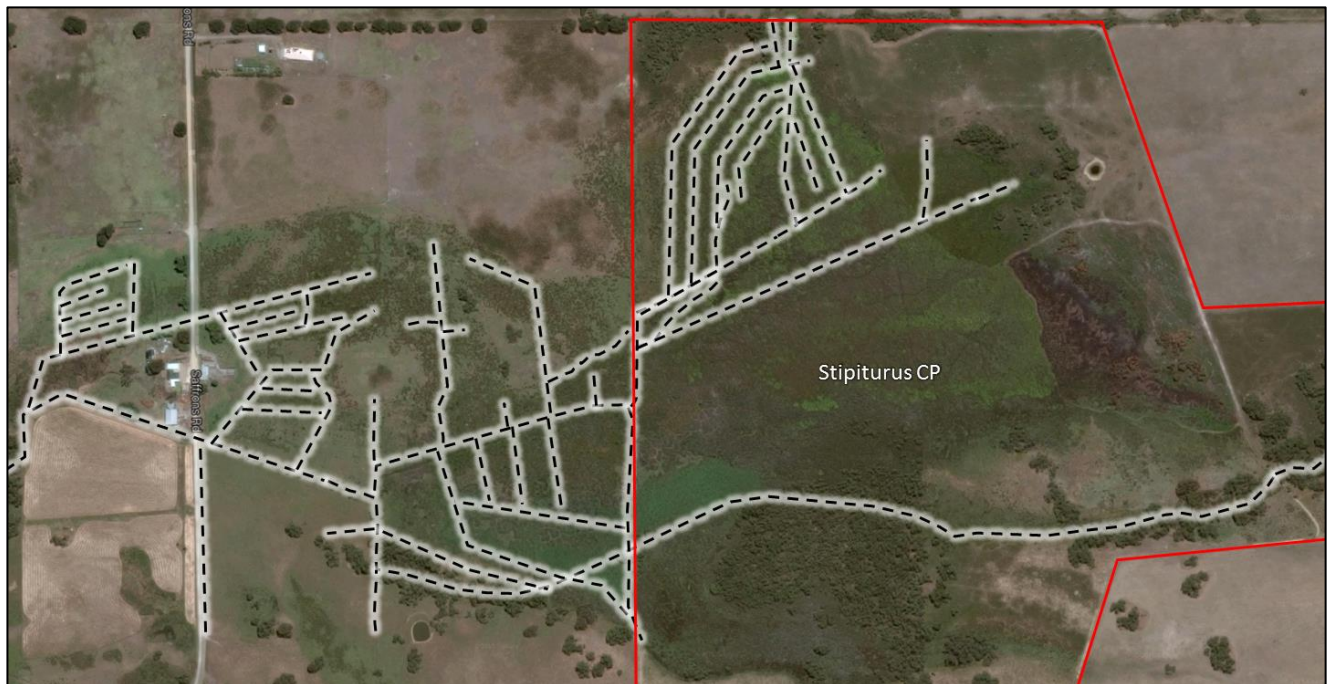
September 2014 aerial image of Glenshera Swamp, showing drains (black dashed lines) and Stipiturus Conservation Park boundary (red line)

Today a sizeable portion of the former extent of Glenshera Swamp is situated within Stipiturus Conservation Park and is widely considered one of the most important remaining swamps of the Fleurieu Peninsula, a nationally threatened ecological community. The site retains a suite of important biodiversity values, despite efforts over several decades (up to its reservation in 2003) to make the area more suitable for agricultural production, through attempts at comprehensive drainage, as well as clearance and grazing activities.

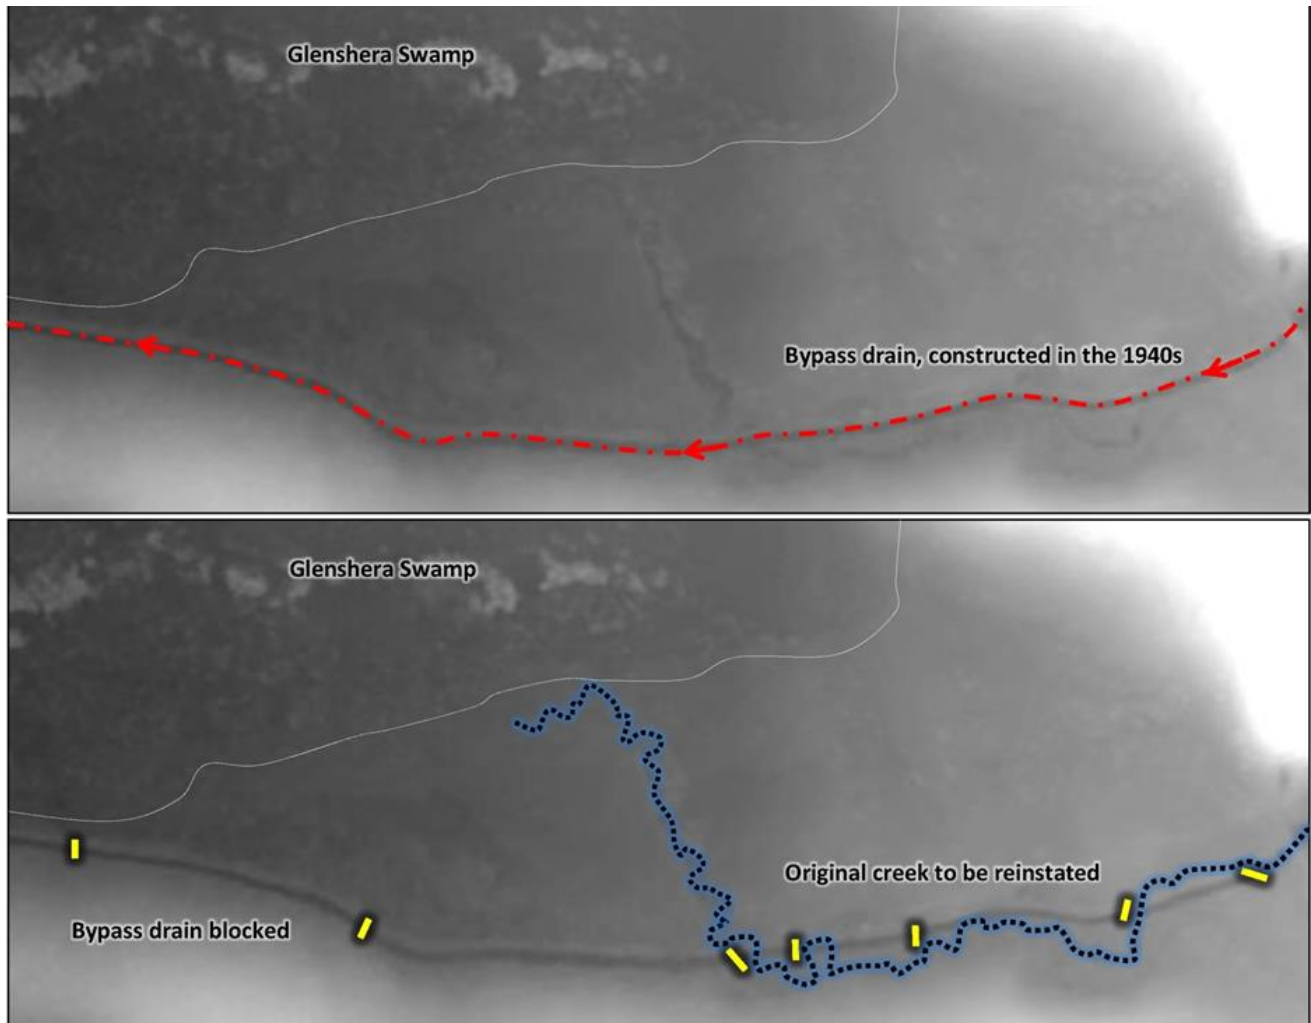
Before and after: proposed reinstatement of the meanders in the creek, and bypass drain decommissioning

Addressing alternations to hydrology caused by the bypass drain constructed in the 1940s was the initial primary focus of work in the Conservation Park, as shown below. These works, funded by the Department for Environment, Water and Natural Resources, were primarily intended to reinstate inflows to the swamp. Additional works included three weirs downstream of the original creek, which were intenintalled to slow flows and/or prevent lateral drawdown of water from the swamp margin.

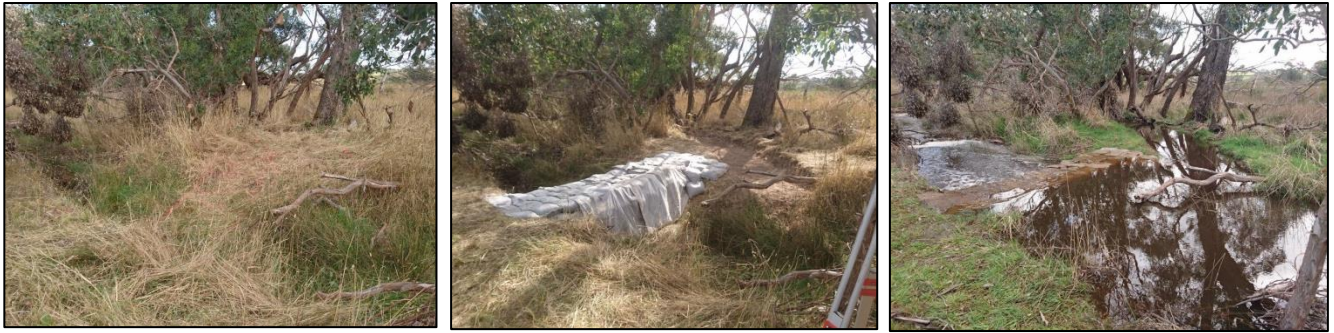
Location of the Structure #1: March 2017 (left), April 2017 (middle) and August 2017 (right)

Despite a dry June, the works have been fully operational since July 2017, when the catchment started to generate sufficient runoff to reactivate the former creek channel, a narrow band of adjacent floodplain and restore all low-moderate creek flows towards the main swamp for the first time in seven decades.

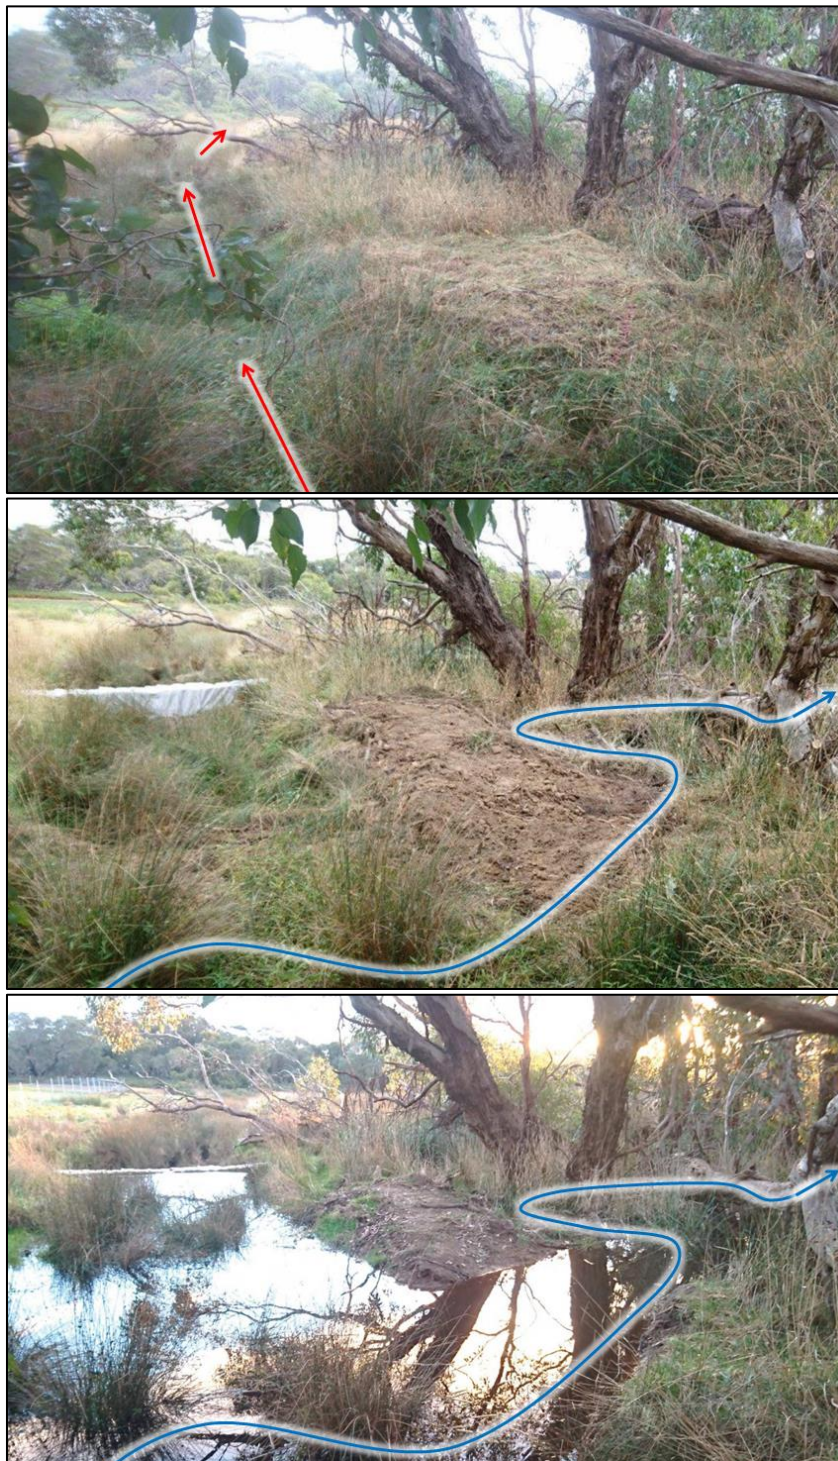
Structure #5: The point where flows are now diverted northwards, back towards the swamp

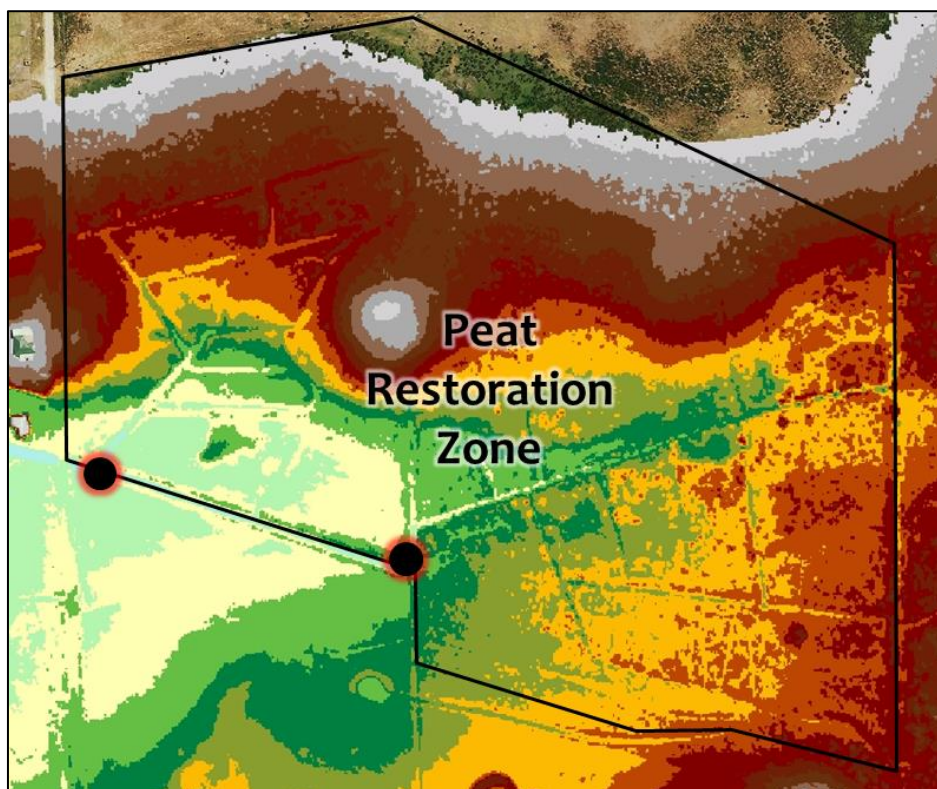
Digital elevation data on private land to the west of Stipiturus CP, with showing the elevation gradient (grey to red to green = high to low) and location of drains (deeper lines). Dots are points where flows from the restored peatland would be regulated back into the artificial drainage infrastructure, which flows west.

Thanks to the fantastic support of the downstream neighbours and funding provided by Natural Resources – AMLR, a significant amount of restoration work also occurred on the more heavily drained and degraded portion of the former Glenshera Swamp outside the reserve boundary. After discussion about the range of ways in which the objective of rehydrating this area of deeply drained peat might best be achieved, it was decided to attempt continuous drain backfilling to pack the channels, to counteract the continuous fall in gradient across the peat bed, utilising former spoil material left on-site from when the network of drains was first constructed.

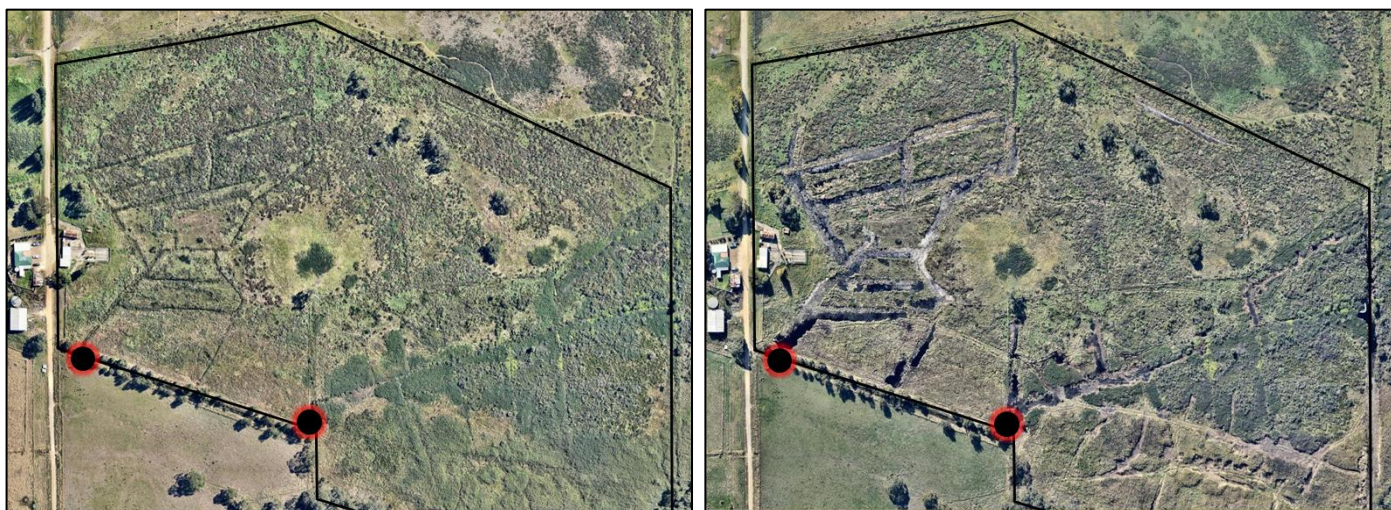
High resolution aerial imagery before and after the completion of peat channel packing (backfilling) in April 2017. Note the surface water visible (black) in the second image, from permanent groundwater discharges.

The vast majority of drains in the network across the area of private peatland, including those situated upslope to extract seepage from the saturated bank, were successfully backfilled, enabling the immediate rehydration of the peat (from groundwater discharges and seepage) to commence.

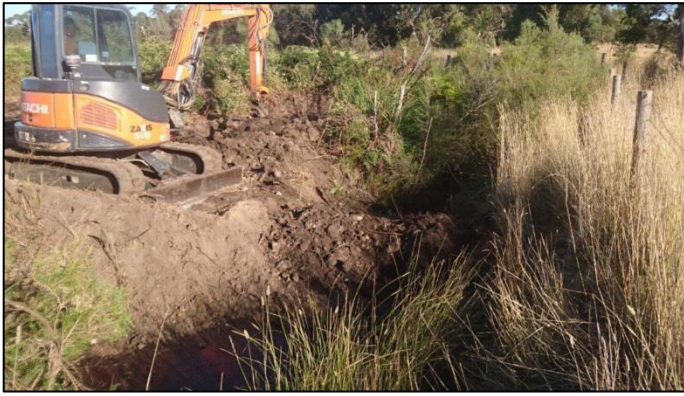
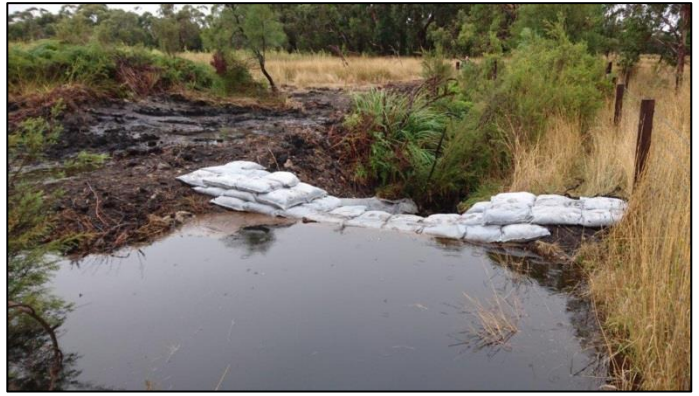
Flow Regulation Point #1: during and a short time after works were completed

At the location of the regulating structures, installed to manage flows back down into the main arterial drain that still fringes the restored peatland, the results were both immediate and visually dramatic.

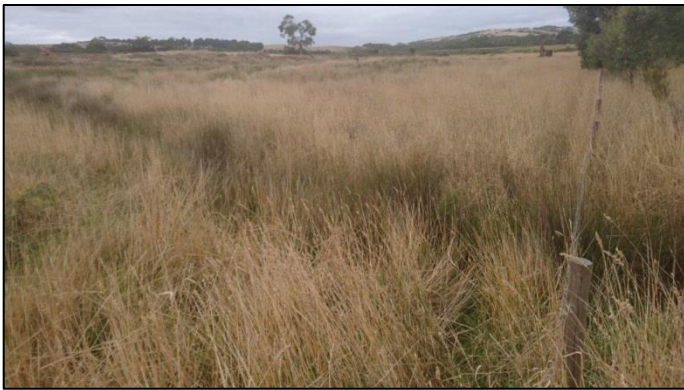
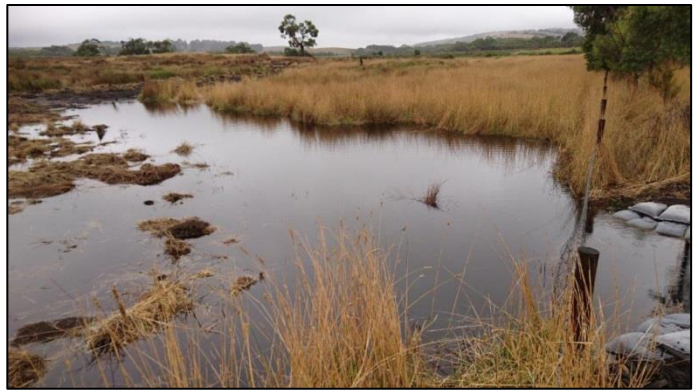
Upstream of Flow Regulation Point #2: before and a short time after works were completed
