Glenshera Swamp hydrological restoration update – 2018

Mark Bachmann, Ben Taylor and Lachlan Farrington, Nature Glenelg Trust (NGT)

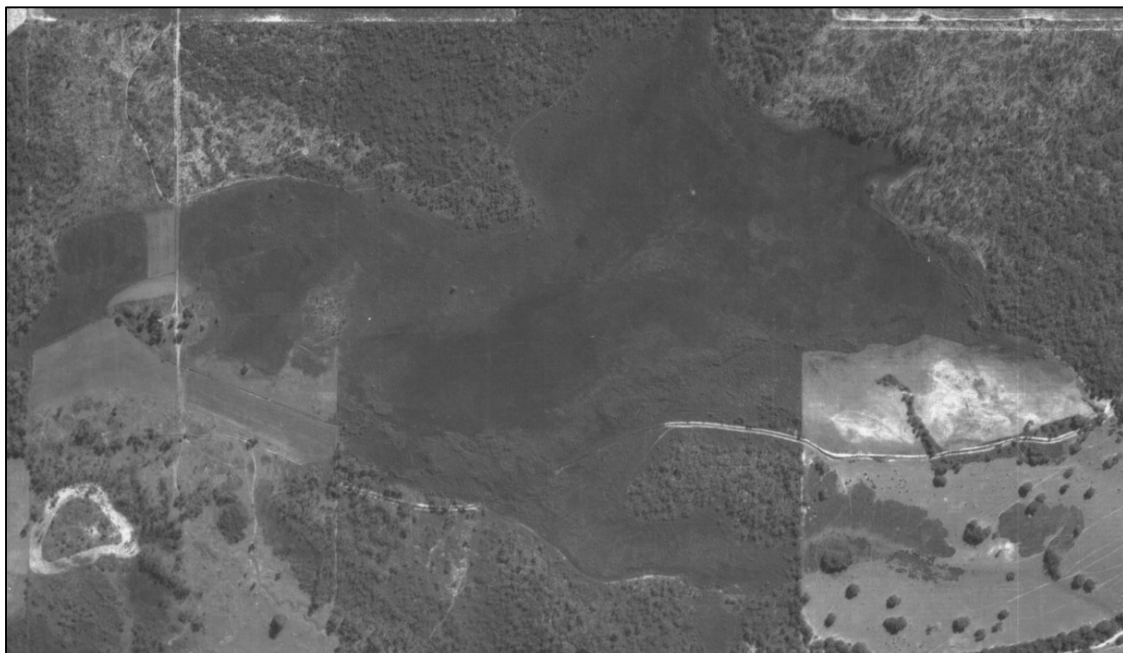
April 1949 aerial photograph of Glenshera Swamp

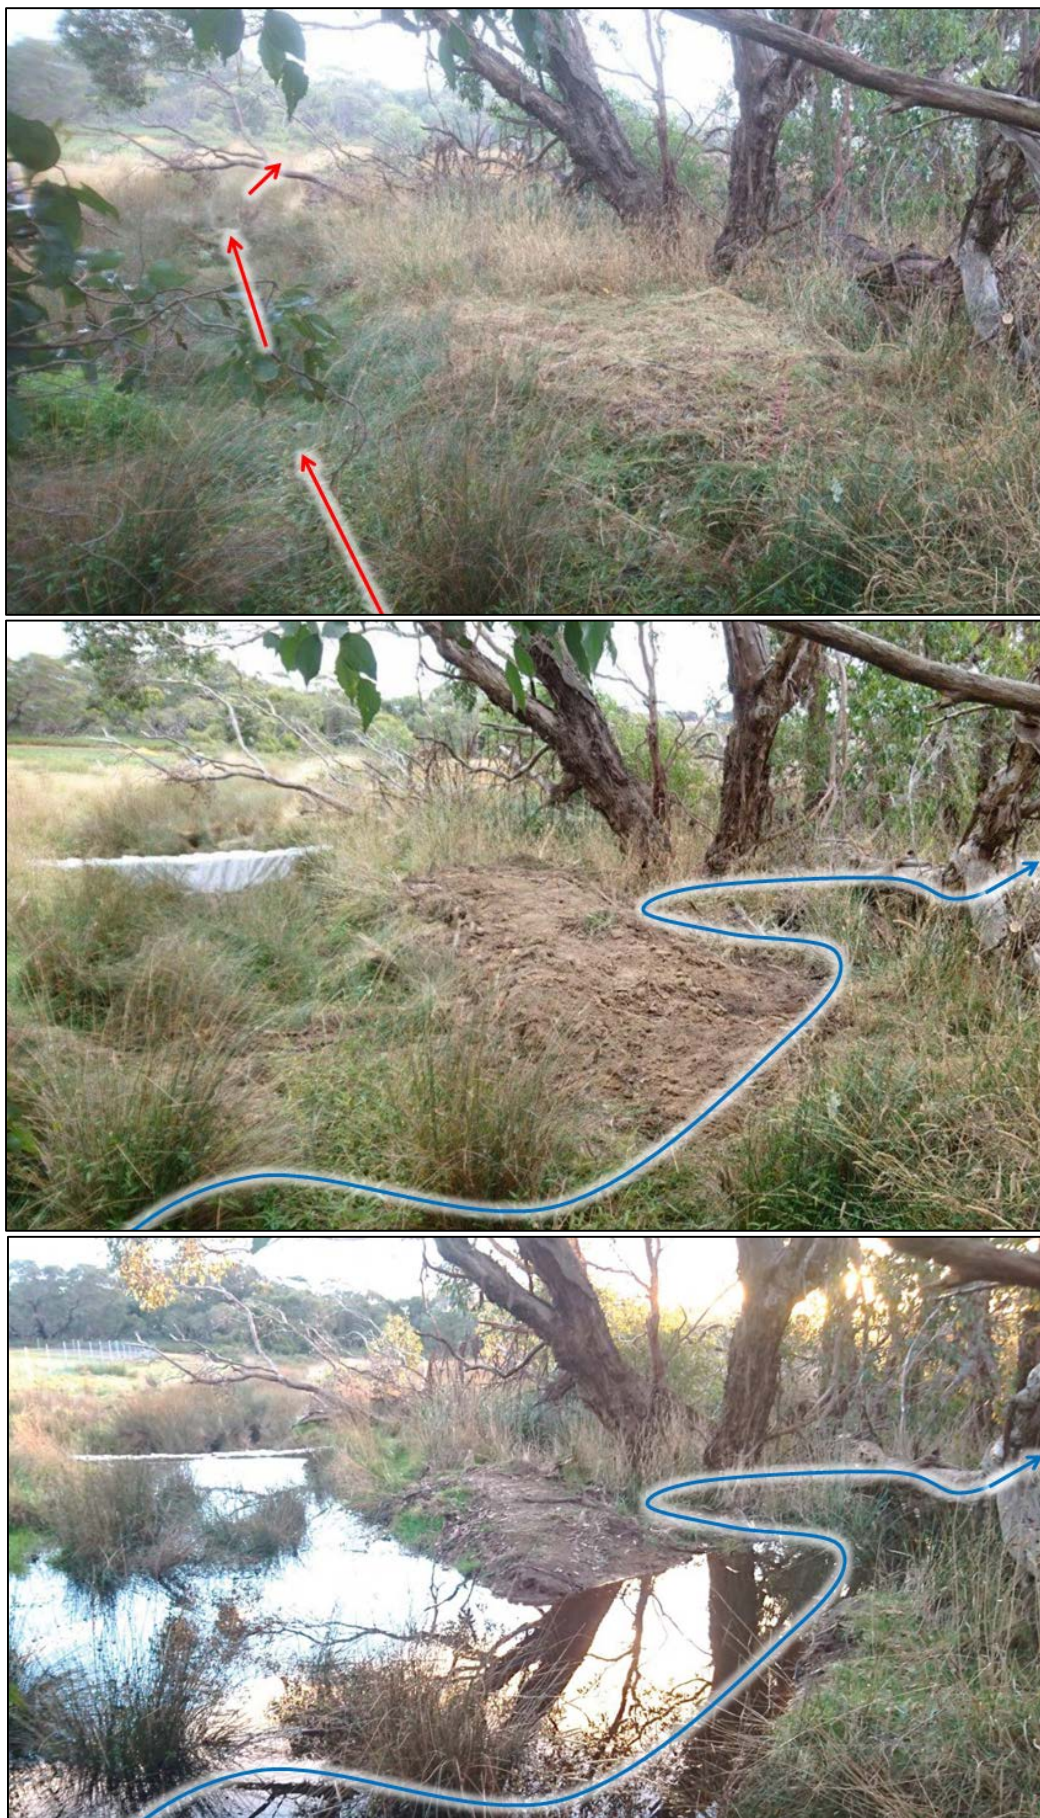
Structure #5: The point where flows are now diverted northwards, back towards the swamp

The works have been fully operational since July 2017, when the catchment started to generate sufficient runoff to reactivate the former creek channel, a narrow band of adjacent floodplain and restore all low-moderate creek flows towards the main swamp for the first time in seventy years.

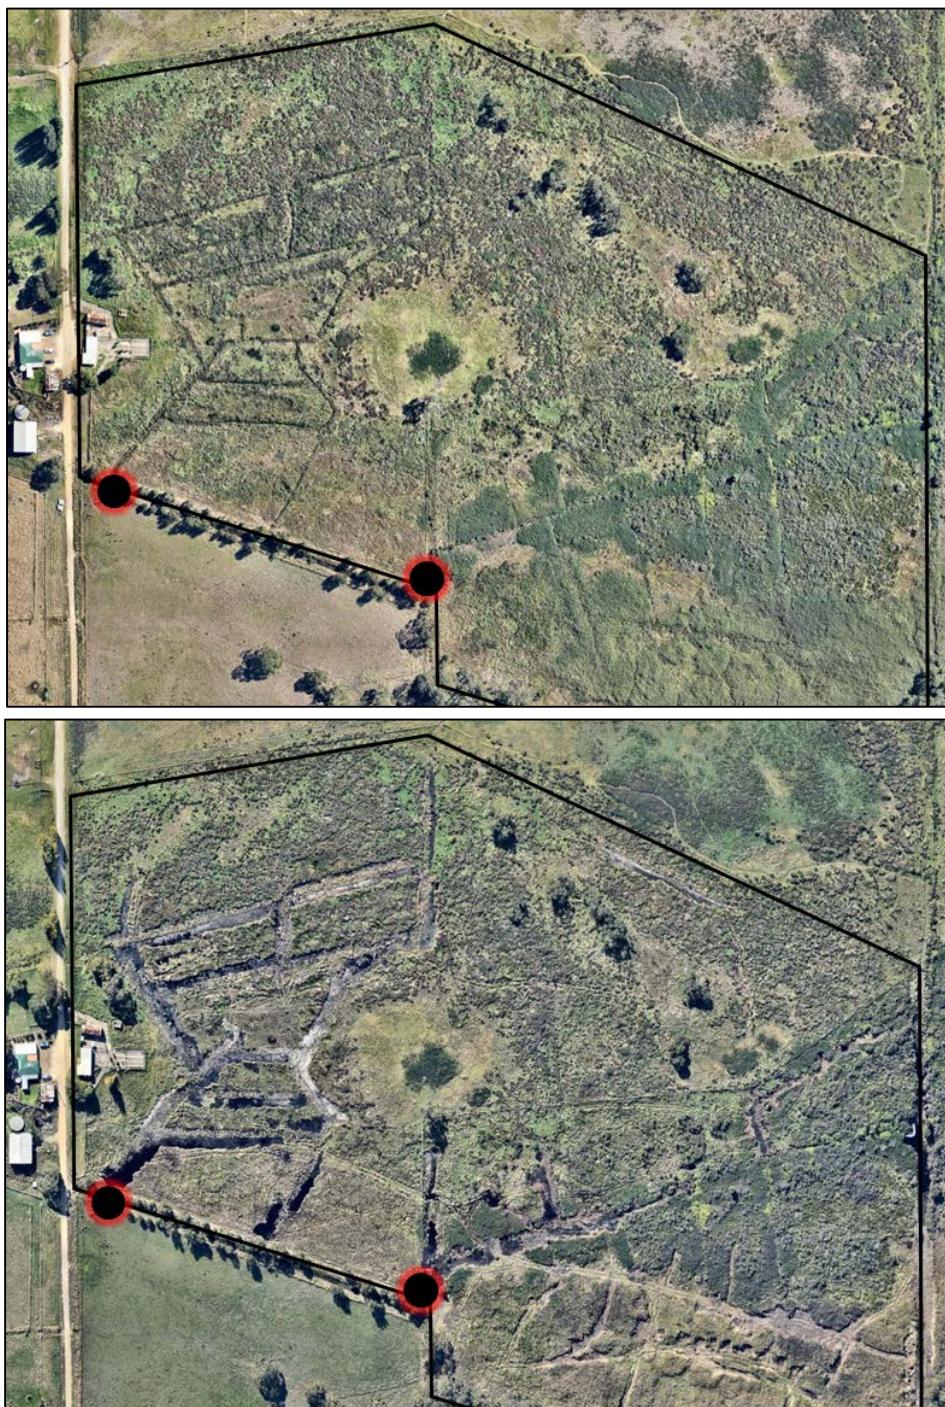
High resolution aerial imagery before and after the completion of peat channel packing (backfilling) in April 2017. Note the surface water visible (black) in the second image, from permanent groundwater discharges. The two black dots are the locations of regulating structures to maintain water levels in the swamp before flow enters the main drain exiting the property.

Thanks to the fantastic support of the downstream neighbours and funding provided by Natural Resources – AMLR, a significant amount of restoration work also occurred on the more heavily drained and degraded portion of the former Glenshera Swamp outside the reserve boundary. After discussion about the range of ways in which the objective of rehydrating this area of deeply drained peat might best be achieved, it was decided to attempt continuous drain backfilling to pack the channels, to counteract the continuous fall in gradient across the peat bed, utilising former spoil material left on-site from when the network of drains was first constructed. The majority of drains in the network across the area of private peatland were successfully backfilled, enabling the rehydration of the peat (from groundwater discharges and seepage) to commence.

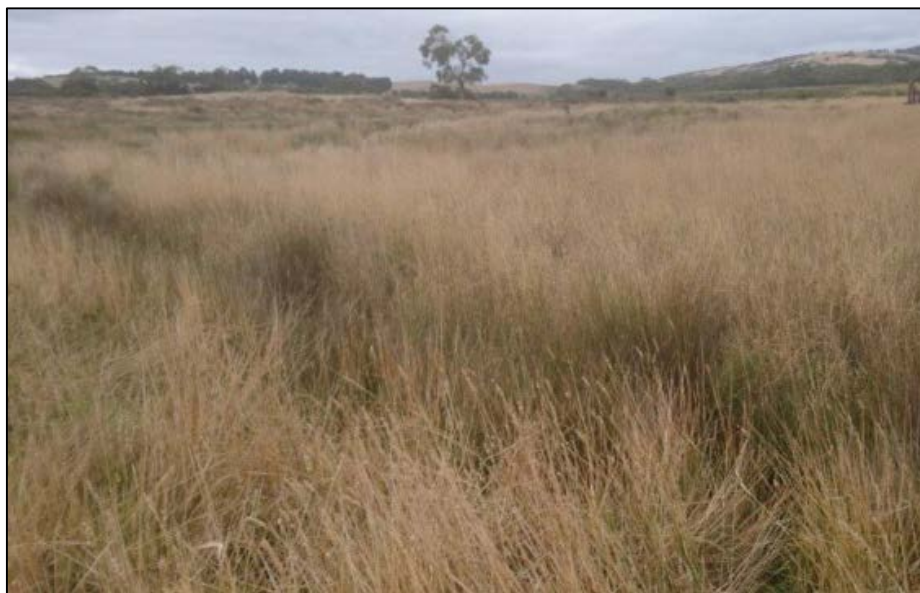
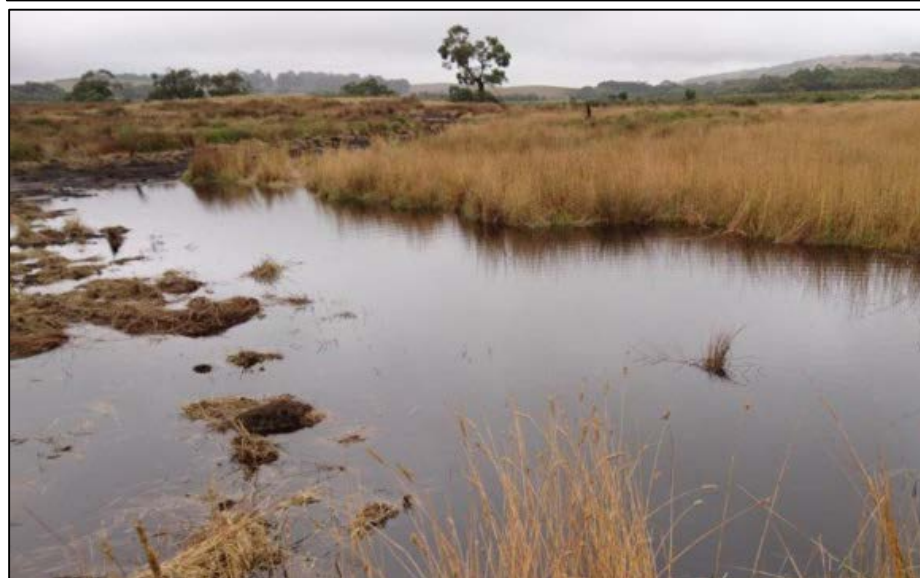
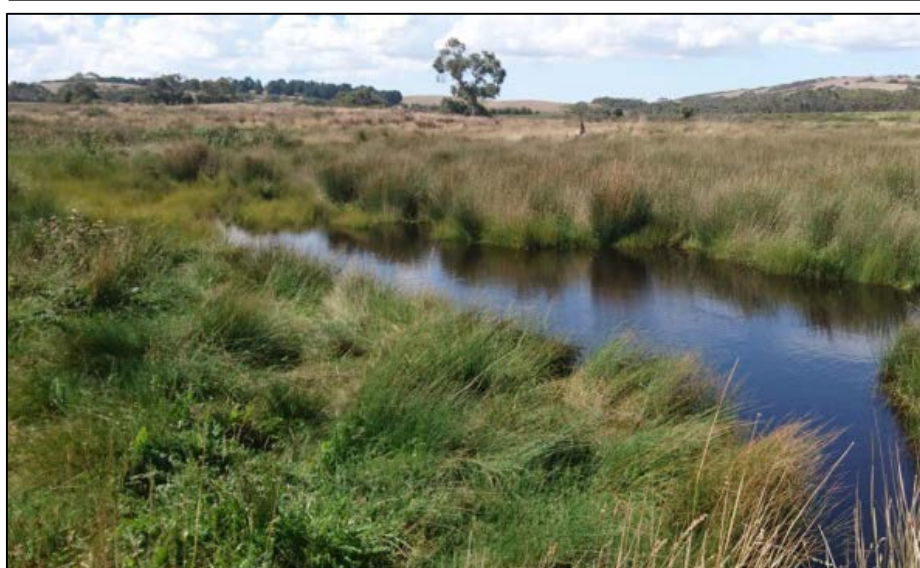
Upstream of Flow Regulation Point #2: before (top), a short time after works were completed in Autumn 2017 (centre) and one year later in Autumn 2018 (bottom) – what a difference a year makes!

At the location of the regulating structures, installed to manage flows back down into the main arterial drain that still fringes the restored peatland, the results were both immediate and visually dramatic.

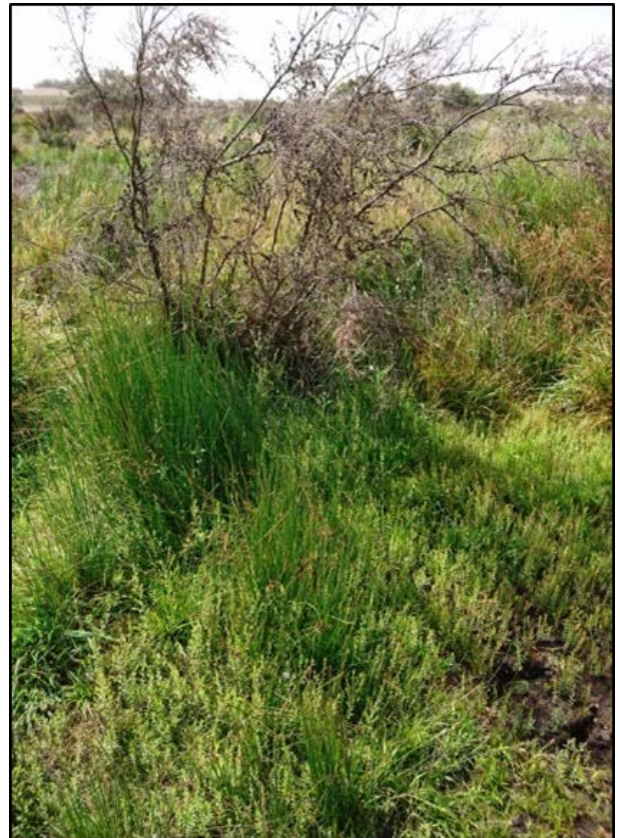
The most pronounced impacts across the rehydrated peatland are now being observed upstream (to the east) of this area in the portion of the swamp on private land. Here, the peat has re-saturated, and the swamp vegetation is quickly bouncing back; helped along by the fact that a significant amount of remnant swamp vegetation was still present in this area. Despite the tea-tree (*Leptospermum* sp.) shown right being drowned, as it was growing in the now back-filled drain, the importance of leaving these adult plants in place is clearly apparent. As the adult plants die, they release masses of seed from their fruit capsules. This process, which is the same as occurs after a fire, is resulting in the emergence of thousands of seedlings that are happily growing at the right elevation (i.e. on the surface) of the now re-saturated peat – meaning the self-sustaining process of swamp recovery we were hoping to kick-start has now begun.

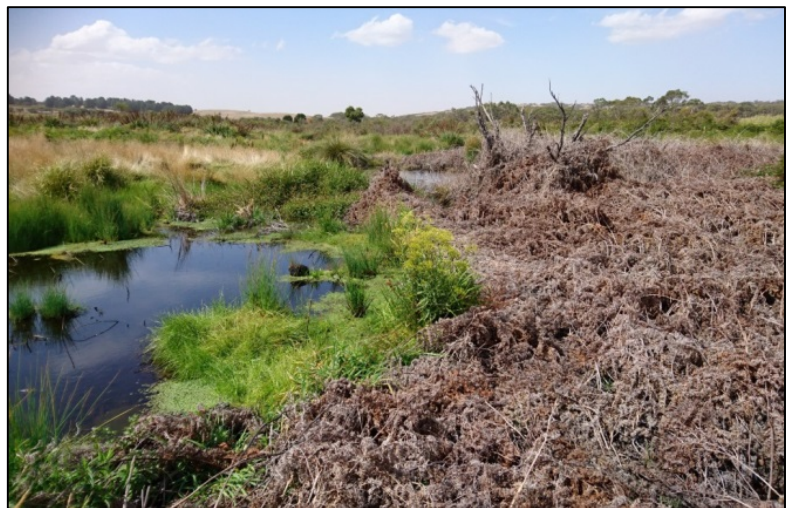
Elsewhere in this peatland, more dramatic signs of change are clearly visible – some of which even appear counter-intuitive at first glance. In the image below, the lowest elevation areas of the peatland next to the former (now back-filled) deep drain (right of image) through the peat bed are looking extremely brown / dead, despite the ground now being saturated or under water. This is because with the drain in place, this area had previously transitioned over many years to a terrestrial (dry) vegetation community – in this case

dominated by Bracken and Blackberry. With the drain no longer functional, this area of unsuitable vegetation (for a wetland) has rapidly died off and should now begin to revert to wetland vegetation. The area to the left of the image, despite being of slightly higher elevation, actually retained remnant swamp vegetation as a result of bank seepage that kept this area moist – hence with the drain no longer functioning, it has been ready to bounce back and more quickly take advantage of the new conditions.

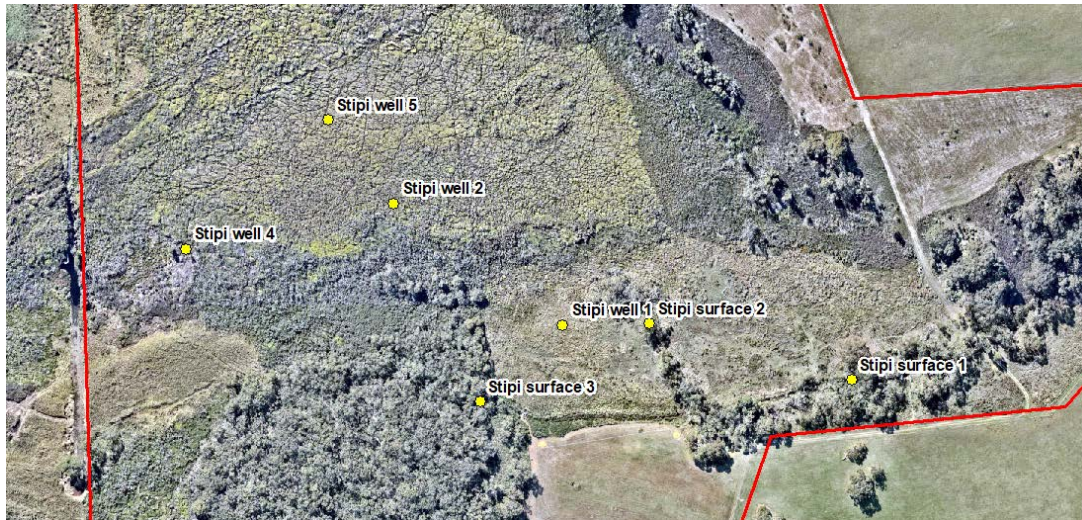
To measure the effects of hydrological restoration we are monitoring groundwater and surface water levels and vegetation throughout the swamp. Some of the water level monitoring locations, and some early results from two stations, are shown below.

The groundwater data for well 4 show that after the structures were installed, groundwater was maintained consistently higher in this area the following winter. This is an encouraging result given that winter 2017 had

slightly lower rainfall than winter 2016. The recent decline in groundwater level is likely due to the extended dry conditions since last winter. The surface water data for 'surface 1', which is located in the creek upstream of the swamp, are also encouraging, with higher water levels maintained in the winter following structure installation compared to the previous winter. Improved surface water levels increased the area of aquatic habitat in and around the creek and may have increased groundwater recharge.
