Restoration journey of the Piccaninnie Ponds Karst Wetlands, South Australia

By Mark R. Bachmann

Key words: alkaline peat fen, karst rising-springs, Piccaninnie Ponds Conservation Park, Ramsar, wetland restoration.

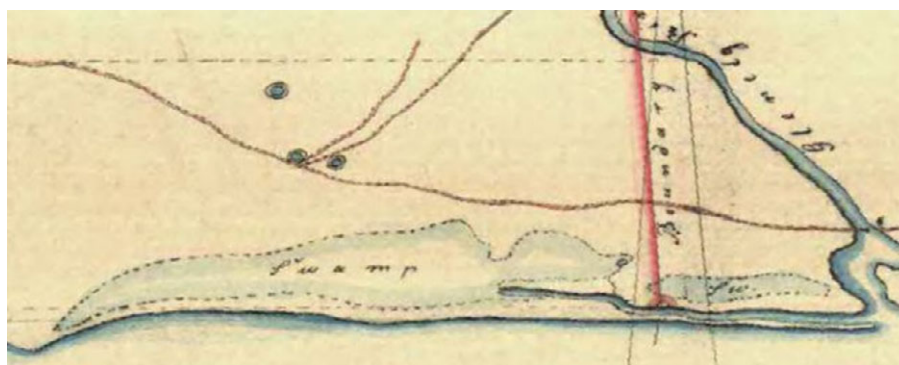
Figure 1. The Piccaninnie Ponds wetland complex as first broadly mapped by William Blandowski (1851). The red line shows the boundary between what were then the relatively new colonies of South Australia and Victoria.

Albrechts and Eel Creek), discharging near what is now the township of Nelson, in far south-west Victoria. The flow path and general area were first mapped by William Blandowski, government-appointed surveyor of pastoral leases in the South East of South Australia, in 1851 (Fig. 1).

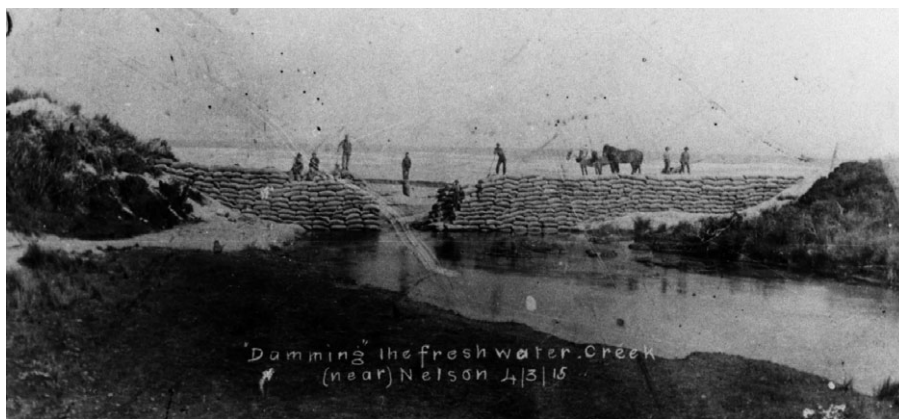
Figure 3. The 1915 damming of Freshwater Creek at the location of the 1906 artificial outlet to the sea, just inside the Victorian border, near the township of Nelson. (Image courtesy of the Les Hill Collection, Mt Gambier Library).

This early form of environmental activism was rewarded in 1915, when the state governments agreed to share the cost of damming the new outlet through the dunes (Fig. 3) and con-

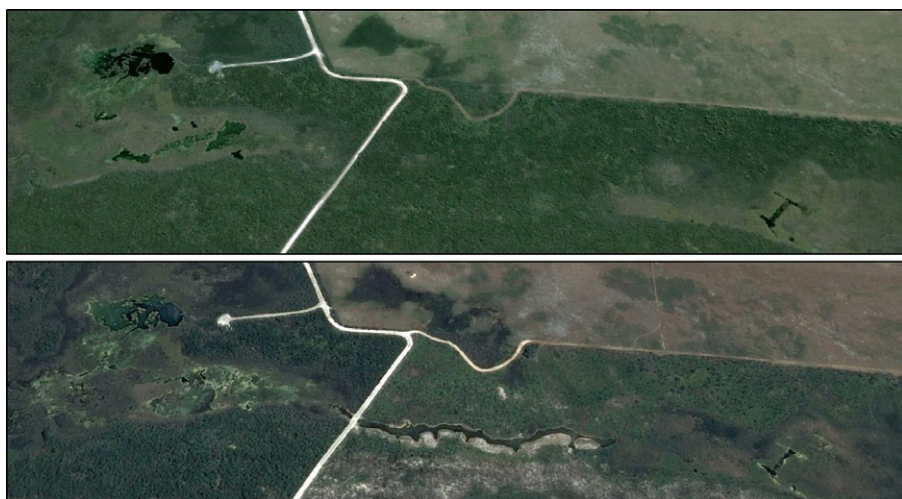
Figure 8. Aerial imagery showing the reconstructed flow path and culvert location under the Piccaninnie Ponds Road. Above – Preconstruction image from January 2003. Below – Postconstruction image from January 2014. Construction occurred in 2013. The main Piccaninnie Ponds (in the western wetland) are in the top left of each image, while Hammerhead Pond (in the eastern wetland) is in the bottom right corner of each image. Also note the increase in open-water habitat to the south of the main Ponds, associated with the installation and operation of the stage 1 and stage 2 weir structures.

the elevation of the Piccaninnie Ponds Road and installing new culverts under the road, as well as creation of a new flow path reconnecting the eastern and western wetland basins of Piccaninnie Ponds (Fig. 8). These wetlands had been separated for several decades by a combination of lower water levels, sand drift and the footprint of the road.

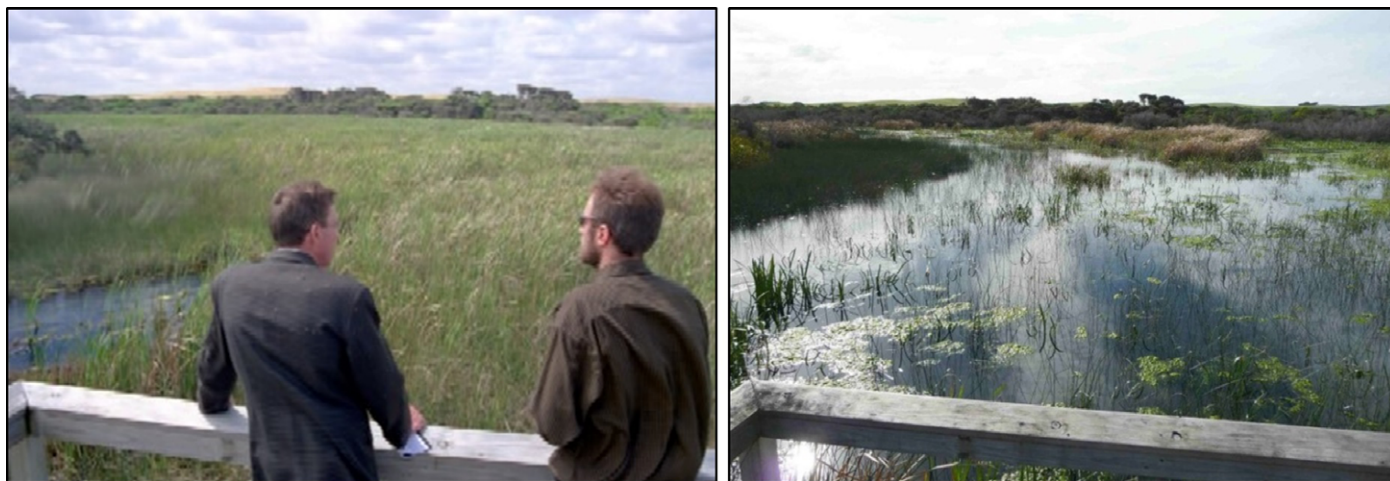
Figure 9. The upstream inundation impact and desirable changes to aquatic habitat caused by the operation of the stage 1 weir. The left image is from 2004 (prior to works in 2006), while the image to the right is from 2012.

inundation immediately upstream of the structure. This caused a positive shift in habitats associated with an increased depth and duration of inundation, as shown in Figure 9, such as the retreat of invading Cumbungi *Typha domingensis*.

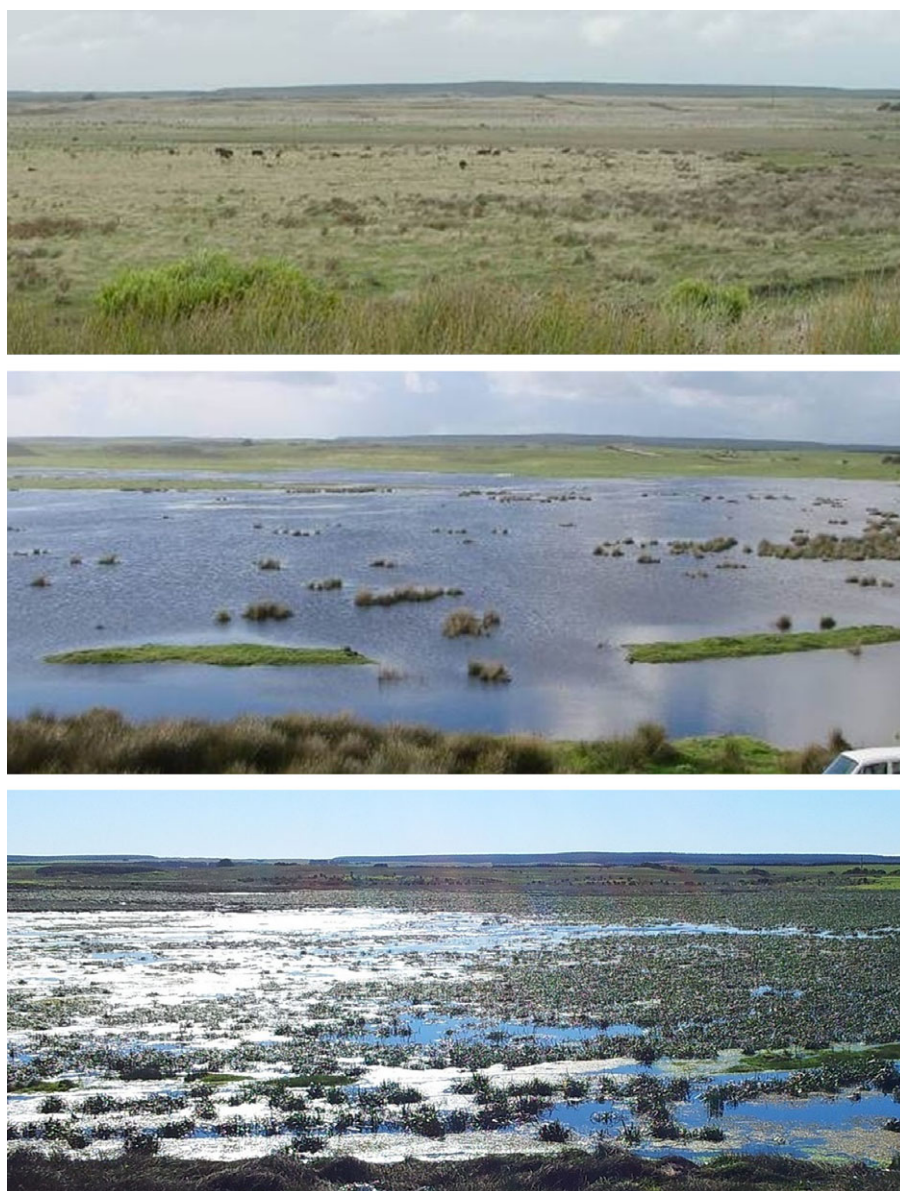
Figure 10. The restoration of Pick Swamp. Above – May 2007 (before restoration); centre – July 2007 (several weeks after restoration commenced); and below – June 2012 (5 years after restoration commenced). Note the rapid natural recovery of aquatic plants.

Over the same period, the hydrological restoration of Pick Swamp resulted in approximately 130 ha of land being permanently re-inundated, and the aquatic floristic component

has recovered to an excellent degree with minimal management intervention in the time since the project commenced (Bachmann & Holland 2015), as shown in Figure 10.
