**WALKER SWAMP 1<sup>st</sup> ANNIVERSARY CELEBRATION –  
Sunday 29<sup>th</sup> September 2019**

*Mark Bachmann, Greg Kerr and Lachlan Farrington - Nature Glenelg Trust (NGT)*

**Welcome to the Walker Swamp Restoration Reserve!**

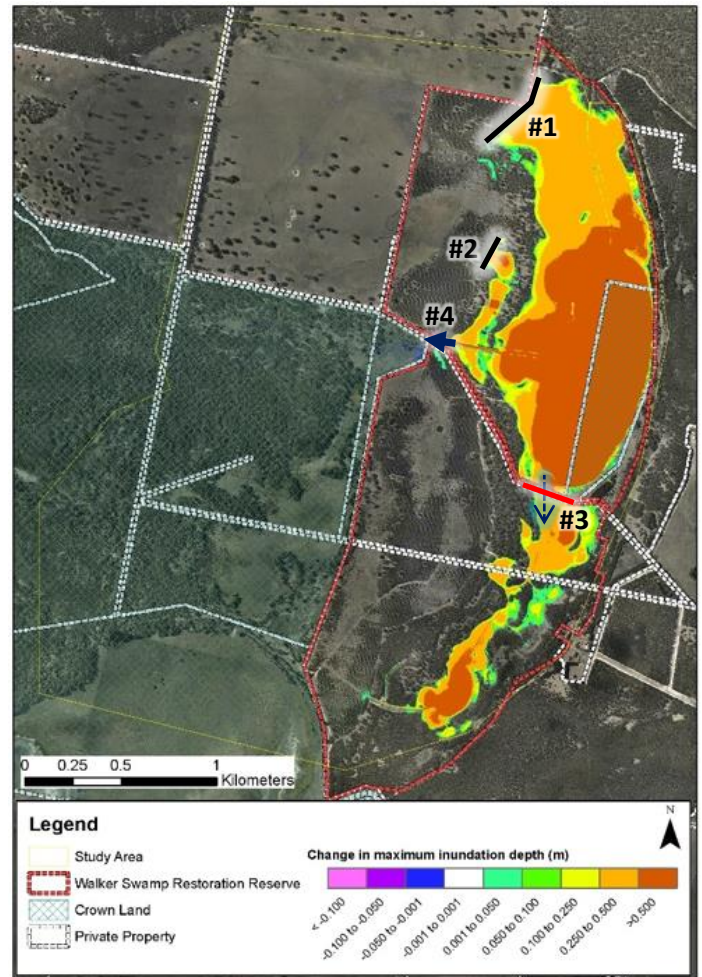
Prior to the commencement of any earthworks, a hydrological investigation, commissioned by the Glenelg Hopkins CMA, was undertaken by NGT to enable the impact of backfilling artificial drains across the property to be understood, and to inform the design, implementation and permit approvals for those works. The hydrological study allowed us to predict how drainage inflows into a restored Walker Swamp could be managed on the eastern floodplain portion of the property, as shown right (note that the floodplain wetlands on the western portion of the property are not highlighted on this map).

This in turn highlighted key locations on the property where additional remedial works would be required to facilitate restoration, such as:

- reinforcement of existing levee banks (black lines marked #1 and #2 on the map),
- upgrading the road (red line at #3) and culverts (thin arrow at #3) to allow flows to reach the full wetland extent to the south, and
- constructing a new spillway, set to the natural sill level (thick blue arrow at #4), to enable flows to be conveyed down the existing artificial channel to the west when the swamp is full.

The two northern levee banks on the property (see #1 and #2 on map above) are artefacts of the era when the artificial drains were constructed, and were designed to ensure that drainage inflows coming into Walker Swamp from the north-east were contained on the eastern portion of the property and prevented from spilling west during major rainfall events. After such events, even in its drained state Walker Swamp would temporarily inundate (acting as an equalisation basin), only to disappear again within days or weeks as the major channel through Walker Swamp would rapidly carry away the excess water, as soon as inflows dropped below the outflow capacity of the drain. This water would discharge towards Gooseneck Swamp via the main artificial outlet and under Lynchs Crossing Road, near the corner of the Grampians National Park.

The single exit point chosen for conveying flows from Walker Swamp and the wetlands on the eastern portion of the property (see #4, on page 2 map) presented the following design challenges. On the upstream side, as discussed in the previous section, the goal was to completely backfill all the artificial drains through Walker Swamp, and to use the finished height of the spillway itself at natural surface to set the restored full supply level of the wetland. However, on the downstream side we were planning to keep a short existing section of drain operational in order to have a means of managing outflows in major events under Lynchs Crossing Rd, using existing drainage infrastructure. That meant establishing a spillway capable of resisting erosion and conveying flows over an approximate 1.5m drop from the restored natural surface level upstream into the base of the artificial channel downstream, noting that this drain is now not expected to carry flows very often, due to the immense increase in water storage capacity within Walker Swamp and adjacent eastern floodplain wetlands.

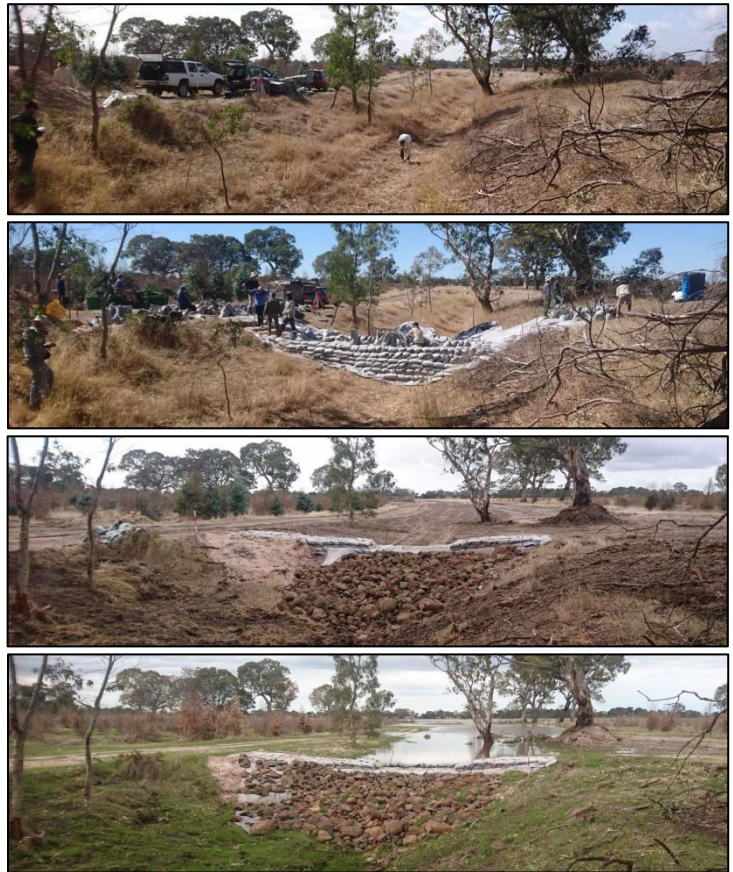
After weighing up the options, rather than using concrete, we decided to adapt an inexpensive and more flexible construction method we have previously employed in trials, by building the spillway out of an interlocking structure of 2500 geo-fabric sandbags. After surveying the site and setting the levels in January 2019, over 2 days in March 2019 a team of volunteers helped us get the job done in quick time – as shown right (images from Jan, March, May, Aug).

After lining the whole structure with fabric, backfilling the drain upstream and capping the spillway with donated rock, the job was done...

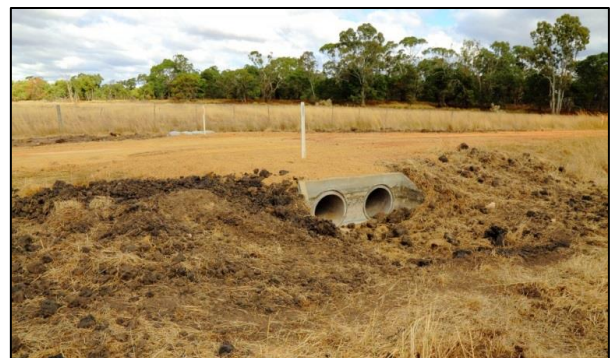
The solution (see right) was to build up Lynchs Crossing Rd by approximately 50 cm, and to install additional culverts with sufficient capacity to carry flows (which will

occur when Walker Swamp is full enough to spill southward, noting that at the time of writing this is very close but has not quite happened yet in 2019) through to the southern wetland chain, maintaining connectivity and ensuring the road remains all-weather accessible. Ararat Rural City generously provided a significant contribution to this component of the project, as well as incredibly helpful design and technical assistance.

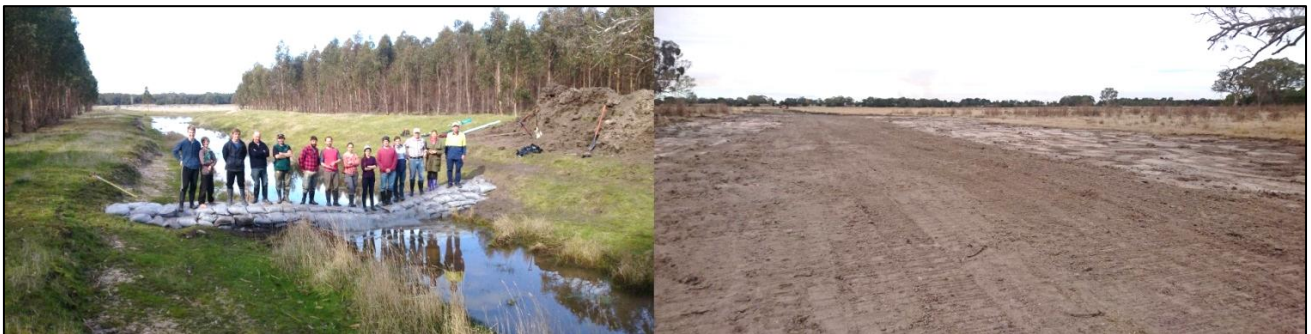
*Looking east at the former 2014 trial location on the main drain out of Walker Swamp. (See yellow dot on map above)*

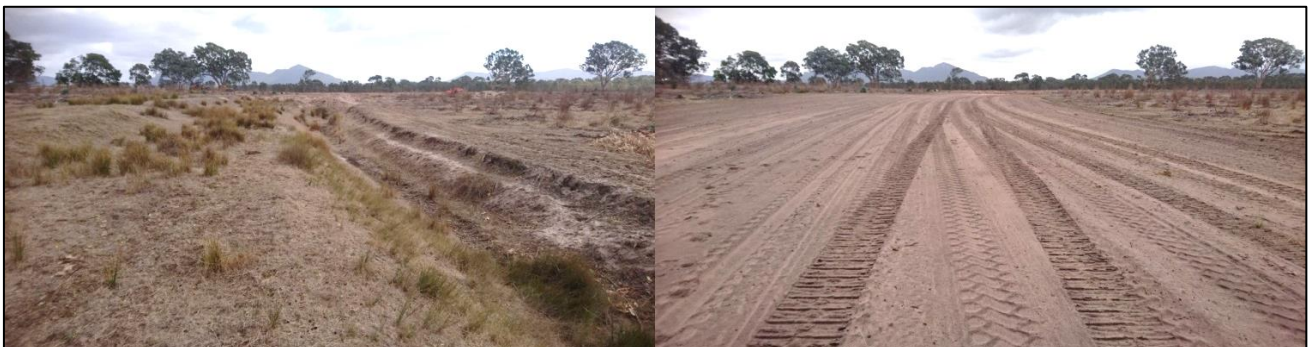
*Looking west at the now completely backfilled southern outlet drain through the lunette. (Red dot on map above)*

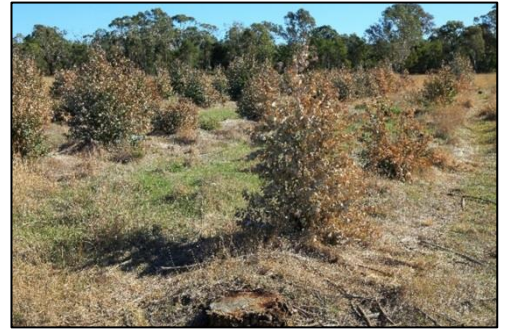
## 1. Recently Harvested Areas and Coppice Spraying

The plantation areas that had been recently logged prior to NGT taking possession of the property were at various stages of regrowth, due to coppicing from the stumps. These areas were located across the northern part of the property, west of Walker Swamp, and in a central strip through the southern portion of the property. The coppice was sprayed by contractors in autumn 2018 and repeated (thanks to Ararat Prison via the Landmate Environment Program) in autumn 2019, leaving these areas requiring only minor follow-up.

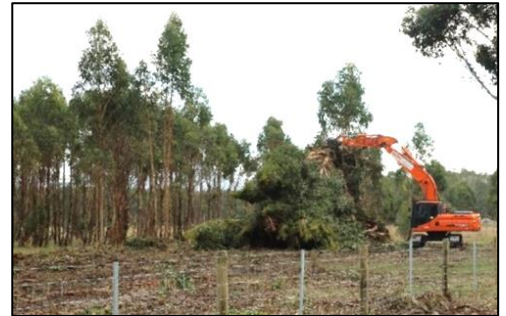
## 2. Removal of Standing Plantations

Small leftover areas of plantation in the northern part of the property (see dark blue areas on p. 5 map) remained uneconomic, so NGT contracted an excavator to remove and stack these trees (roots and all) for burning, avoiding the need for any further treatment (right).

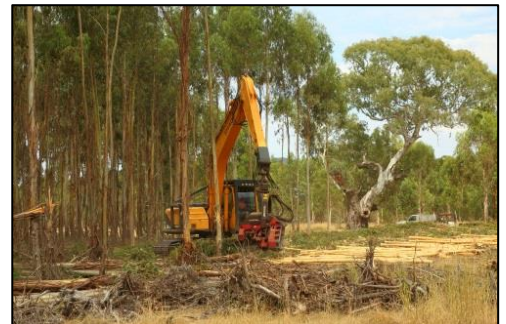
However large areas of the southern portion of the property retained standing trees. We were fortunate that based on extra growth since the property changed hands, and improved woodchip market conditions in early 2019, we were able to negotiate their harvest at no cost to NGT (right) and indeed generate a modest income stream. That income will help us cover the cost of coppice spraying as these areas reshoot over the next two years.

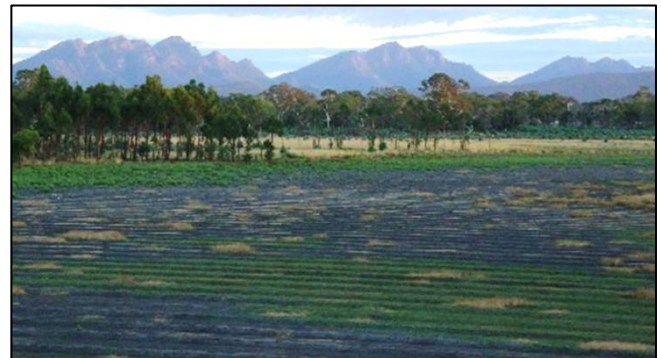
## 3. Failed Plantations and Wetland Bed Remediation

The vast majority of the 1000 acre (420 ha) property was mounded to prepare for plantation establishment, including Walker Swamp (right) and almost all other wetlands across the site. As a result of the plantations not surviving in the deepest areas of those wetlands (which still temporarily inundated each winter despite the artificial drains), the mounds and furrows still remained in these heavy wetland soils. As well as interfering with natural inundation patterns and water movement, the elevated ridges of the mounds were also harbouring weeds in areas that would otherwise be too wet for them to grow, and negatively impacting on the natural zonation and recovery of native wetland plants.

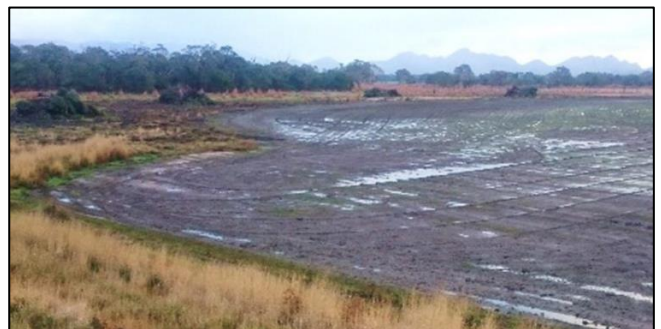
After progressively remediating the ground over two seasons in all the failed areas of plantation in those deepest wetland beds (right), these areas are now rapidly and spectacularly recovering with native wetland plants, establishing in the right zones within and around each wetland.

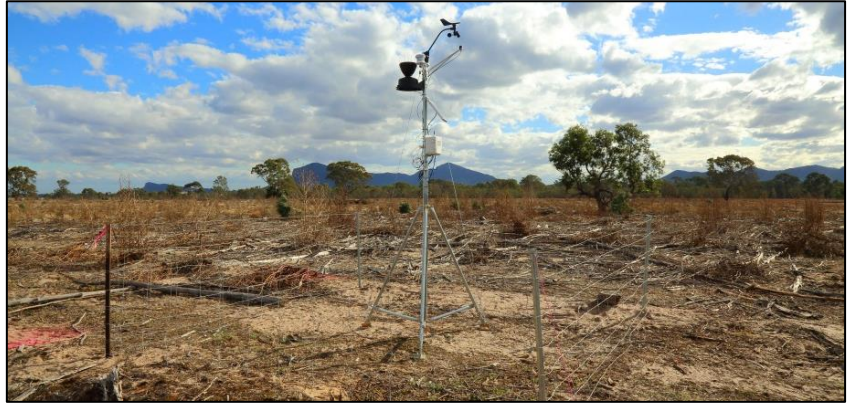
We now have a complementary network of data loggers in place across the property, including the recently installed weather station (see right – also note the areas of treated Blue Gum coppice in the image). This is allowing us to record temperature, wind speed, gust speed, wind direction, rainfall, relative humidity, solar radiation, dew point and atmospheric pressure around the clock, via a system that can be remotely accessed via the internet. In combination with our network of water level loggers, we are now able to more accurately chart and predict how the site and its wider catchment respond to rainfall events, as shown in the graph below.

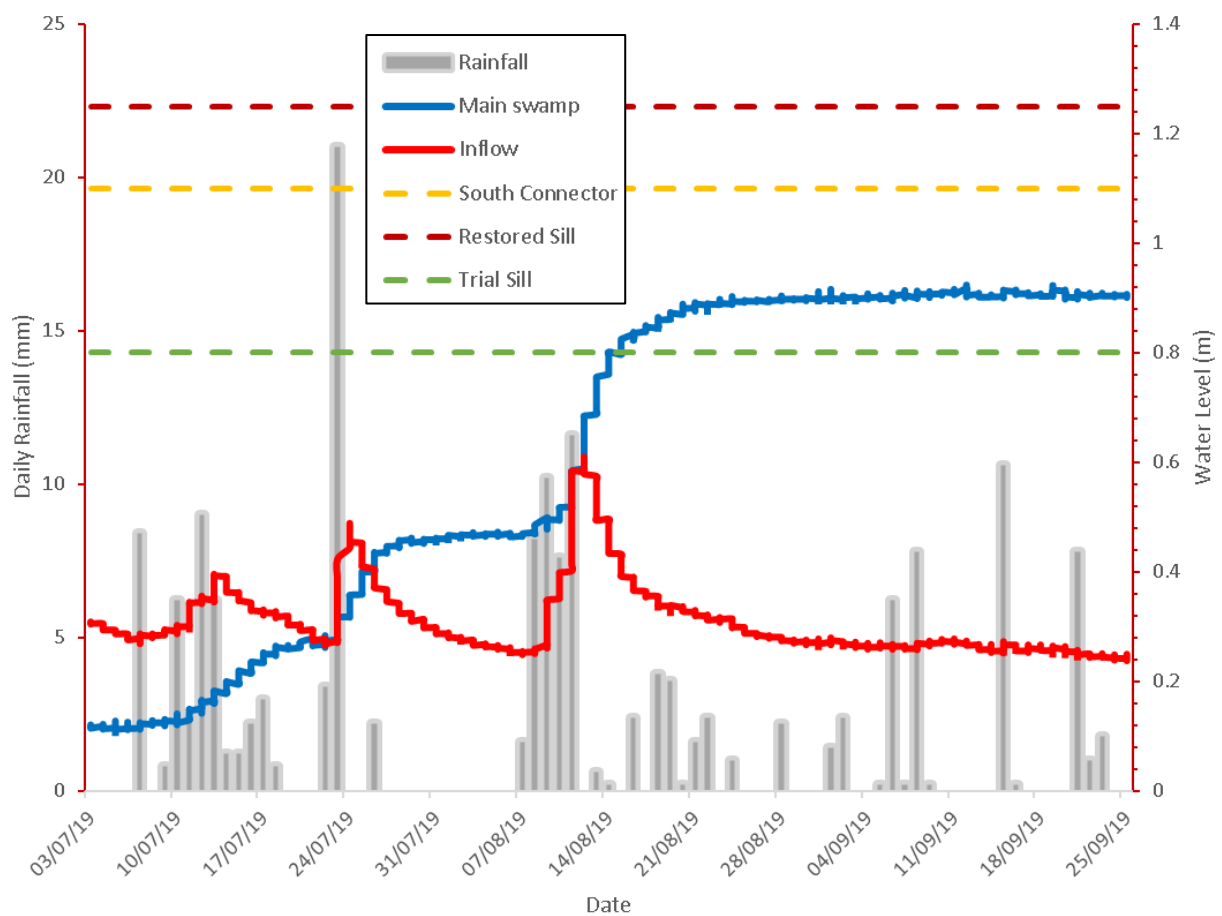
This year the main wetland started filling in July and peak inflows occurred after consecutive days of rainfall in early August. Unfortunately no noteworthy runoff from the drainage catchment has subsequently occurred since then and into spring – a period when we would normally hope to see peak seasonal runoff, meaning that so far these remain the only two significant inflow events to have occurred in 2019.

Despite these challenging climatic conditions, retained water levels in Walker Swamp in 2019 have surpassed those achieved during the trial period (2014-2018), as a direct result of the successful restoration works outlined in this paper, but (due to below average rainfall) are currently still sitting about 35 cm below the now restored full supply level of the swamp. If we are to witness flows passing south under Lynchs Crossing Rd, or see the new spillway fully operating this year, we are going to need at least two significant rainfall events (>30 mm daily rainfall) between now and December, subject to upstream catchment conditions at the time.

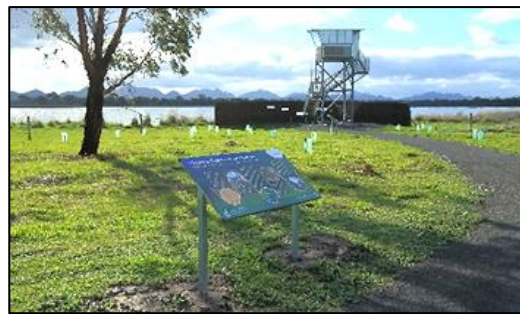
## Bird Observation Tower, Site Interpretation and Signage

The observation tower that was donated in 2018 was relocated earlier in the year to its new permanent home, set up behind brush fence screening (to minimise disturbance to birds), and situated a short walk from our nearby visitor carpark. Interpretative signage along the path helps to give visitors a glimpse into the fascinating history of the site. The viewing deck has now been fully enclosed to offer protection from the elements, and the site is already proving its value for bird counts and educational activities. Once the remaining fundraising target to cover land purchase costs has been achieved, this is where permanent signage will be installed to recognise everyone who has participated or donated towards the project so far.
