Eco-hydrological Investigation and Restoration Planning for Big Marsh

**The Spit Nature Conservation Reserve, Port Phillip Bay
(Western Shoreline) and Bellarine Peninsula Ramsar Site**

Report to Port Phillip and Westernport
Catchment Management Authority

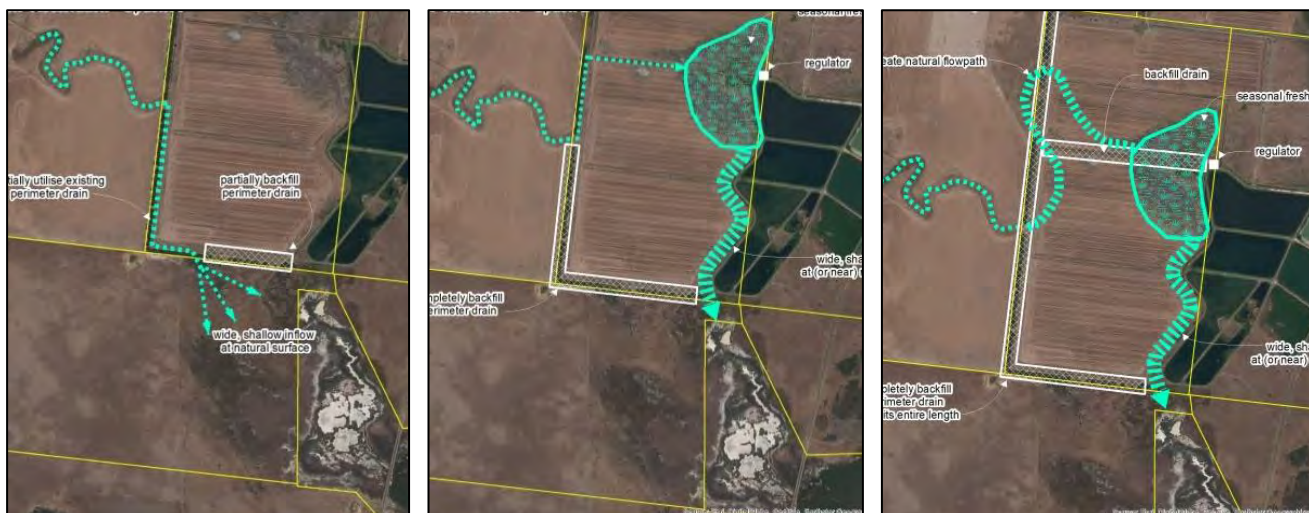
- Achieve streamflow dynamics that are as close as possible to natural conditions, by:
 - re-instating seasonal catchment streamflow to Big Marsh by recreating shallow, diffuse, slower surface flow conditions that ideally would mimic the original natural stream conditions.
 - subject to the consent of neighbouring landholders, implementing works according to one of three options as outlined in this report (Option A, B or C, as per the thumbnail images from left to right shown below – see Section 10.2 for additional detail).

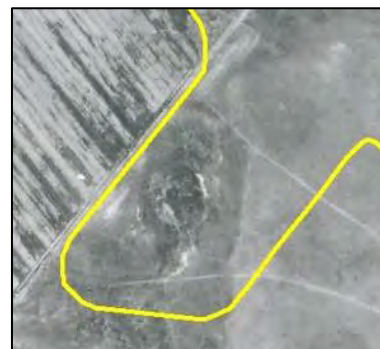
Option WL3: Complete removal of Ponds 3 and 4 to facilitate restoration of this area as saltmarsh habitat.

To illustrate, the southern portion of Ponds 3 and 4 is shown here supporting saltmarsh habitat in 1947, prior to the development of the lagoons.

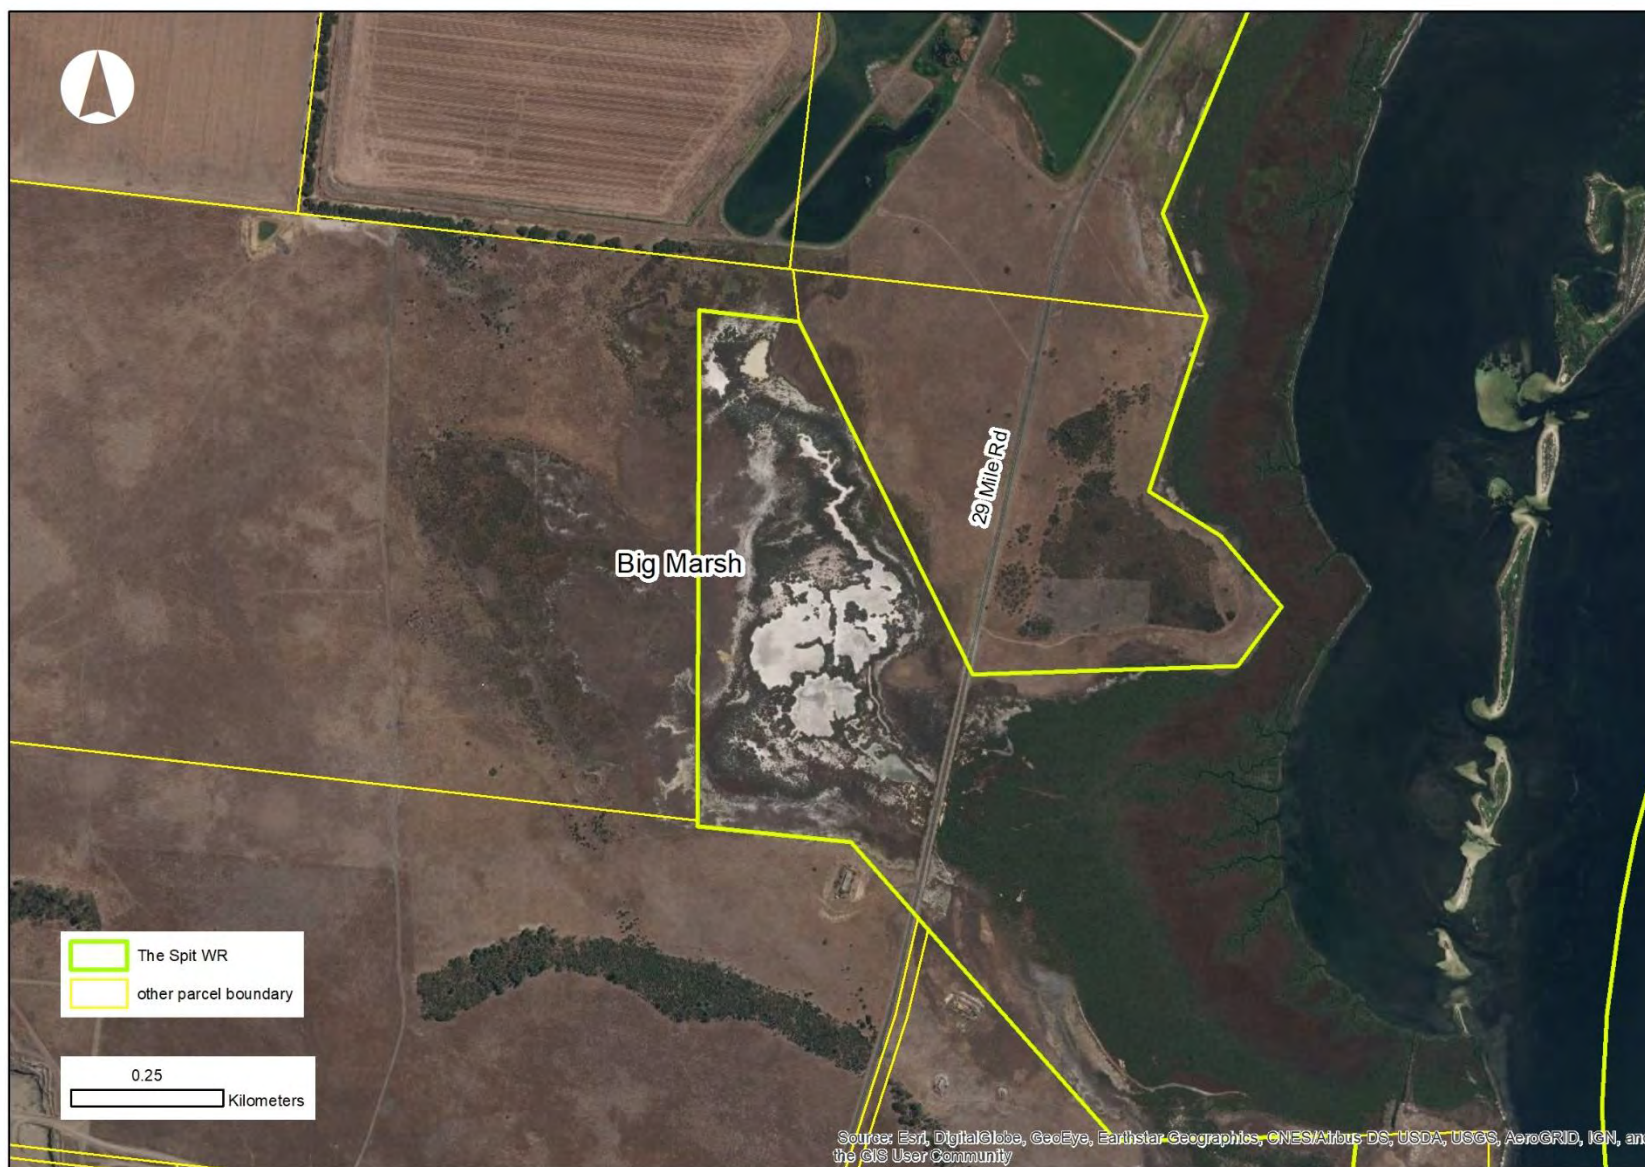
Figure 2. The Big Marsh area of The Spit Nature Conservation Reserve.

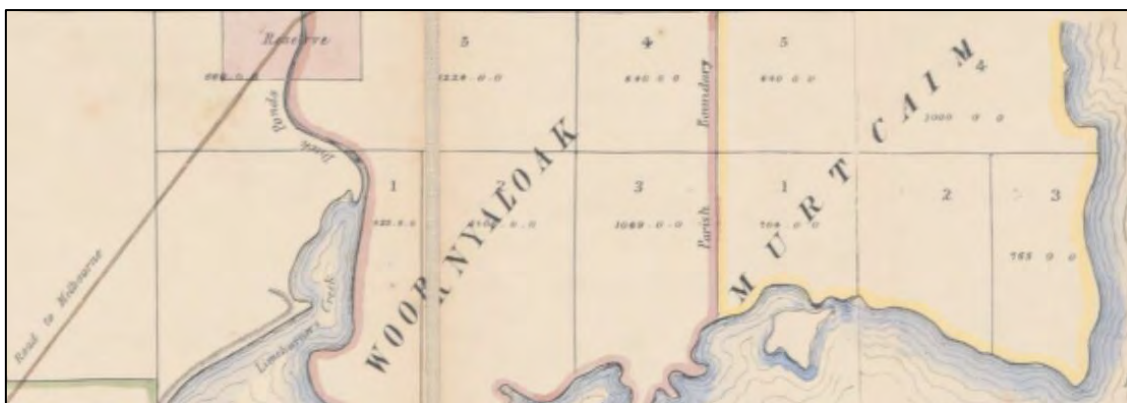
Figure 7. Lots 1-5 in the Parish of Murtcaim, which includes part of the project area, were purchased by James Walsh in 1849 (Map is from Garrard and Shaw (1850)).

Land in the vicinity of Point Wilson and The Spit was later sub-divided and offered for public sale in December 1849 (as opposed to a grazing licence where the Crown retained ownership), and all five lots in the Parish of Murtcaim were purchased by James Walsh (Argus 1849). The bulk of the saltmarsh in the project area falls partly within Lot 4 (see top right corner of Figure 7).

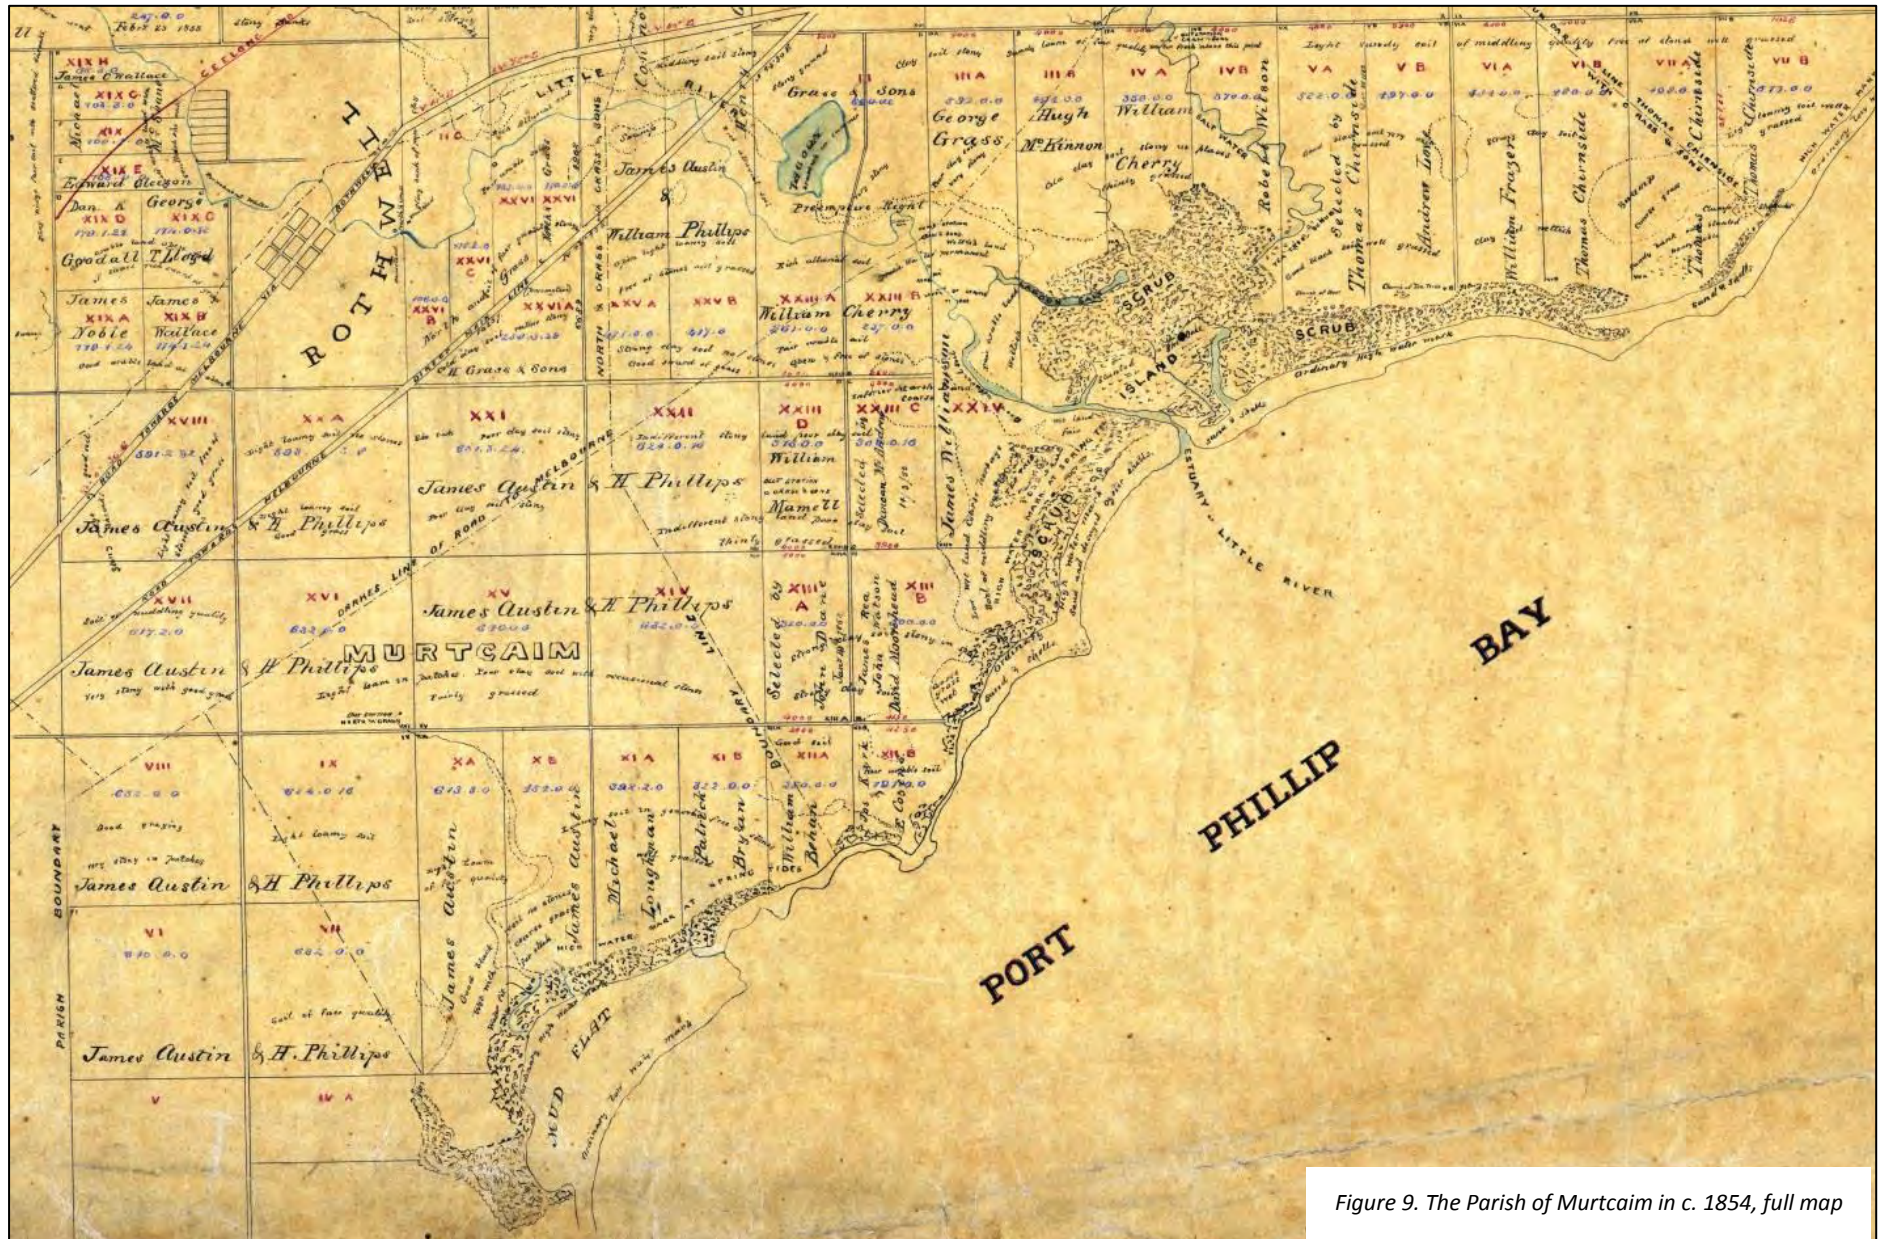
Figure 9. The Parish of Murtcaim in c. 1854, full map

The Big Marsh area is very clearly mapped (marked with an arrow above), as is an interesting extended (apparent feeder) waterway or saltmarsh area to the north. This will be explored in more detail later. Otherwise, the general view of the wider open surrounding landscape appears consistent with other earlier accounts.

The remaining northern portion of the Parish of Murtcaim was eventually subdivided and sold in December 1854, when James Austin and Henry Phillips purchased the remaining lots in the project area (Geelong Advertiser and Intelligencer 1854). A map produced around that time captures a little more useful detail of the project area; an era when the land, despite being grazed, had not yet been drastically modified. This is the earliest map we have been able to source that illustrates the broad extent of saltmarsh at The Spit (Figure 8 and see Figure 9 for the entirety of the coastline to Little River).

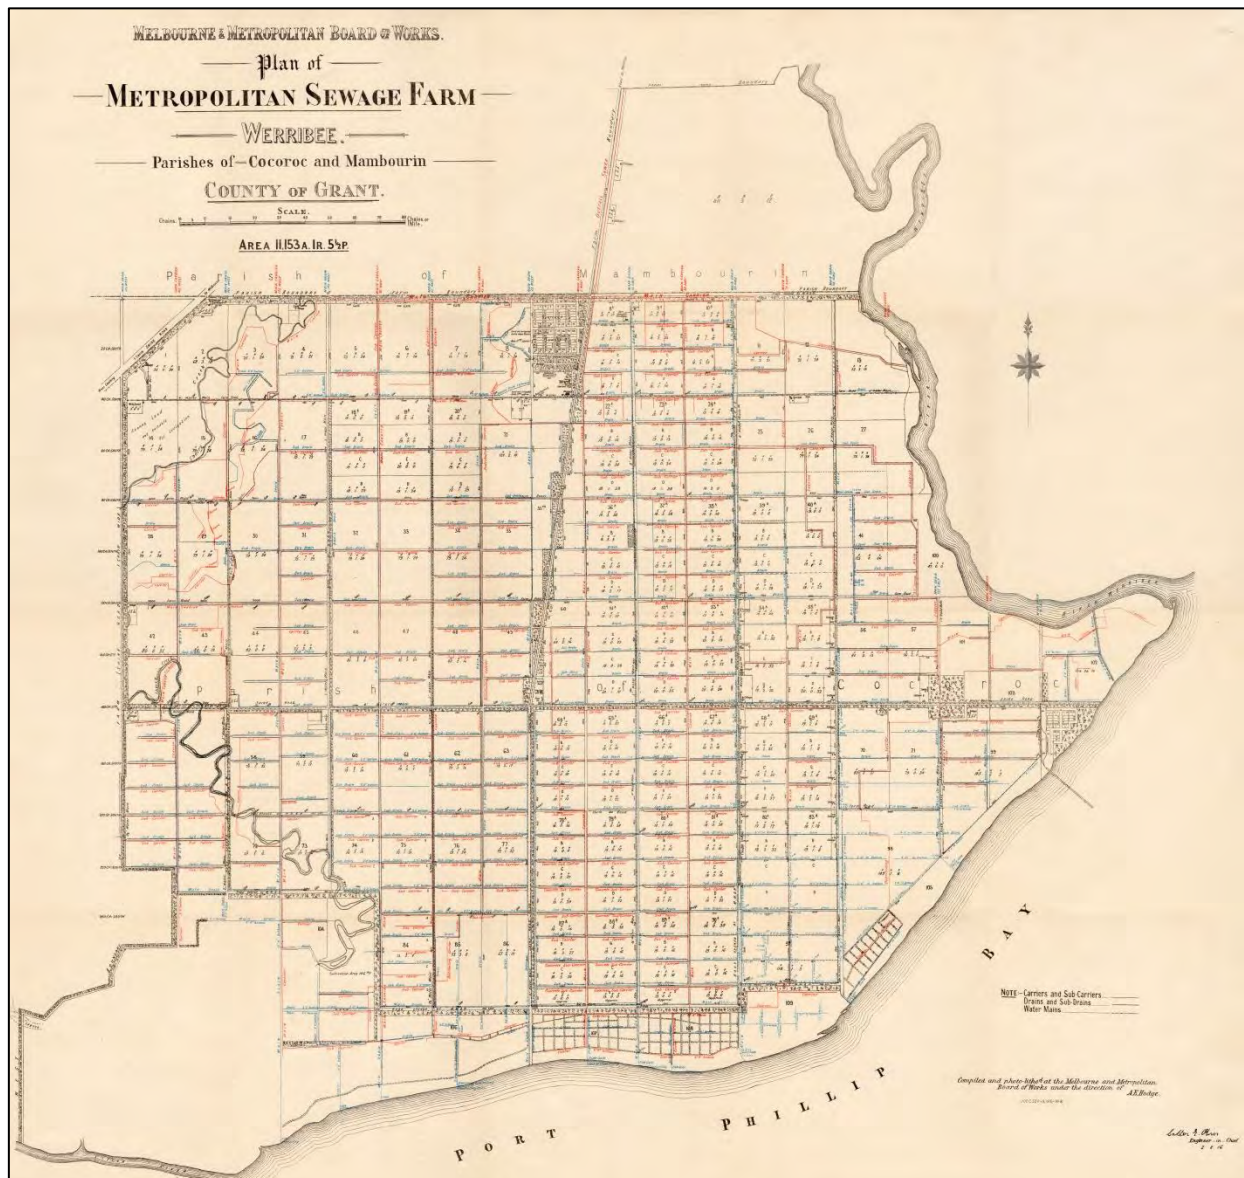
Figure 10. The Metropolitan Sewage Farm in 1916. Map courtesy of Schott (2020).

In brief, the development of the sewage farm in the 1890s was a massive project, necessitated by the need to safely address the health problems associated with the volume of human waste being generated by a rapidly growing population in Melbourne. The sewage farm development started in the north, initially on land at Werribee purchased from the Chirnside family (in what had been their pastoral run since 1853), and was expanded gradually over the years to keep up with population growth in Melbourne. The extent of the sewage farm in 1916 is shown in Figure 10.

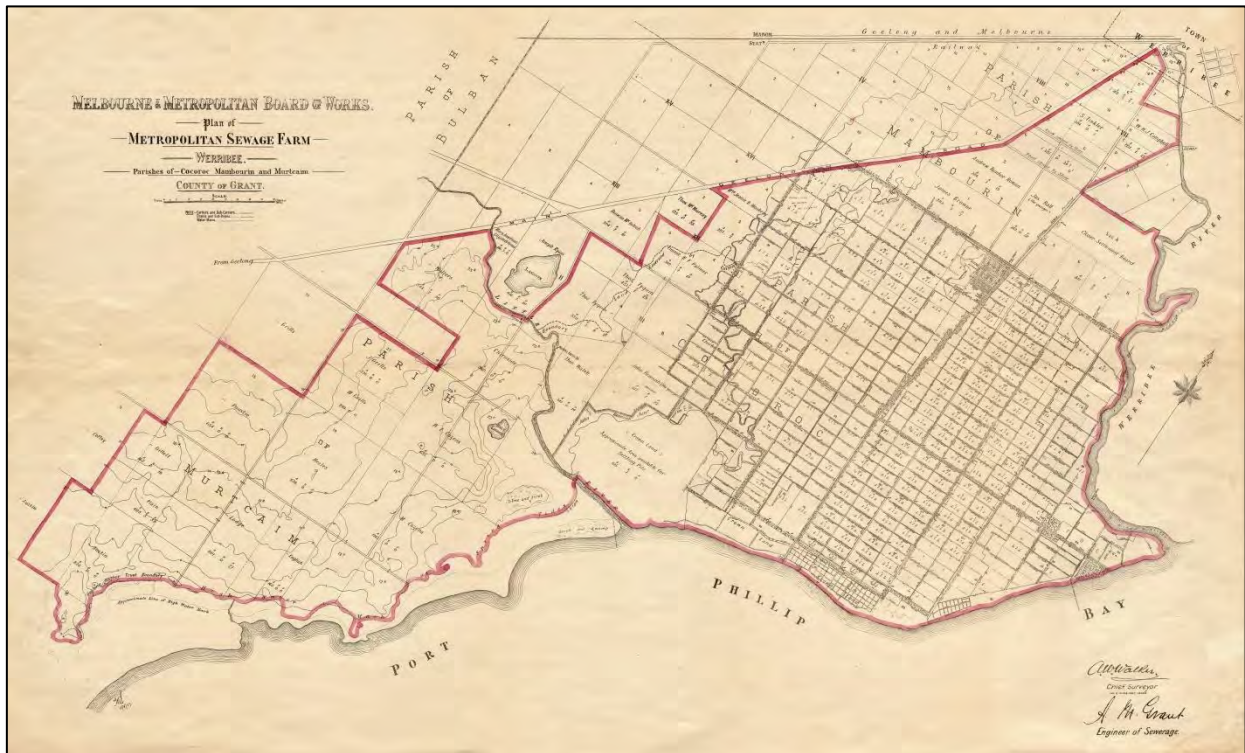
Figure 11. The Metropolitan Sewage Farm in 1916. Map courtesy of Schott (2020).

The final major expansion of the sewage farm to the south and west in the 1910s and 1920s resulted in the land adjacent to the Big Marsh project area being purchased (Figure 11). This had previously formed part of

The way the sewage farm has been managed over time has changed significantly as a result of the evolution in technologies used to treat wastewater. This means that not only were the newer parts of the farm developed differently to the older sections, but it also means that the overall configuration of the treatment plant has significantly changed over time, as can be seen by comparing Figure 11 and Figure 12.

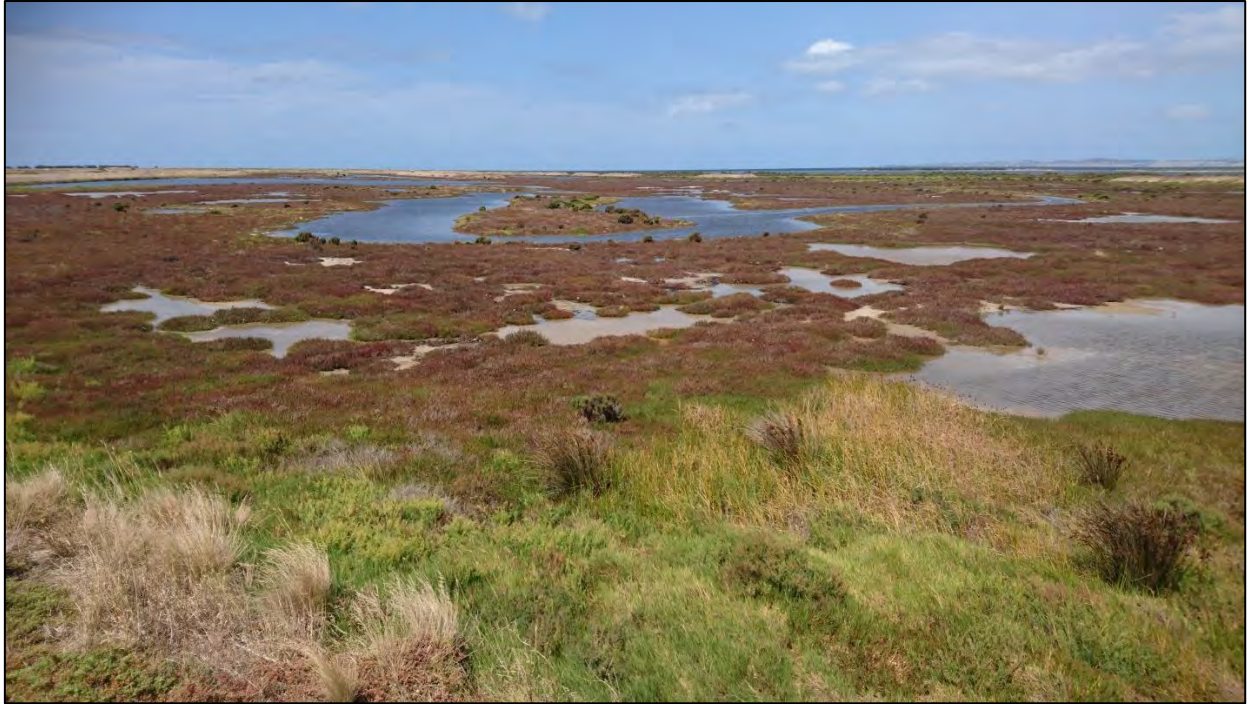
Figure 15. Restored saltmarsh habitat on Melbourne Water land approximately 2 km north-east of Big Marsh.

The lagoons in this portion of the treatment plant are now managed specifically to provide environmental values to support the wide range of wetland dependant species that utilise the Ramsar site (W. Steele pers. comm. 2019). Nearby, immediately adjacent to the coast, this has also included some work over the past decade to rehabilitate saltmarsh habitat by removing artificial banks that were impeding tidal flows, and removing sediment, accumulated from its previous use as treatment lagoons, with some excellent results (Figure 15).

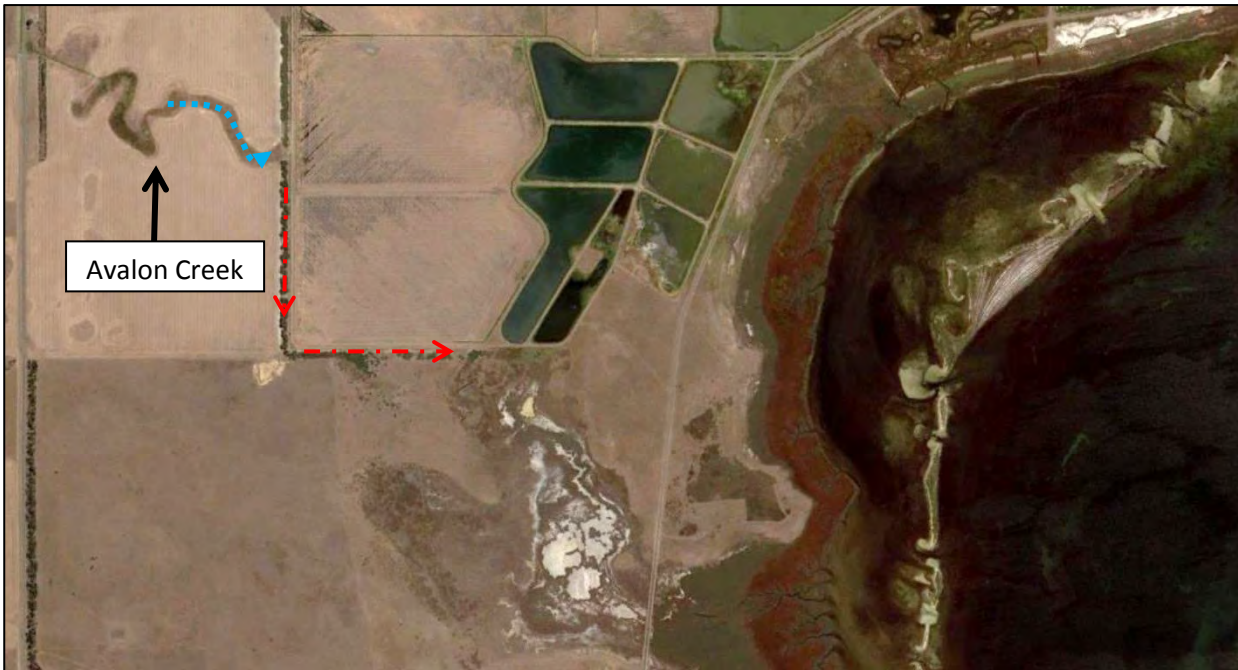
Figure 16. The location of the minor seasonal watercourse, named here as Avalon Creek, and the T-section lagoons in the centre/top of the image. The red arrows show the direction of flow down the drain that intercepts Avalon Creek (blue arrow)

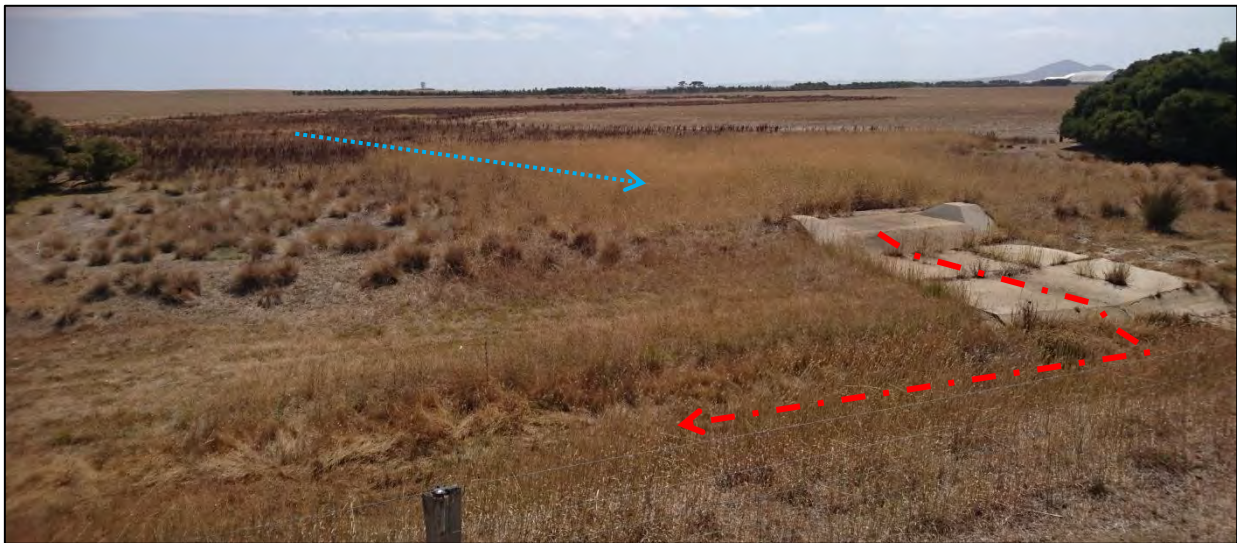
Figure 17. Looking west up Avalon Creek, a minor seasonal watercourse whose natural path is intercepted at the western boundary of the T-section treatment paddocks. The concrete spillway prevents erosion where the flows reach the boundary drain. Natural flow direction is shown in blue arrow, before reaching the perimeter drain and being diverted away (red arrow).

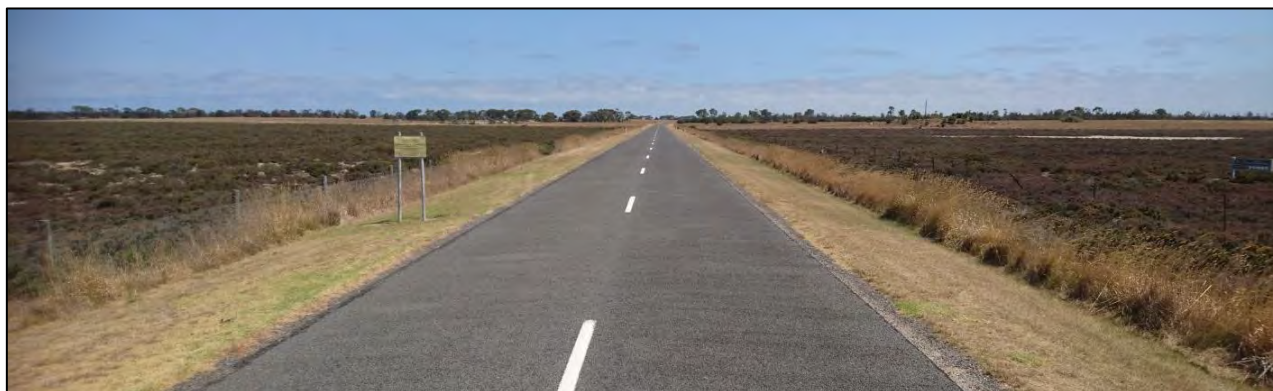
Figure 20. Looking south towards Point Wilson down 29 Mile Road. Note the clear difference in colour of the saltmarsh either side of the road, which illustrates the suddenness of this apparently artificial ecological boundary. To the east (left) is the seaward side under regular tidal influence and to the west (right) is the inland side and Big Marsh.

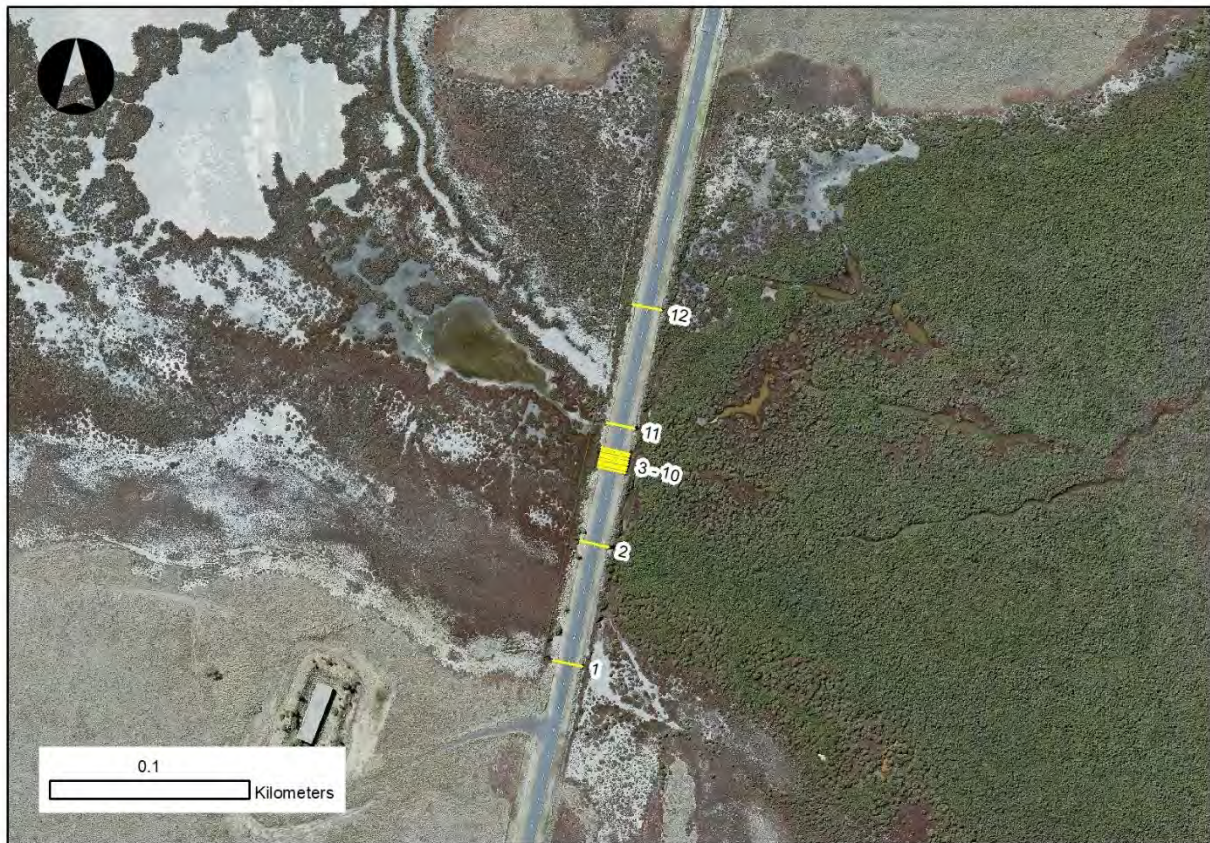
Figure 22. Box culvert identity numbers (for this study) and arrangement, 29 Mile Road.

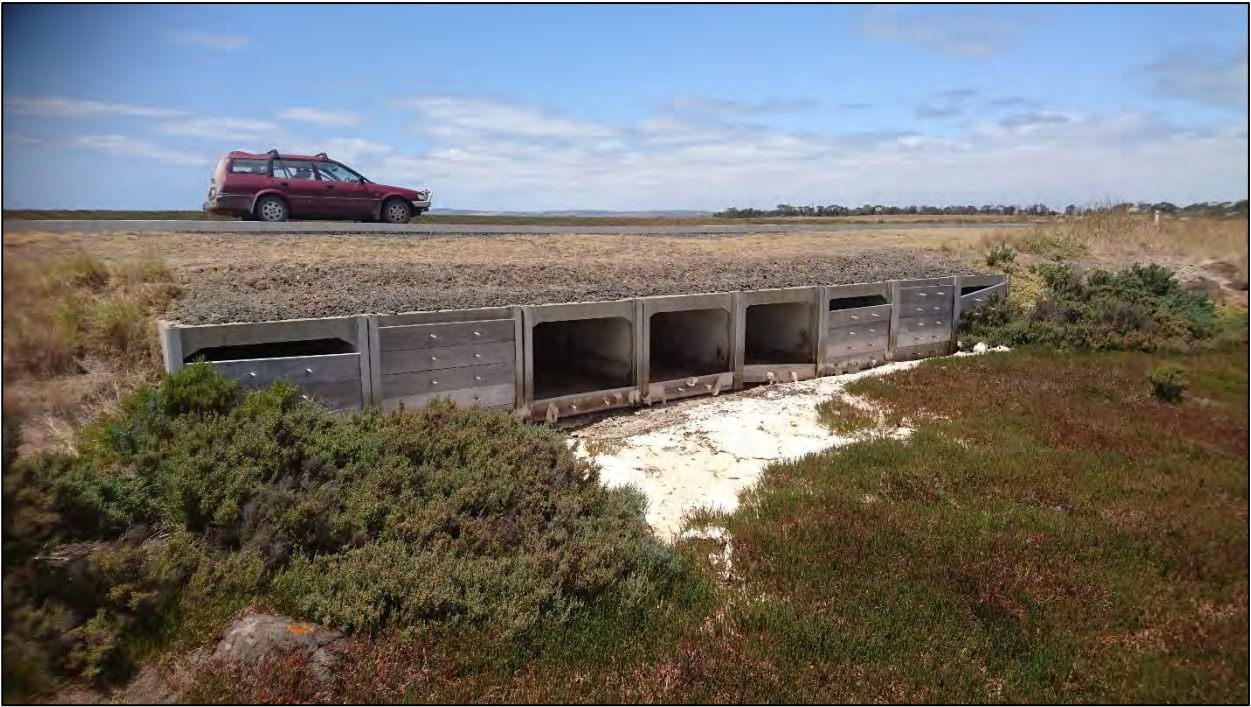
Figure 23. View of the western (inland) side of culverts 3-10 (right to left), showing stoplog arrangement at the commencement of the study, January 2019.

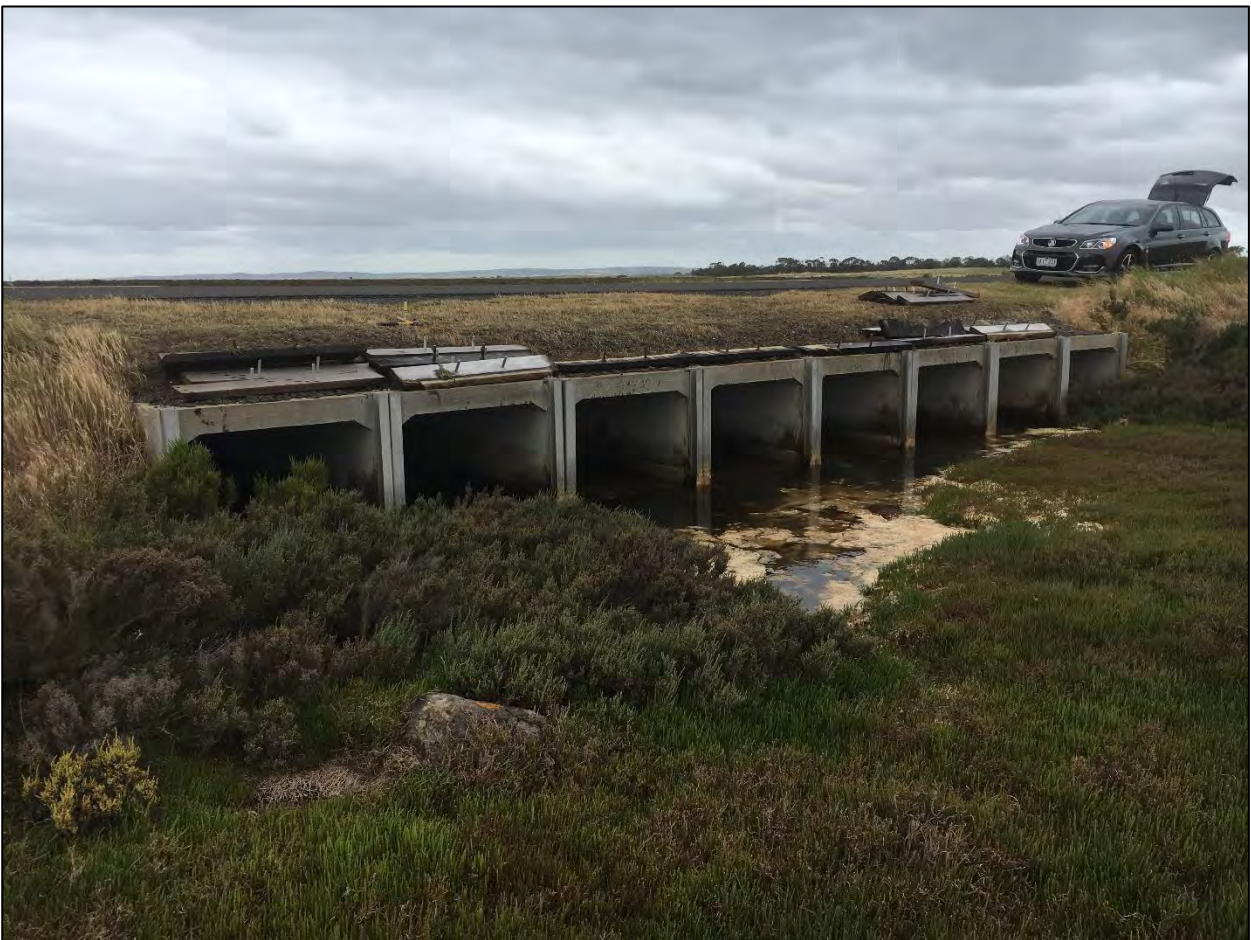
Figure 24. View of the western (inland) side of culverts 3-10 (right to left) on the day of stoplog removal, 13th November 2019.

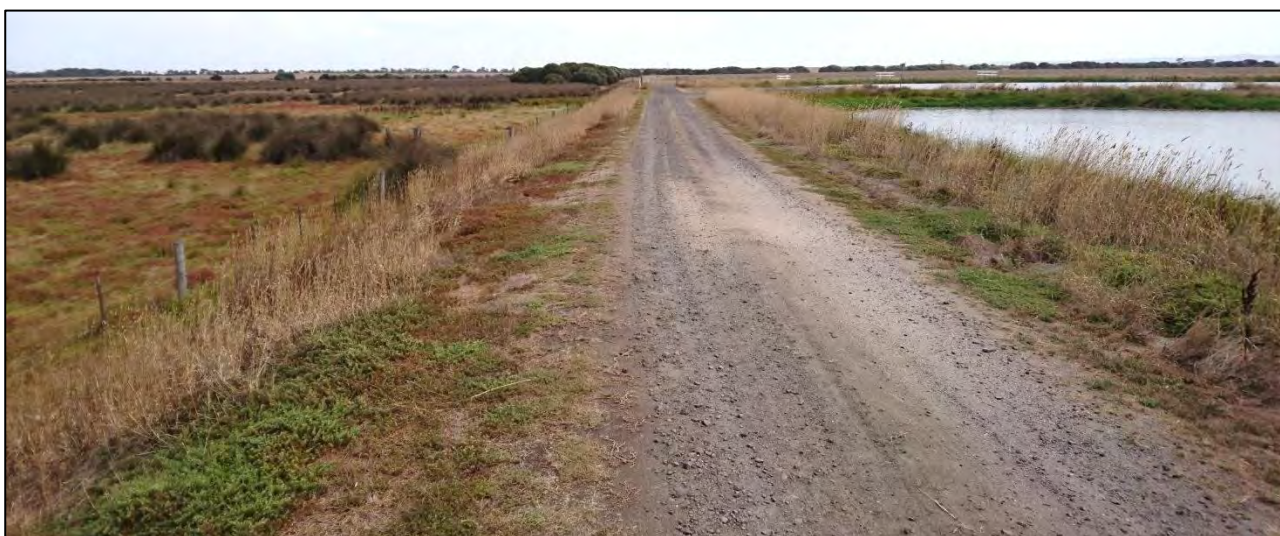
Figure 25. Looking west along the bund/boundary track that separates the T-section Ponds 3 and 4 (right) from the Big Marsh (left).

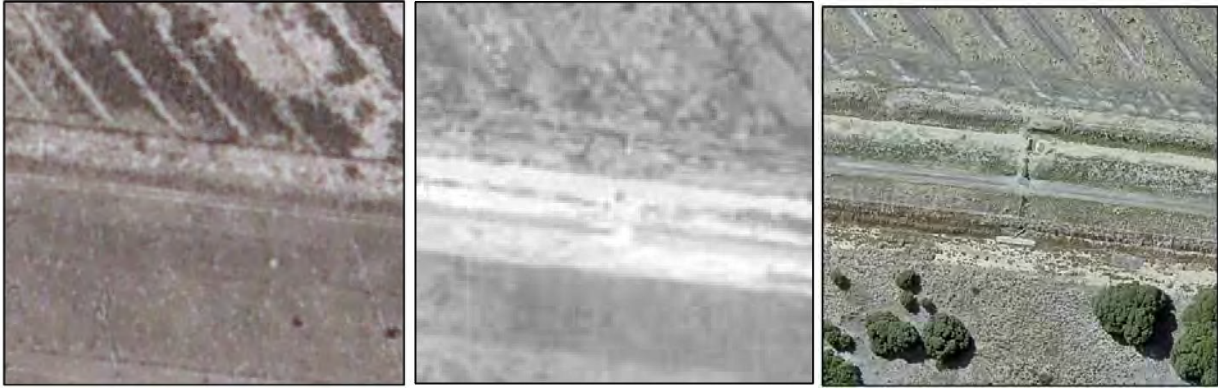
Figure 28. Location of the perimeter drain diversion structure in 1963 (left), 1970 (centre) and 2018 (right). 1970 image quality is poor but the structure is observable, however it is absent in 1963.

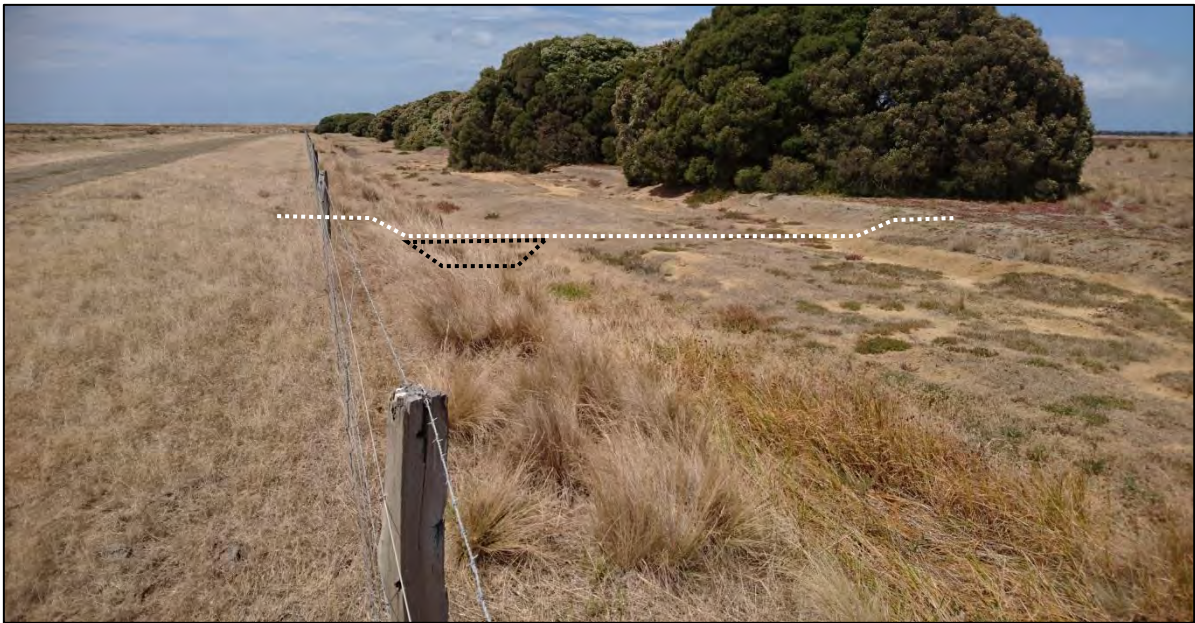
Figure 29. Looking south along the western perimeter drain that carry inflows from Avalon Creek. The white dotted line shows the profile of what appears to have been the original c. 1940 drain, while the black dotted line is the deeper channel that was constructed within the original drain, presumably c. 1970, around the time the diversion structure was installed downstream.

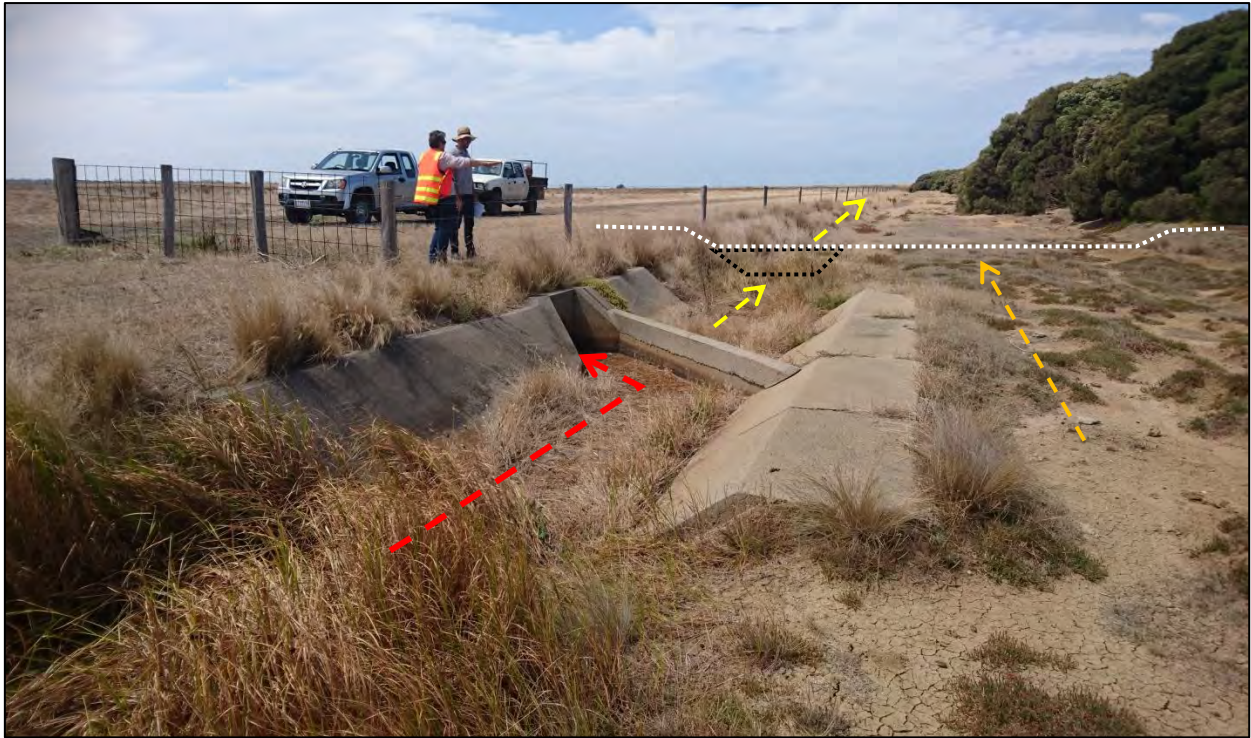
Figure 31. Looking east at the southern perimeter drain low flow diversion structure, being inspected here by Will Steele and Ben Taylor in 2019. Red line is the direction of all low flows between since c.1970 and 2000 and from 2003 to present. The yellow line indicates the direction of flow in 2001 and 2002, and for any larger flows that overtop the diversion structure. The orange arrow shows the original bed of the drain that can still carry high flows towards Big Marsh. The white dotted line shows the profile of what appears would have been the original c. 1940 drain, while the black dotted line shows the deeper channel that was constructed within the original drain, presumably c. 1970, around the time the diversion structure was installed.

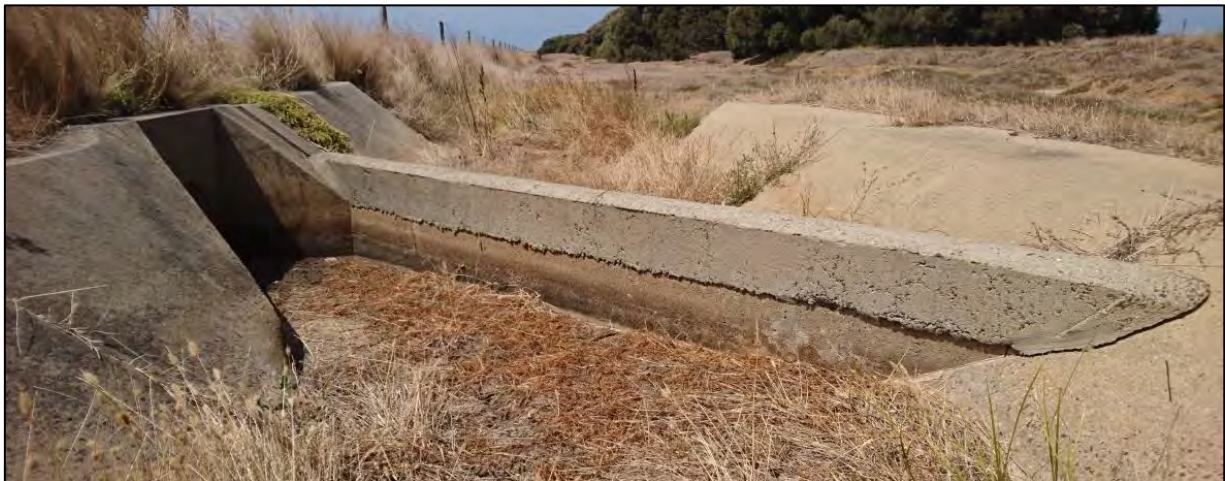
Figure 32. Evidence that the low flow diversion structure has been modified sometime after its c. 1970 construction. Raising the level of the concrete lip at the diversion point is likely to have increased the proportion of flows directed away from Big Marsh and into the T-section drain, requiring larger episodic rainfall events to cause over-topping flows.

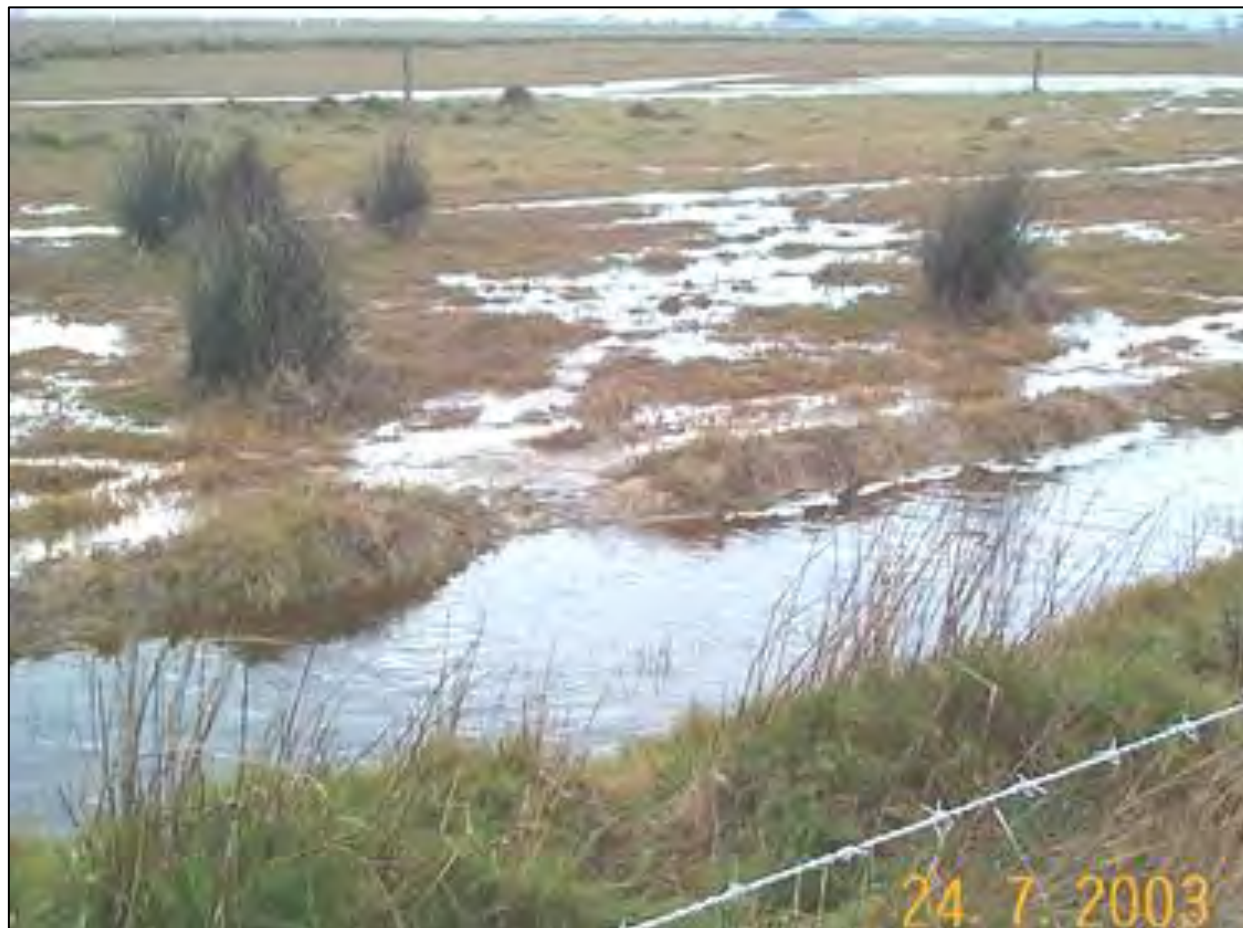
Figure 33. Water flowing into the perimeter drain from adjacent land during wet conditions in July 2003. Avalon airfield is visible in the distance (photo: Trevor Gulovsen).

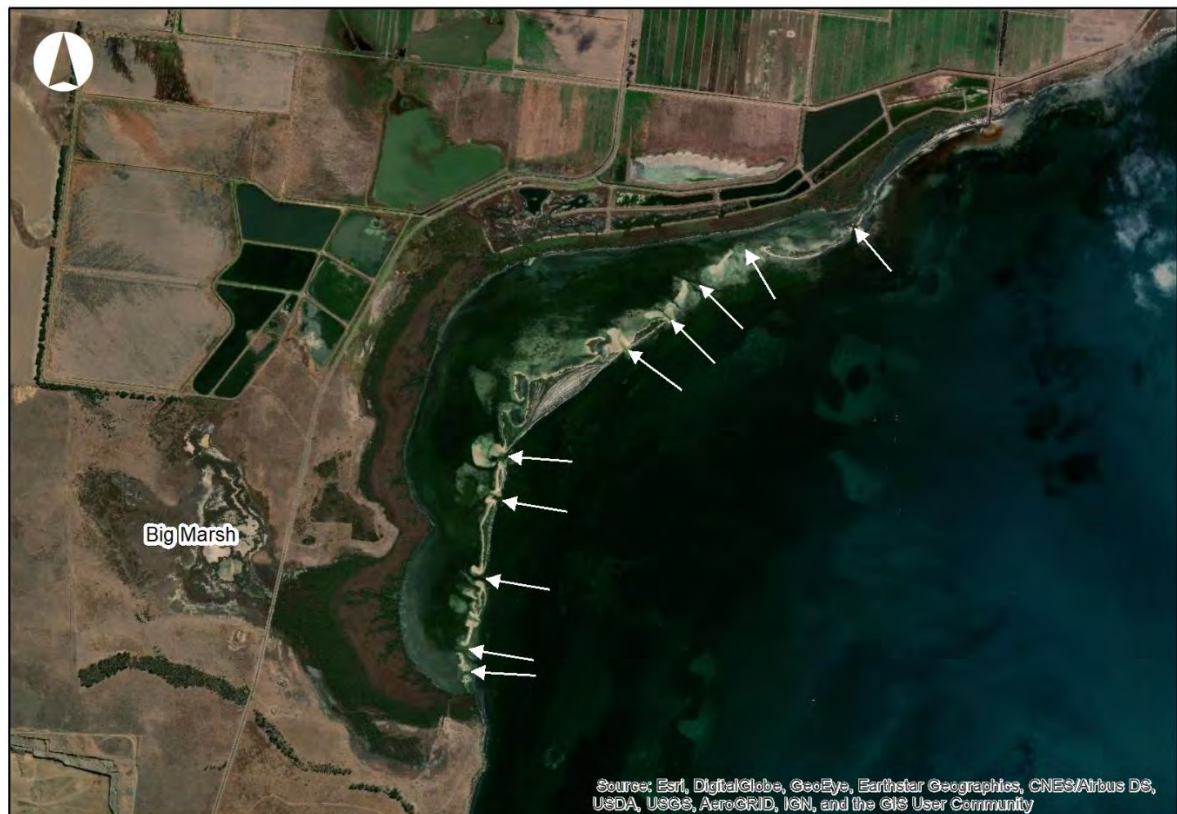
Figure 34. The Spit barrier islands, 2020 aerial image. White arrows indicate channels between the islands into the coastal lagoon.

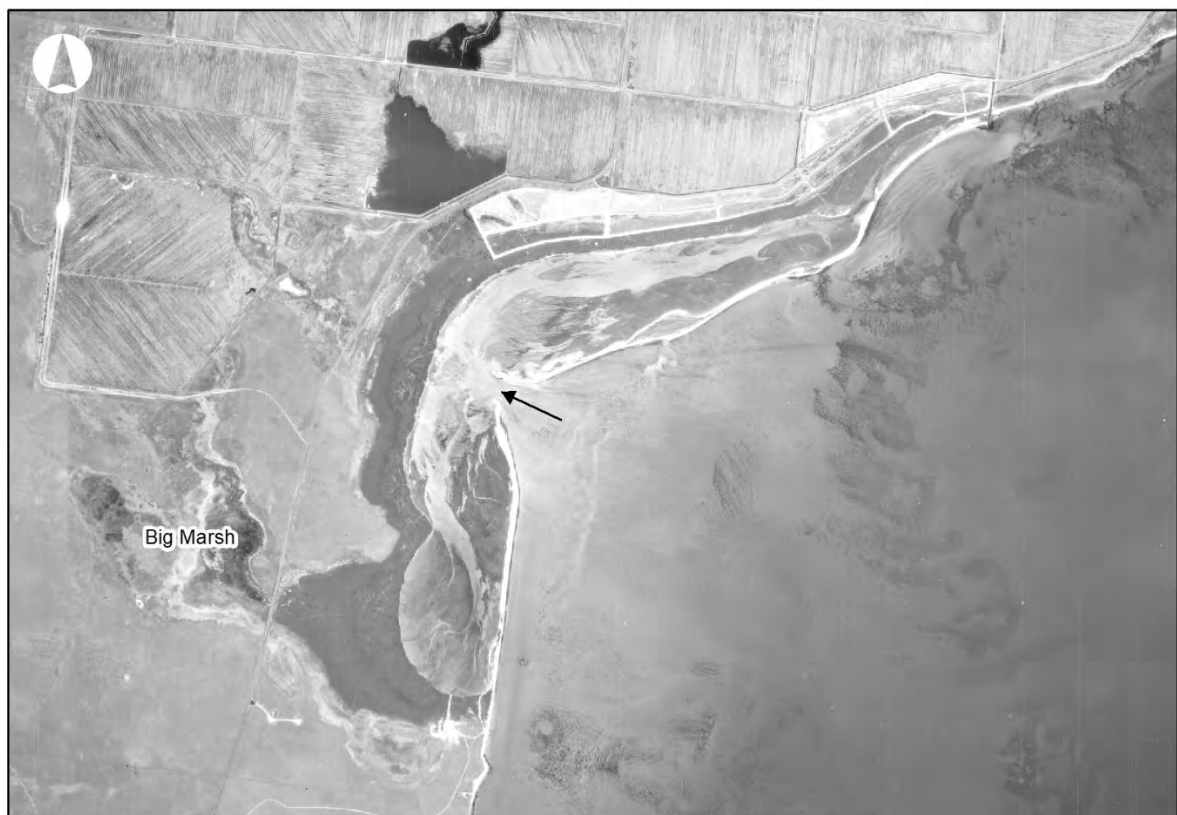
Figure 35. The Spit, 1970 aerial image. Black arrow indicates the single channel between the north and south spits into the coastal lagoon.
