Eco-hydrological Investigation and Restoration Planning for Big Marsh

**The Spit Nature Conservation Reserve, Port Phillip Bay
(Western Shoreline) and Bellarine Peninsula Ramsar Site**

Report to Port Phillip and Westernport
Catchment Management Authority

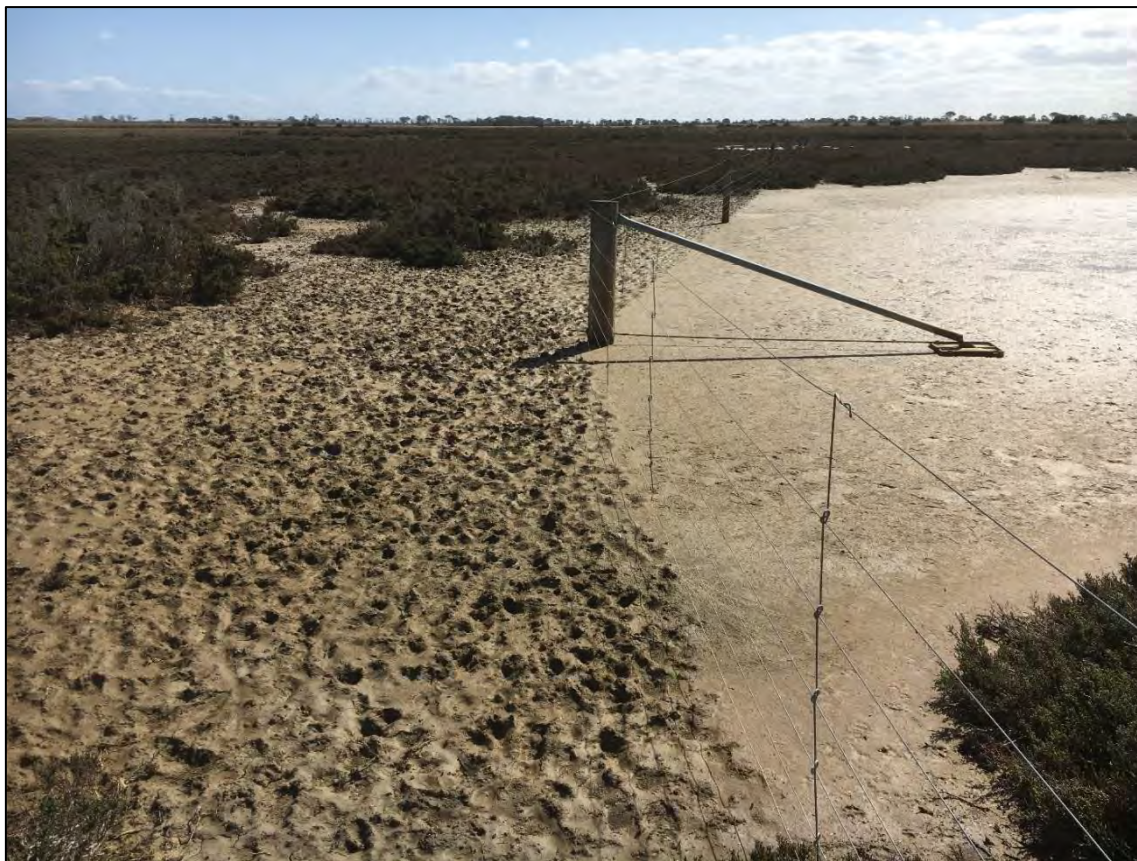
Figure 37. Evidence of sheep access along an internal fence line within The Spit NCR (E280874, N5785507). The ungrazed area to the right is within a small (3 ha) fenced area established for a grazing trial in 2006 (photo Ben Taylor 3/2/2020).

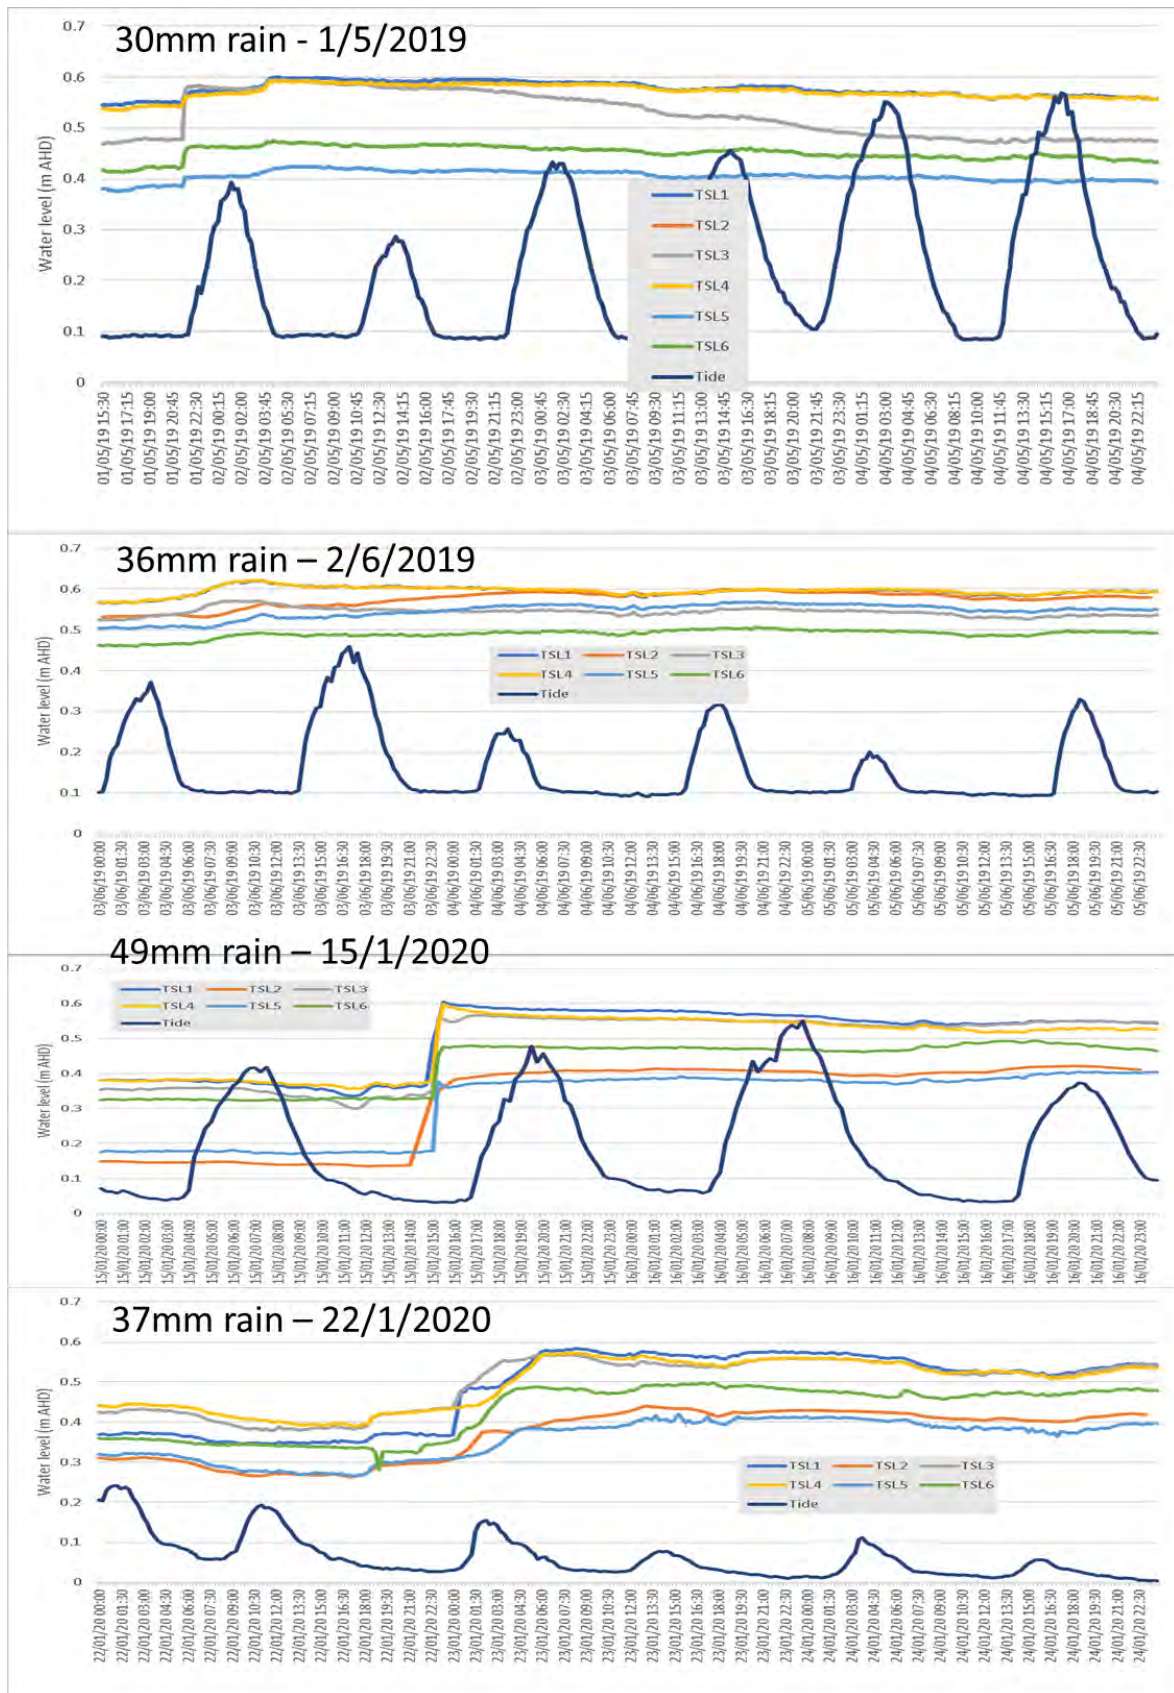
Figure 43. Water level response to rainfall events

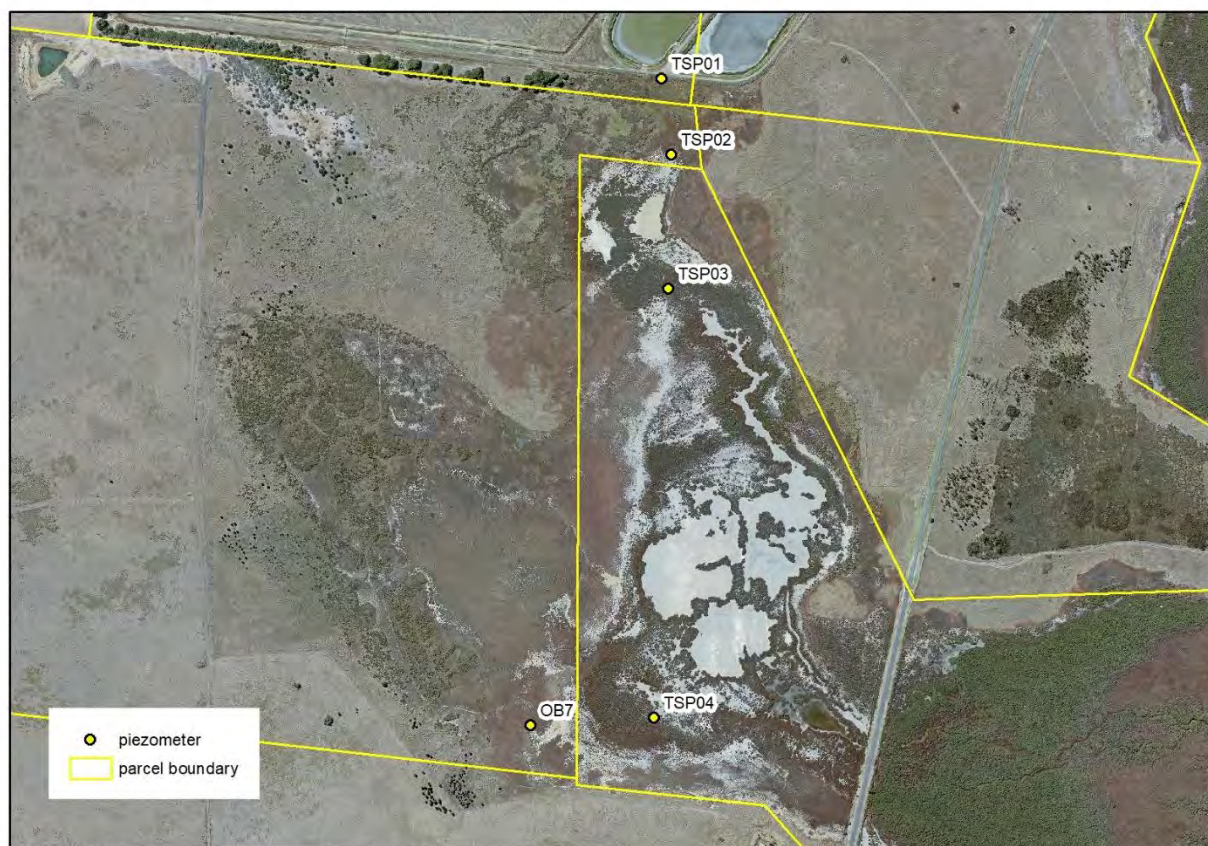
Figure 47. Piezometer locations for groundwater investigation.

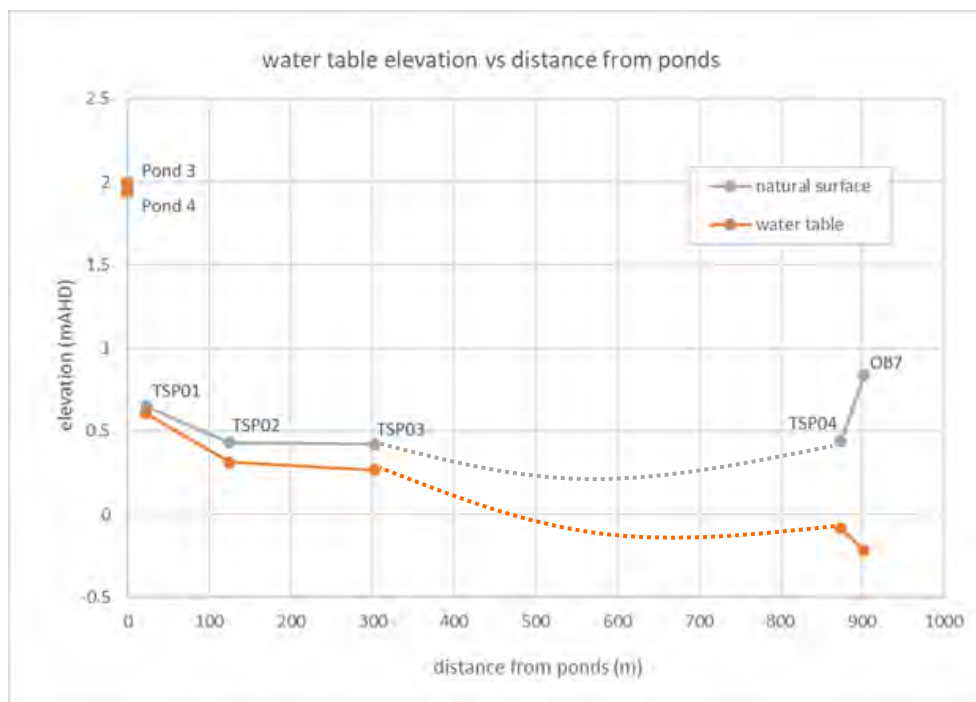
Figure 48. Saltmarsh water table elevation vs distance from T-section ponds, 24th February 2020. Dotted lines are inferred surfaces between these points to account for the basin profile of the middle of the saltmarsh.

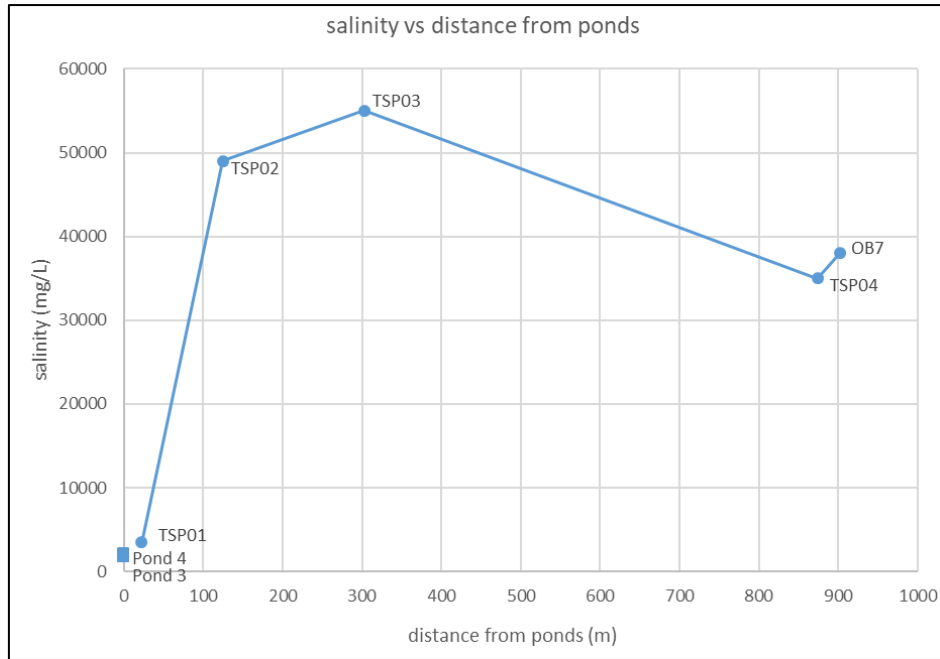
Figure 50. Saltmarsh groundwater salinity vs distance from T-section ponds, 4th and 24th February 2020.

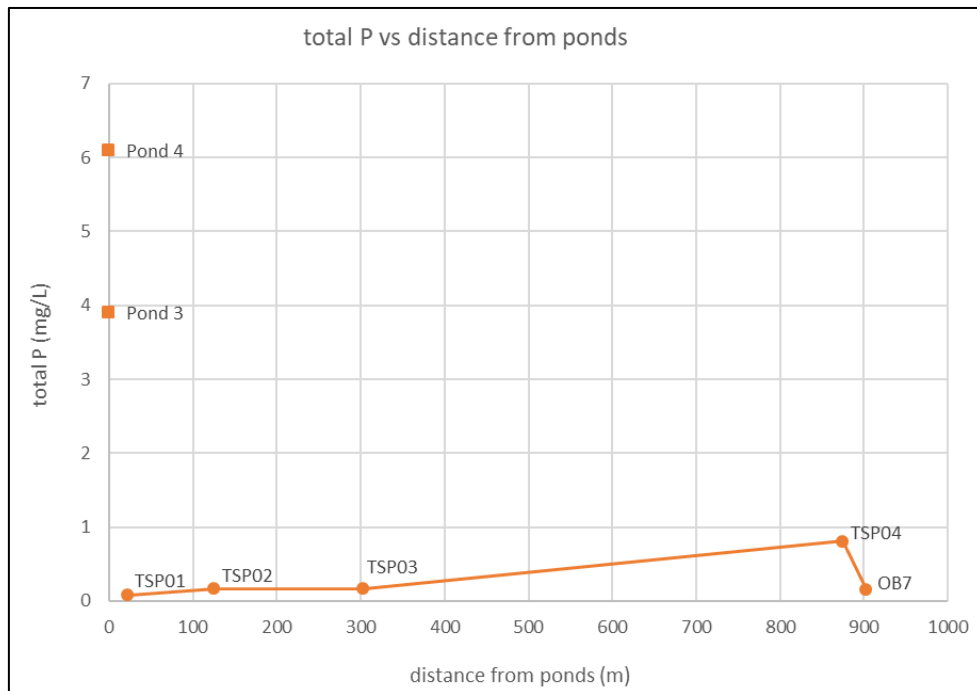
Figure 51. Saltmarsh groundwater total phosphorus concentration vs distance from T-section ponds, 4th and 24th February 2020.

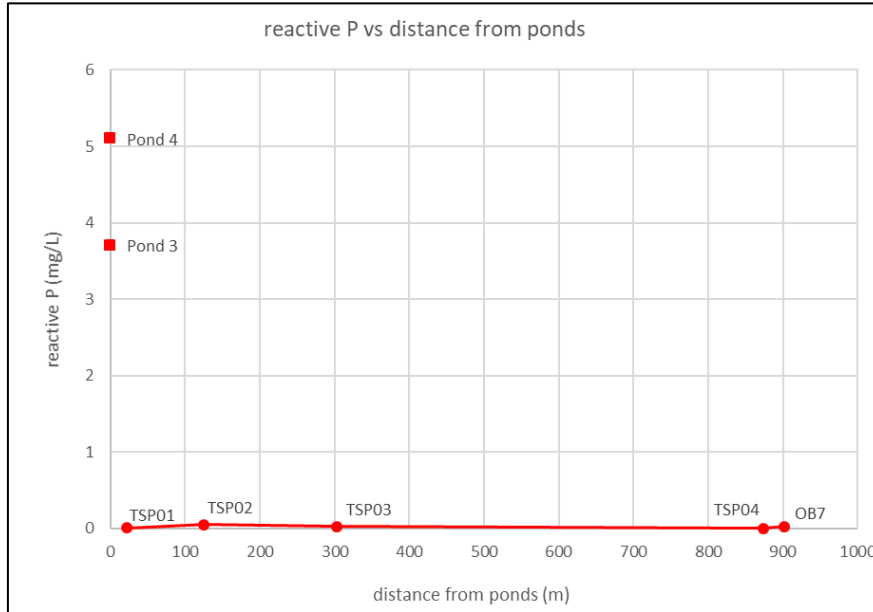
Figure 52. Saltmarsh groundwater reactive phosphorus concentration vs distance from T-section ponds, 4th and 24th February 2020.

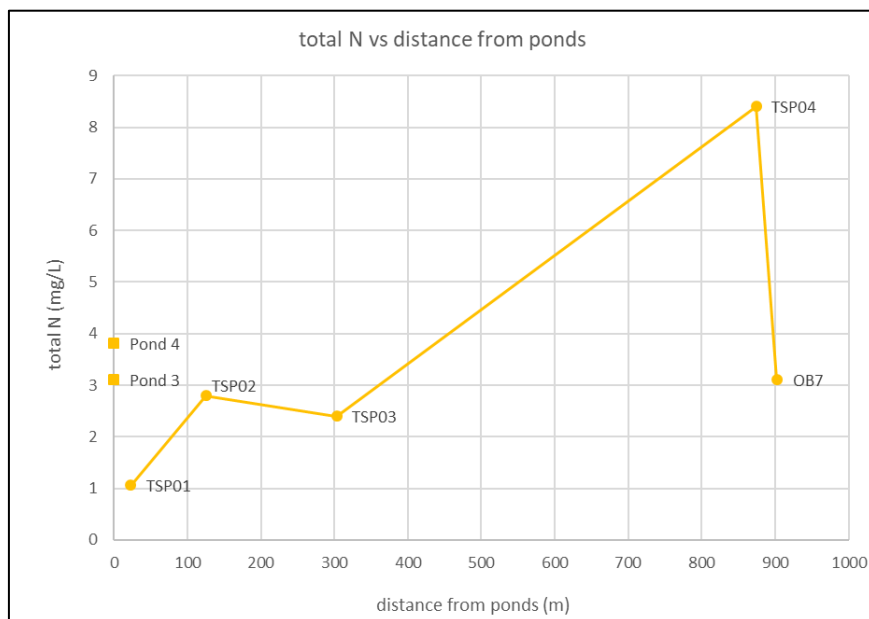
Figure 53. Saltmarsh groundwater total nitrogen concentration vs distance from T-section ponds, 4th and 24th February 2020.

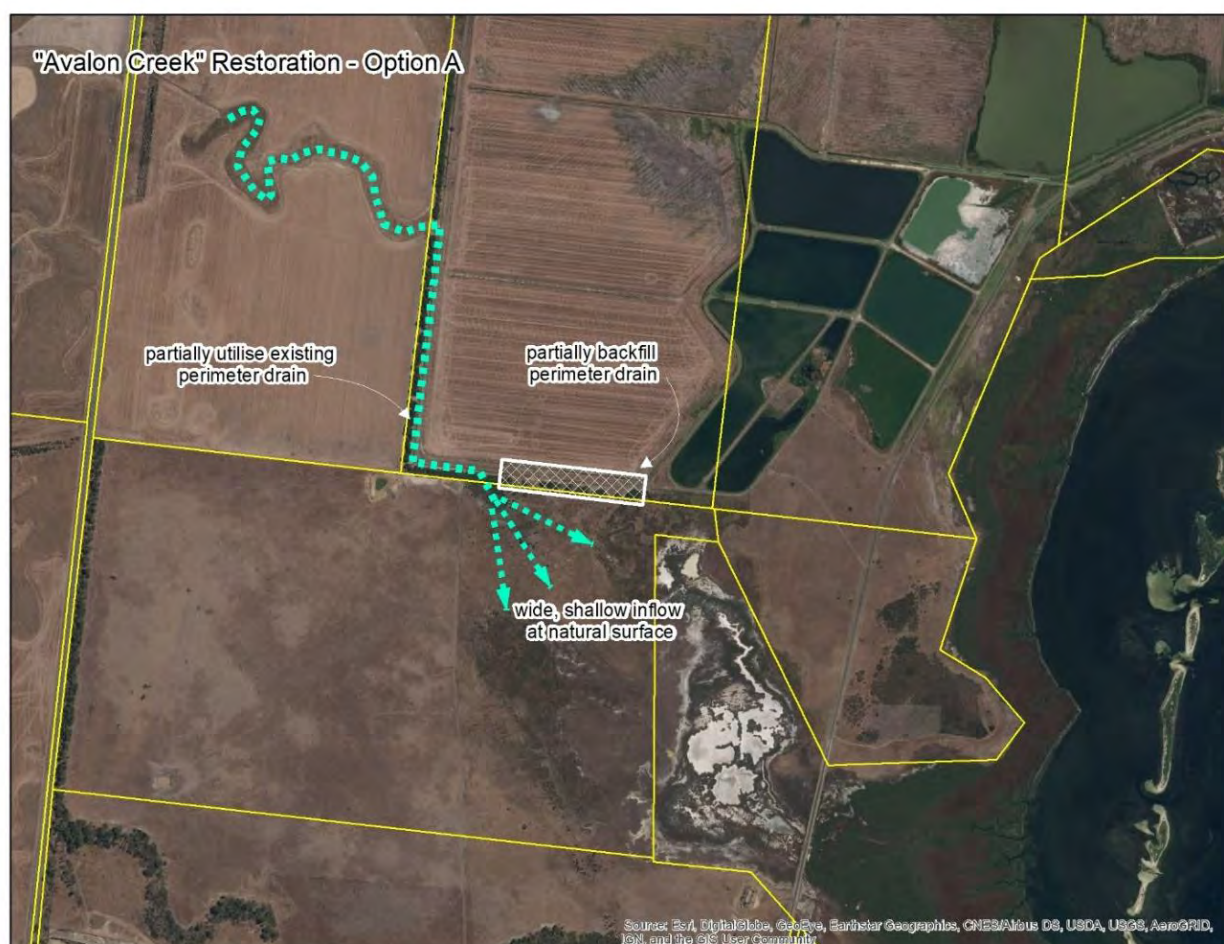
Figure 55. "Avalon Creek" restoration Option A.

This option is likely to be less costly than Options B and C.

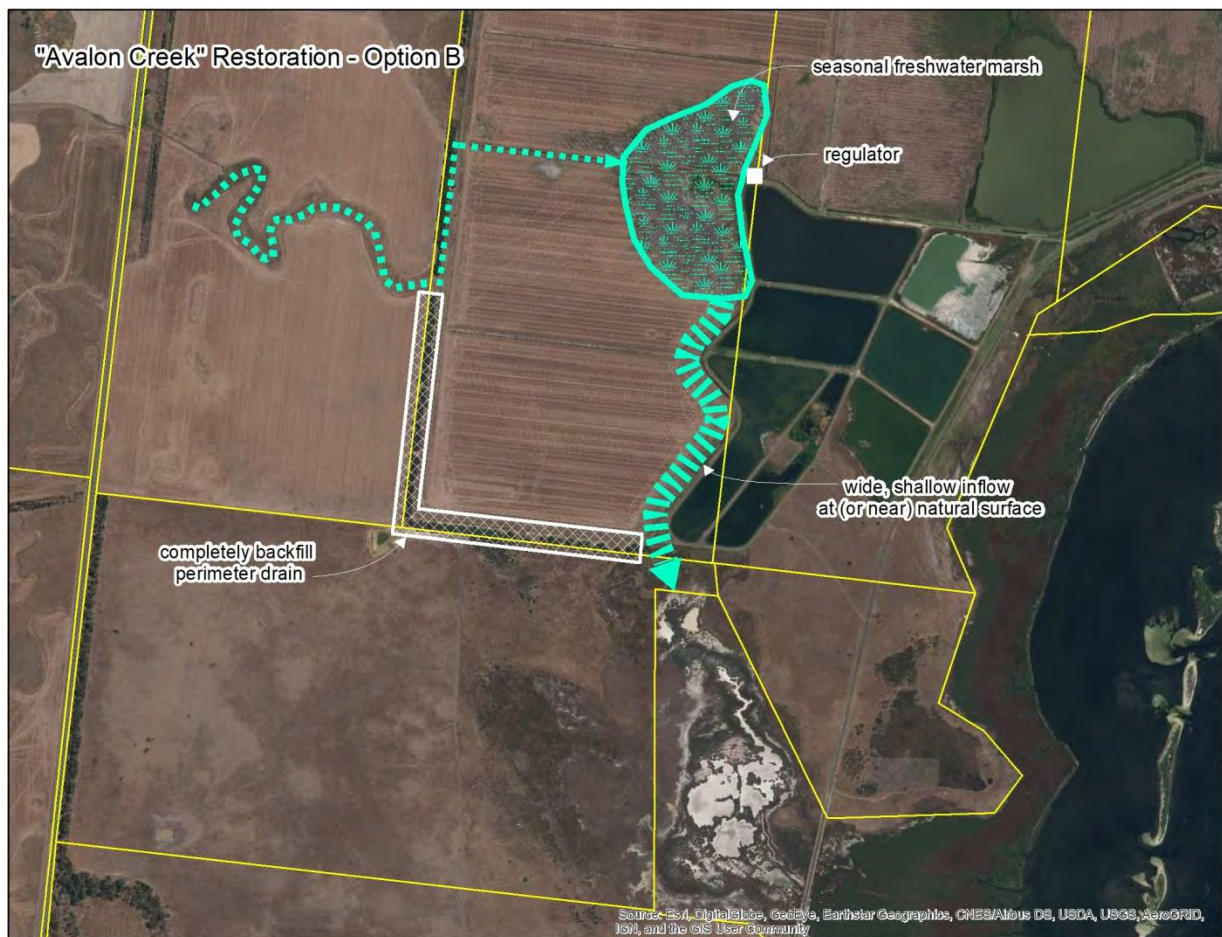
Figure 56. “Avalon Creek” restoration Option B.

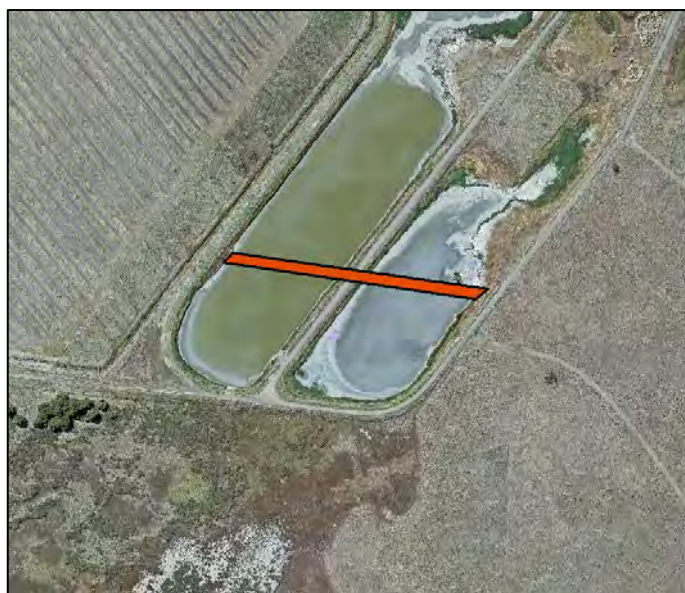
Figure 58. The potential bund location (red) for Option WL2 (b)

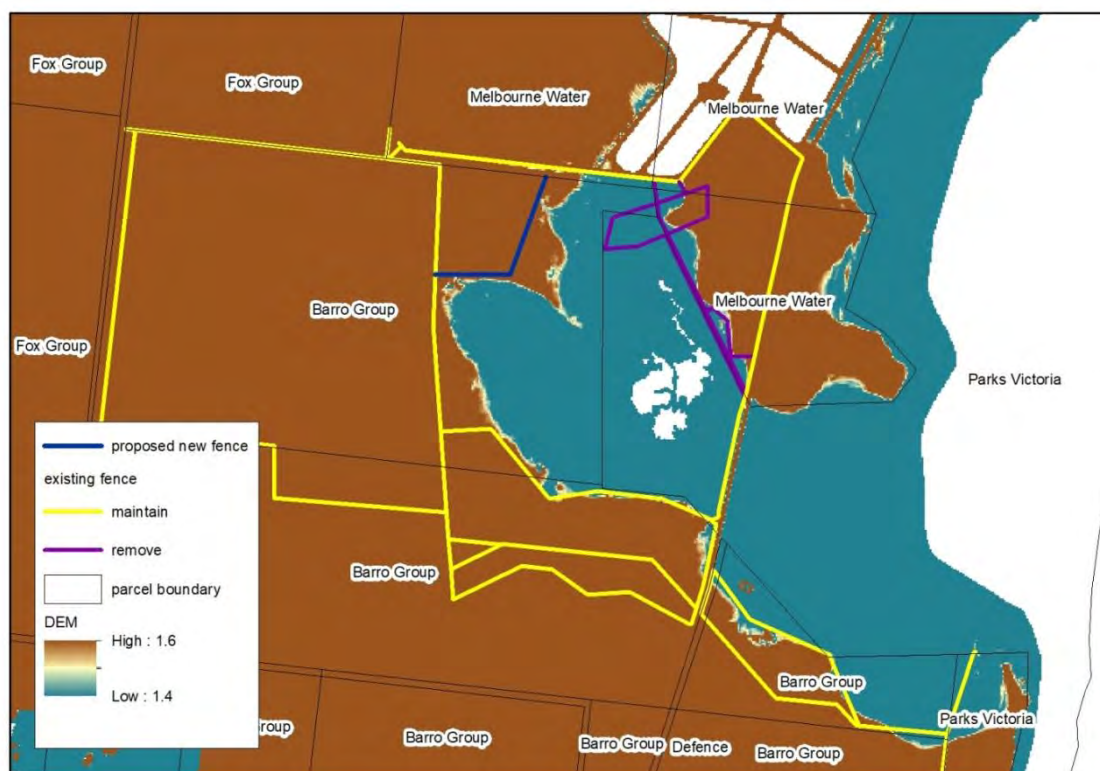
Figure 60. Approximate alignment of proposed new fence (blue line), existing fence to be maintained (yellow line) and existing fence to be removed (purple line) at Big Marsh. The DEM is displayed to differentiate between saltmarsh (blue) & higher ground (brown).

- Fencing should be upgraded as a priority to prevent livestock grazing of saltmarsh vegetation in Big Marsh.
- Achieve uniformity of fencing across the entire Big Marsh site, by:
 - improving fencing on the western side of Big Marsh, with the consent of the Barro Group, to more closely match the landform and identify locations where repairs are required.
 - removing redundant fencing on Public Land to fence the saltmarsh into a single management unit that better aligns with the landform across public and private land.
