Wetlands Australia 34: Putting wetland restoration science into practice at Walker Swamp, Victoria

Author: *Mark Bachmann, Nature Glenelg Trust*

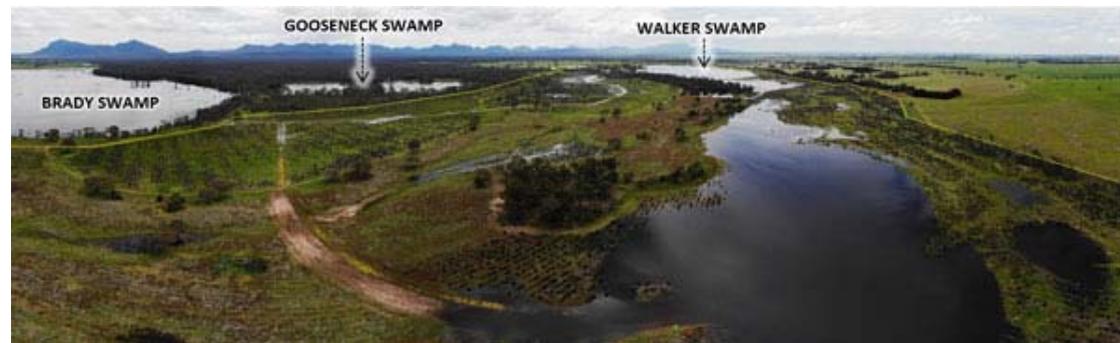
Looking north at the landscape-scale impact of NGT's restoration works across the Wannon River inland delta, across public and private land, straddling the boundary of the Grampians National Park. Photo: Dale Bachmann.

The combined impact of these works can be seen in the image below.

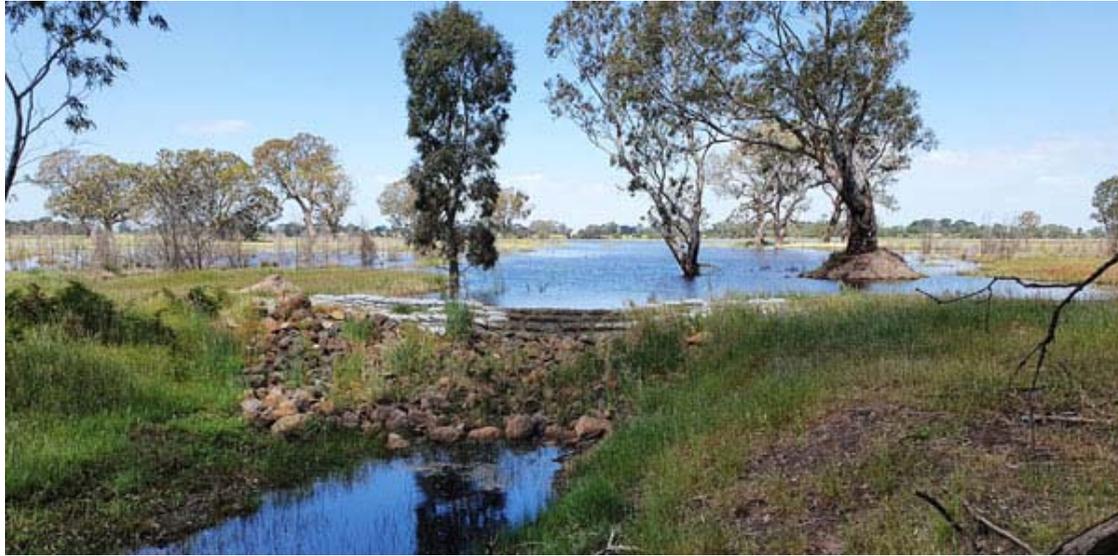
The geofabric spillway where discharge from Walker Swamp is managed back into the artificial drainage network. Shown here full with a slow trickle over the spillway on 16th November 2020. credit: Mark Bachmann.

All surface flows out of Walker Swamp are regulated by an inexpensive geofabric spillway, where a short length of retained artificial drain links the newly restored chain of wetlands back into to the pre-existing drainage network where it exits the property.
