## **Reimagining the future of the wallan wallan wetlands –**

**How historic information and modern tools can guide the restoration of burrung buluk**

### **DISCUSSION PAPER 3 – October 2022**

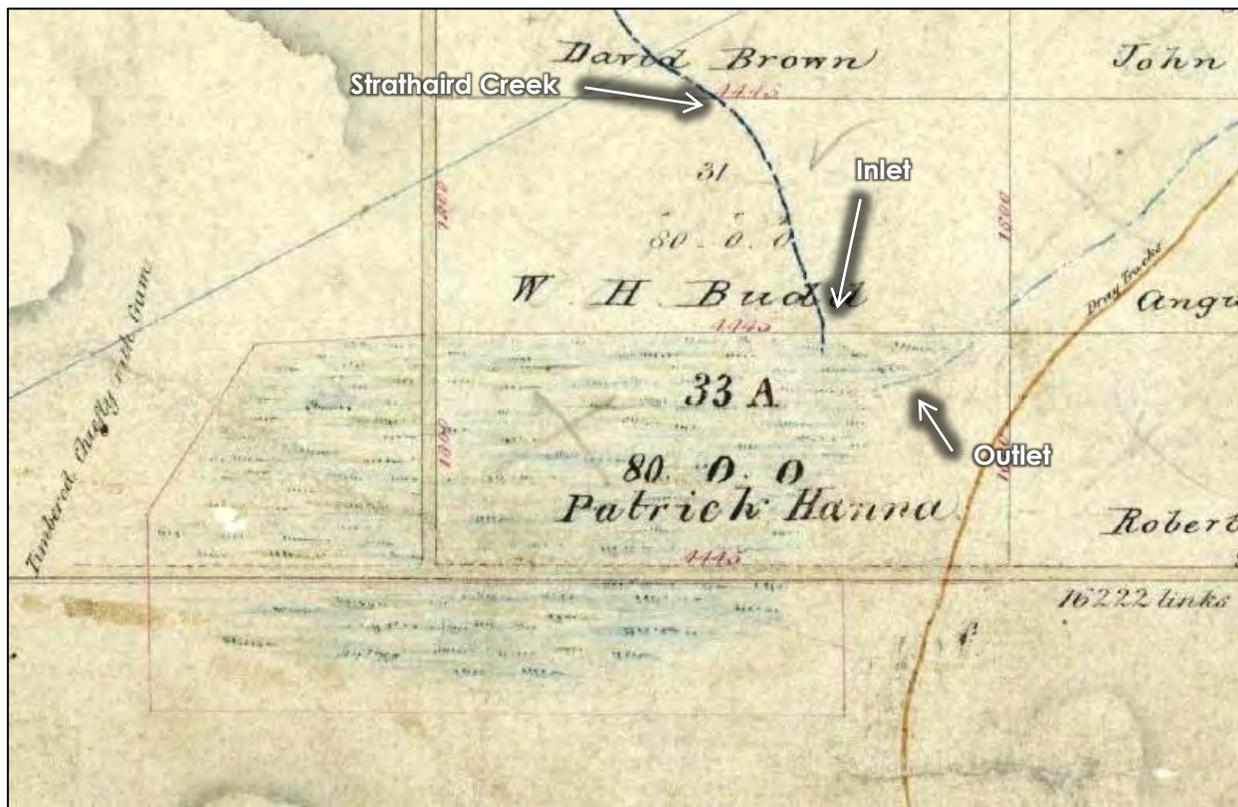
**Inset of the 1854 wallan wallan Parish Plan, showing burrung buluk, and the approximate location of its inlet via Strathaird Creek from the north, and outlet towards Meade and Herne Swamps to the east.**

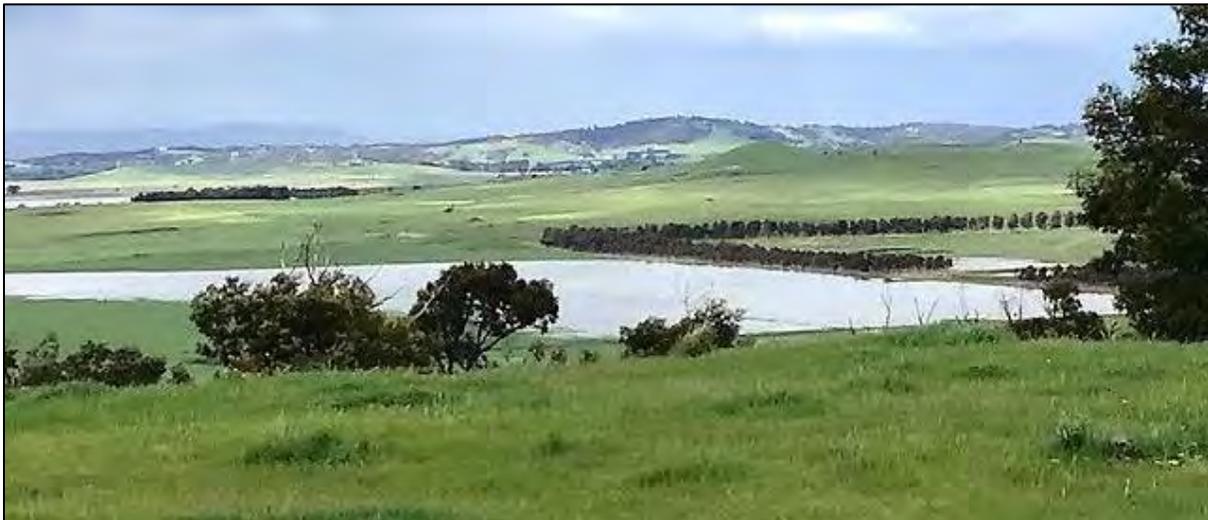
**The view of *burrung buluk* (Hanna Swamp) looking south-east across the wetland towards Spring Hill from Old Sydney Road on the 14<sup>th</sup> October 2022. Photo: Claudia James.**

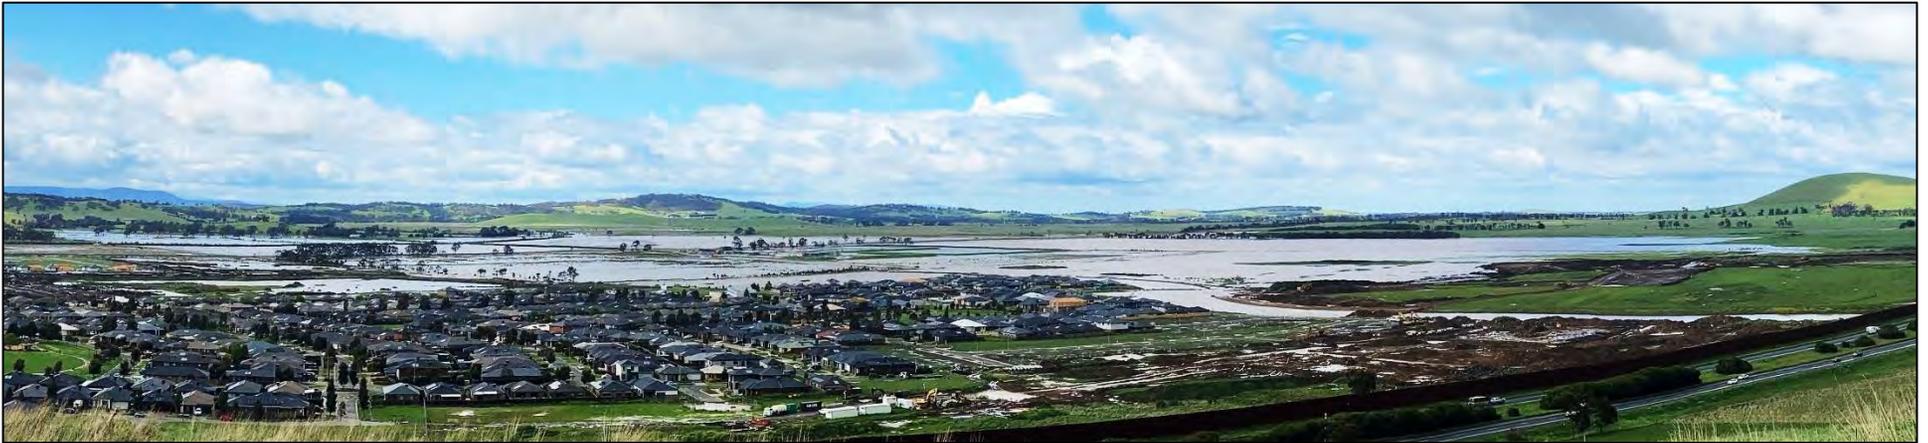
**Looking in a south-easterly direction over Herne Swamp from Green Hill on the 14<sup>th</sup> October 2022.**

**Despite comprehensive artificial drainage of the wetland, Herne Swamp is temporarily inundated across much of its former footprint, as a result of heavy rainfall in the catchment. Some of the former wetland is now reclaimed land (part of the Wallara Waters suburban development, shown in the central foreground). Photo: Rob Eldridge.**

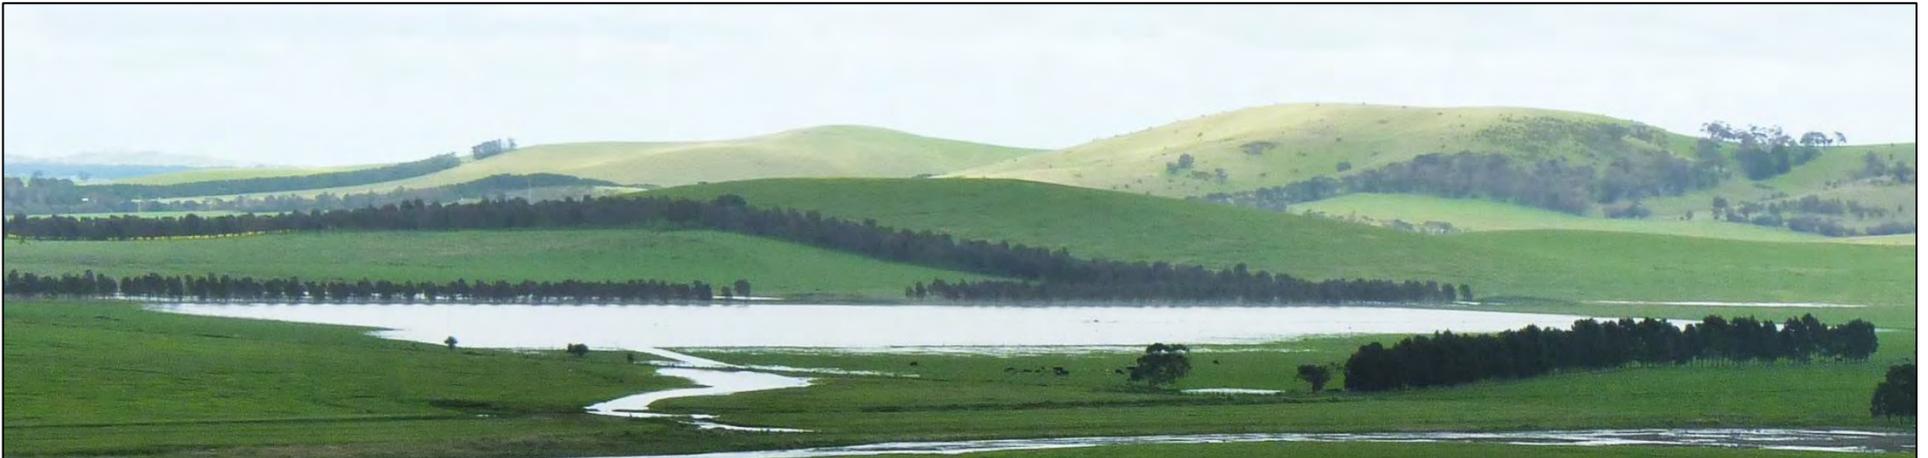
**Looking in a south-westerly direction over burring buluk (Hanna Swamp) from Green Hill on the 14<sup>th</sup> October 2022.**

**As a result of heavy rainfall, the wetland is temporarily inundated across much of its former footprint, despite the impact of the artificial agricultural drains which are cut below the wetland bed level and can be seen discharging here via the single outlet drain in the foreground. Photo: Rob Eldridge.**

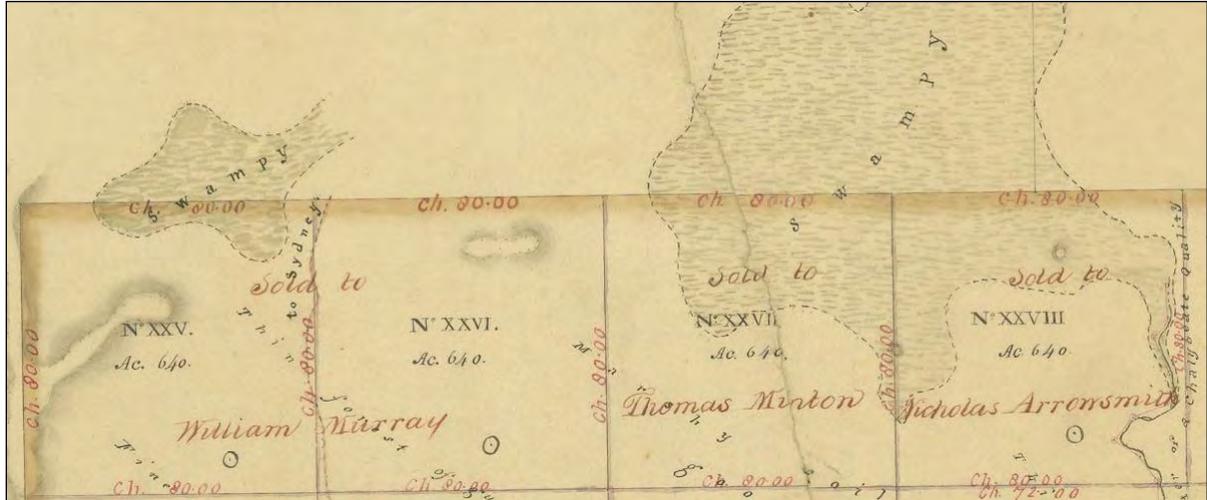
1840 – Inset of the Merriang Parish Plan, broadly showing the location of *burrung buluk* (left) and Herne Swamp (right)

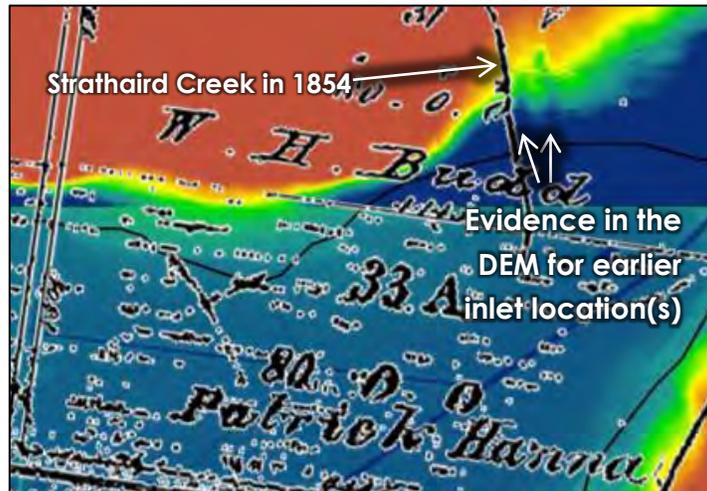
Overlay of the 1854 map combined with the DEM, showing the former location of the Strathaird Creek inlet(s) into *burrung buluk*, in close proximity to the location marked on the 1854 map.

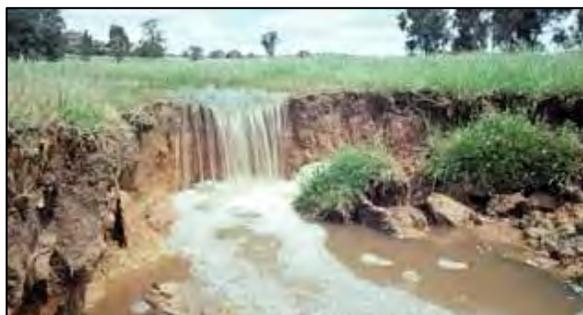
**Example of gully erosion (Agriculture Victoria)**

This illustrates how a gently sloped gully, with a barely discernible waterway that might only flow seasonally, can become a deeply incised, massively eroded ‘creek-line’, the likes of which are now seen across much of Victoria with erodible soils and subsoils. We need to remind ourselves that even where such creek-lines are now fenced off and stabilised, they are not at all representative of original conditions and should not be interpreted as such.

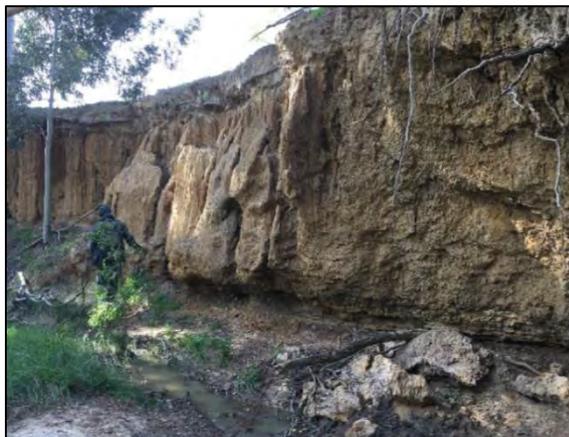
The deeply eroded and incised upper section of Strathaird Creek above *burrung buluk* is shown to the right. This is evidence of a process of gully erosion that commenced long ago, and provides some insights into both the land management history of the catchment and landscape surrounding *burrung buluk*, as well as the nature of the highly dispersive (sodic) subsoils that are present.

**Right: Example of severe, long-term gully erosion in Strathaird Creek (from Alluvium 2021<sup>4</sup>)**

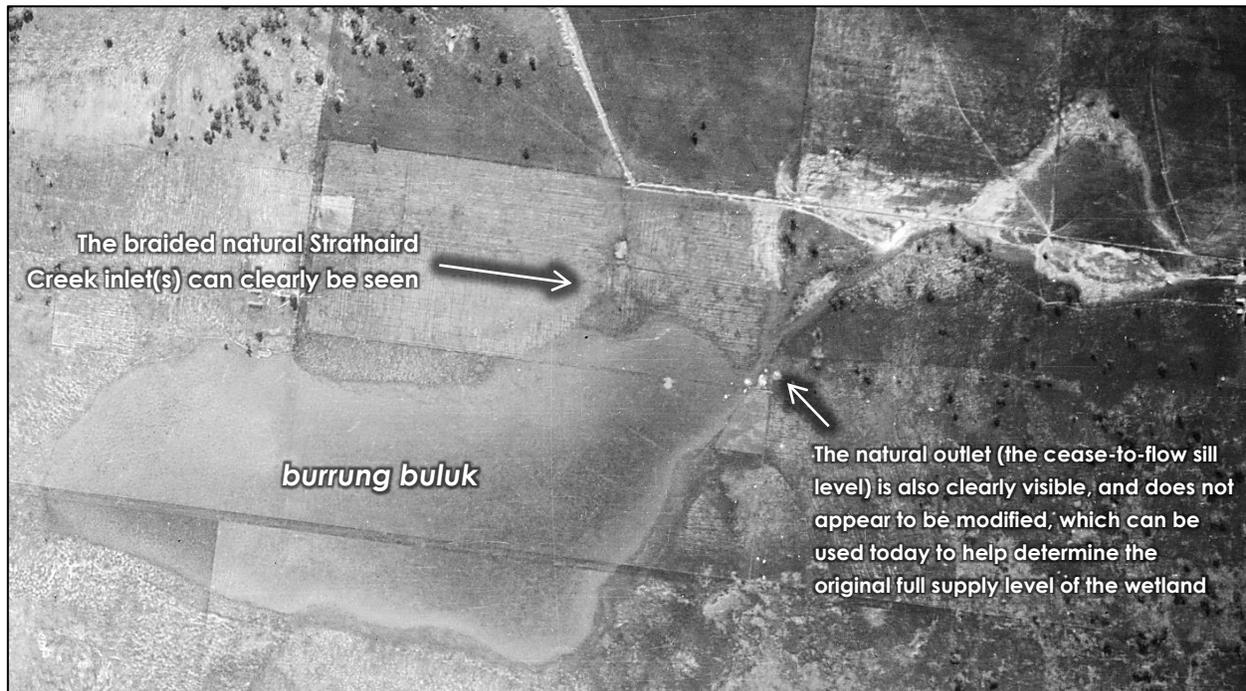
**Aerial photo of *burrung buluk* and the Strathaird Creek diversion drain in 1946. The natural wetland extent, and the natural inlet and outlet from the wetland are still clearly visible. A significant zone of soil deposition as a result of the erosion process, spilling out either side of the diversion drain, is evident.**

Vegetated seasonal wetlands that have never been drained and remain intact today are usually readily detectable in old black and white imagery, and often have a similar appearance to *burrung buluk* as shown above. Aside from the diversion of Strathaird Creek, there is no other evidence to suggest that the wetland has been hydrologically compromised by this time, as no artificial drainage outlet is apparent. Hence, an ongoing ecological response from the wetland vegetation present, whenever conditions were suitable, could be expected. This explains the difference in colour/texture that demarcates the wetland edge, visible in the image above.

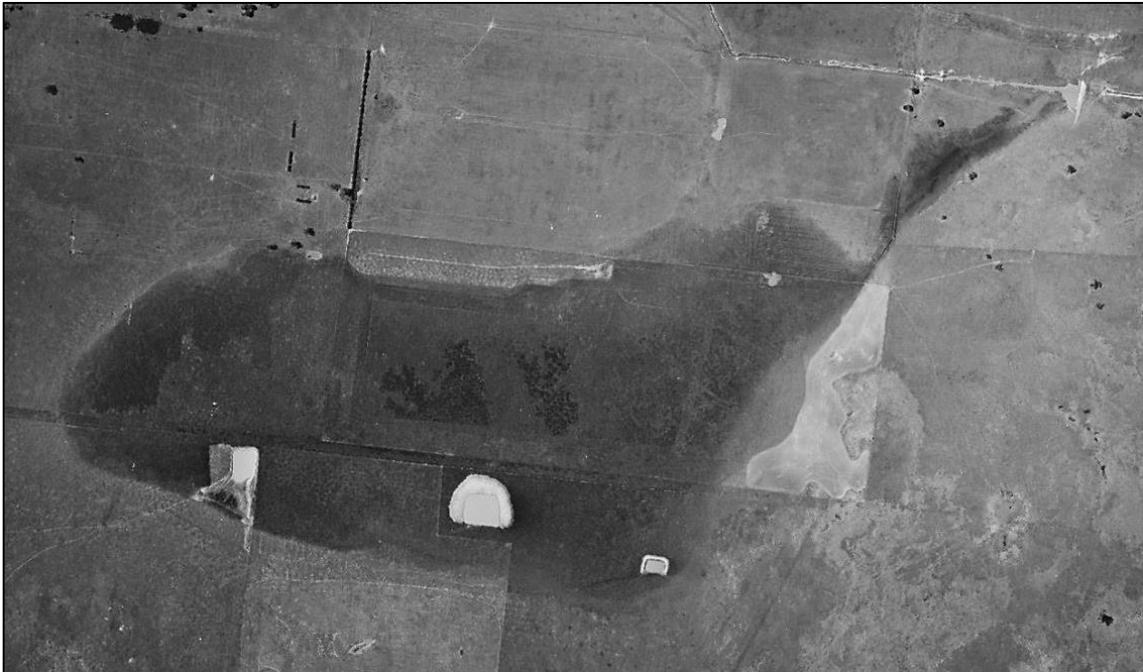
The 1972 aerial photograph shows the construction of dams in the southern portion of *burrung buluk*, noting that the wetland feature is still not drained.

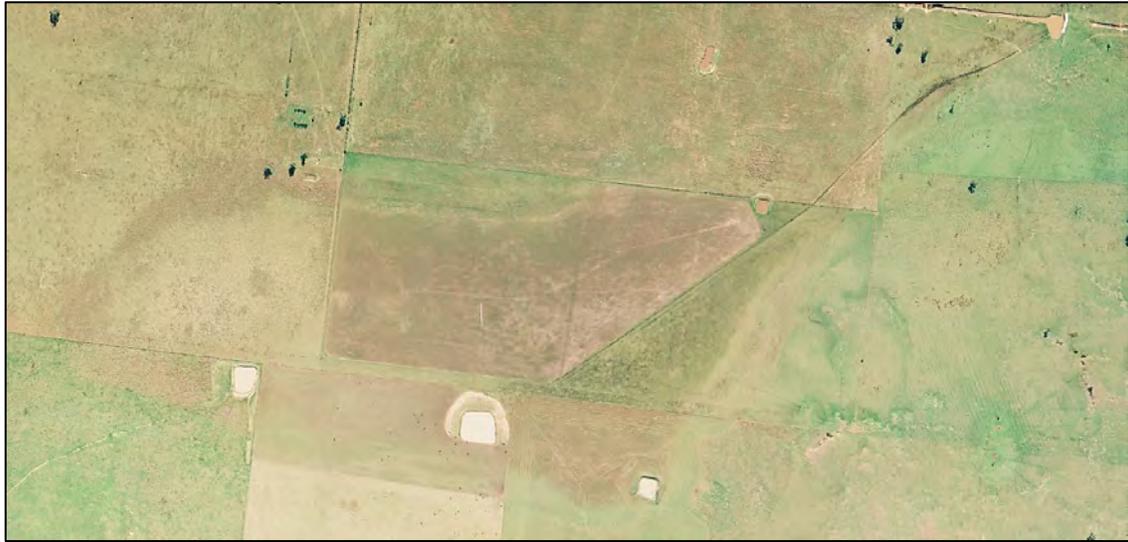
**April 1989 image of burring buluk. No changes to artificial drainage since 1974.**

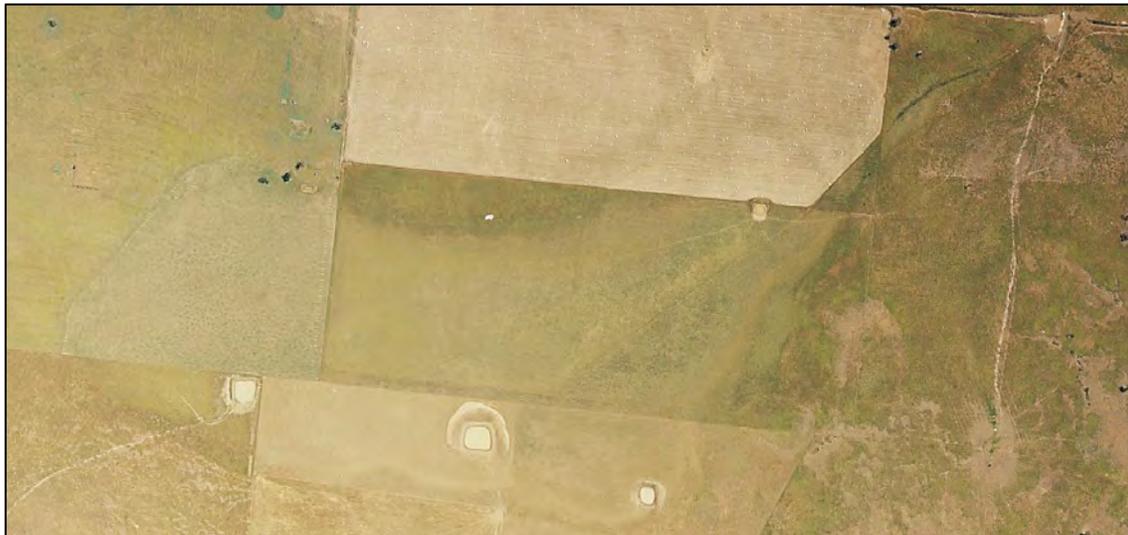
**Jan 2004 image of burring buluk. Again, no changes to artificial drainage since 1974.**

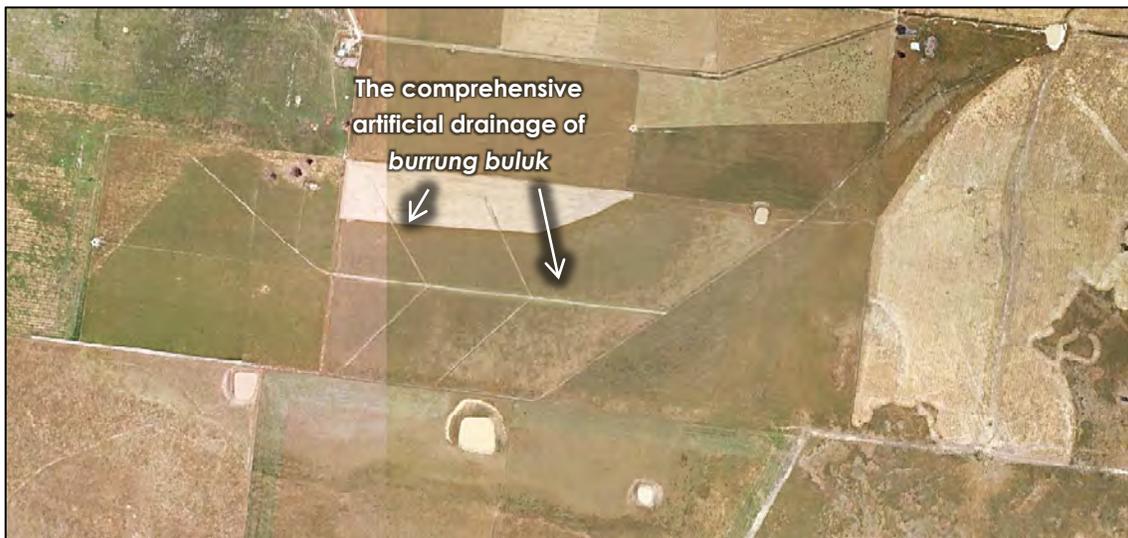
**December 2005 image of burring buluk. We can see that a comprehensive drainage network (the herringbone drain pattern) was constructed in 2004 or 2005, along with an upgrade of the 1970s drain.**

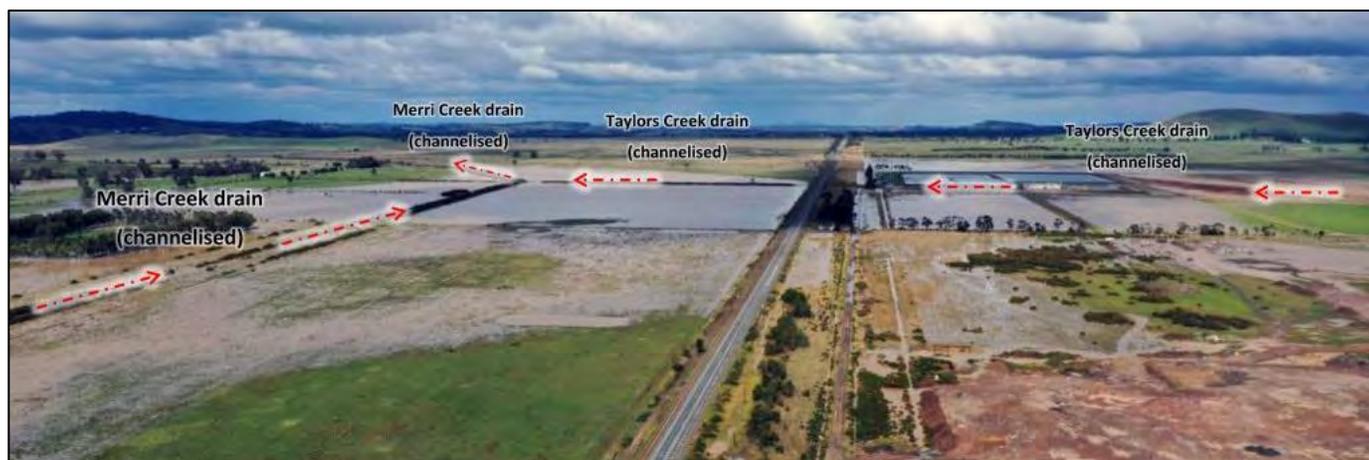
Looking south (towards Melbourne) over Herne Swamp after heavy rainfall on the 4th April 2020. Note the North-East Rail line bisecting the wetland, where (prior to artificial drainage) steam locomotives once used to stop to refill with water. Drone image courtesy of The North Central Review (with marking up of artificial drains by Mark Bachmann)<sup>8</sup>.

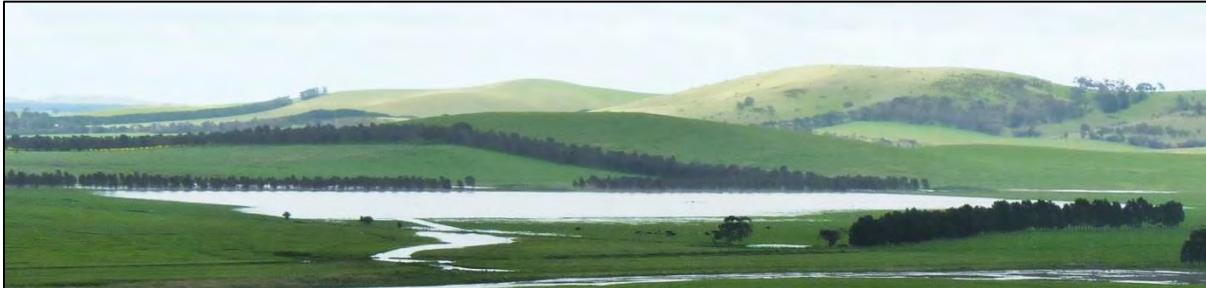
A more recent example event, when 103.4 mm of rain fell over 12<sup>th</sup>-14<sup>th</sup> October 2022 (figures from the nearest weather station at Kilmore Gap<sup>9</sup>) also resulted in the temporary inundation of *burrung buluk*, despite being cut off from the bulk of its original Strathaird Creek catchment. The image below was taken on the morning on the 14<sup>th</sup> October from Green Hill at Wallan.

*burrung buluk (Hanna Swamp) on the 14<sup>th</sup> October 2022. Photo: Rob Eldridge.*

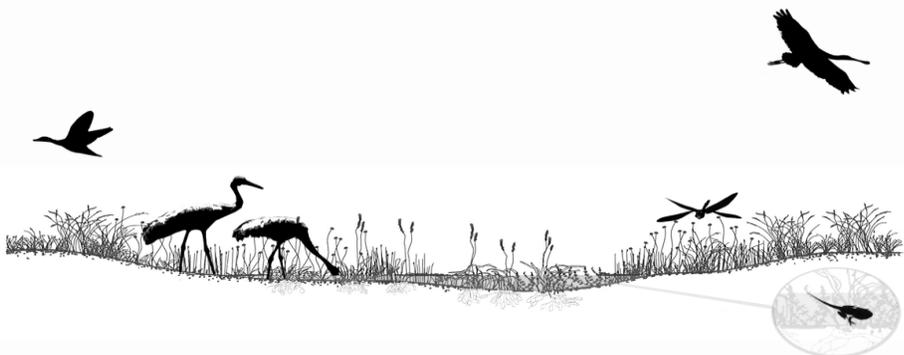
**The typical wetting and drying cycle of a seasonal herbaceous wetland.  
Courtesy of Damien Cook, Wetland Revival Trust. Notes in brackets by Mark Bachmann.**

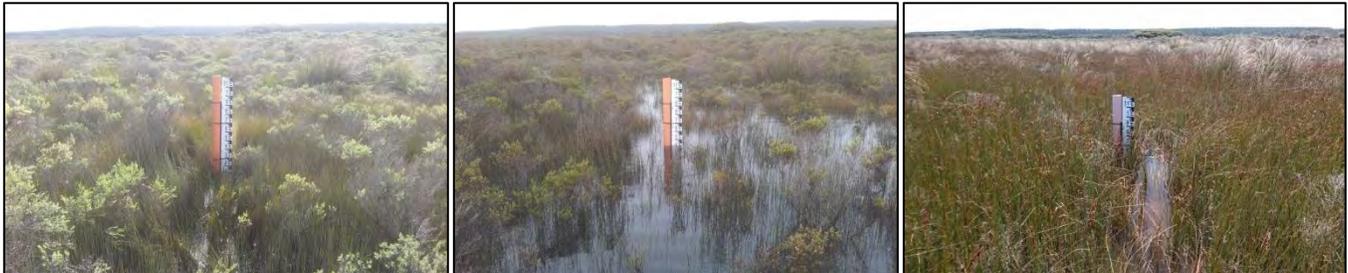
**An ungrazed, reserved wetland managed by Parks Victoria:  
The extremely rapid reversal of terrestrialisation (in this case, wet heath shrub invasion) through NGT's hydrological restoration of Long Swamp, Discovery Bay Coastal Park<sup>11</sup>.**

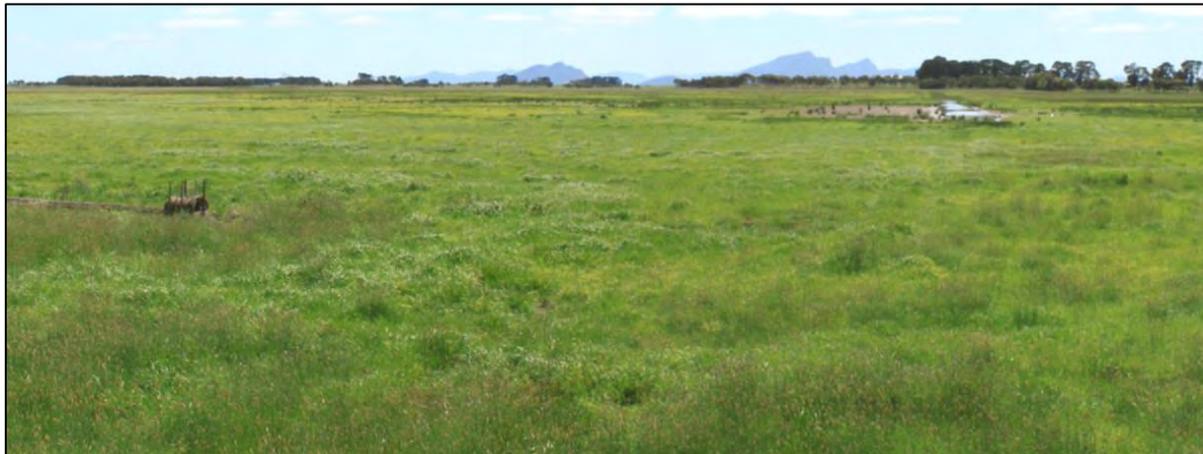
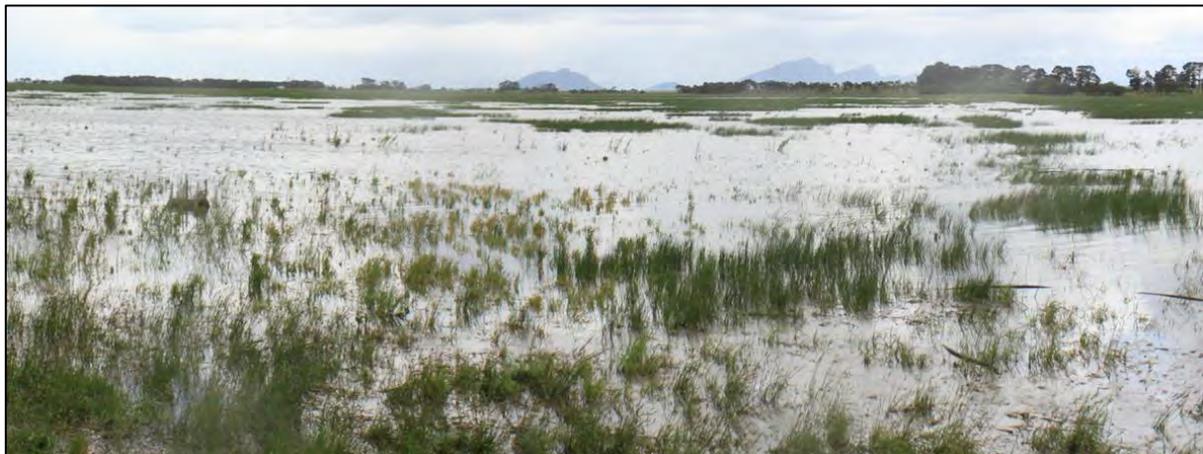
**The appearance and condition of Scale Swamp, immediately before and after restoration: a previously grazed and farmed, privately owned seasonal wetland on the Victorian Volcanic Plain (VVP).**

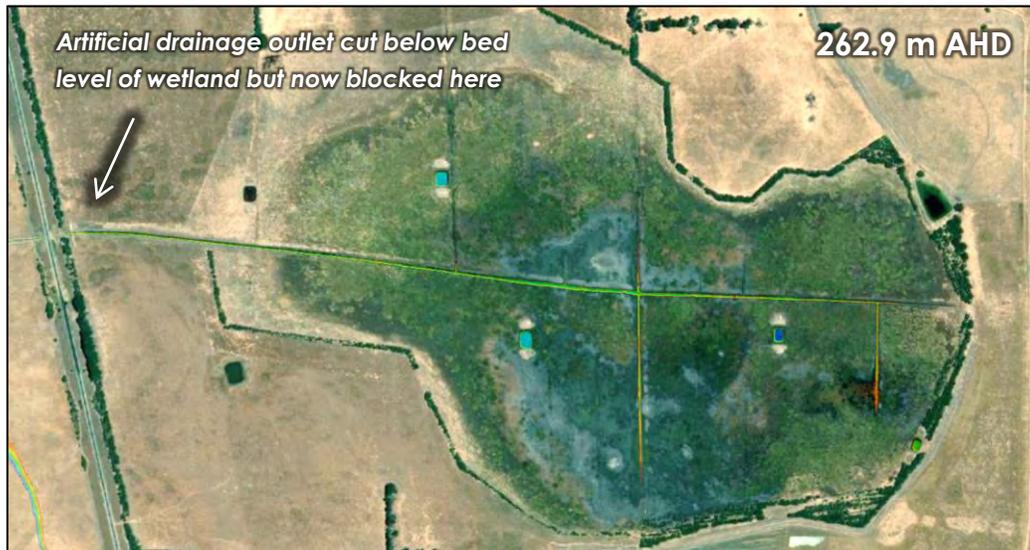
Using modern GIS tools and the DEM, we can illustrate the process of how Scale Swamp now re-fills from empty in 10 cm increments, as a result of hydrological restoration. Approx. depth guide: red/orange - up to 10 cm; yellow - up to 20 cm; light green - up to 30 cm; dark green and blue - over 40 cm.

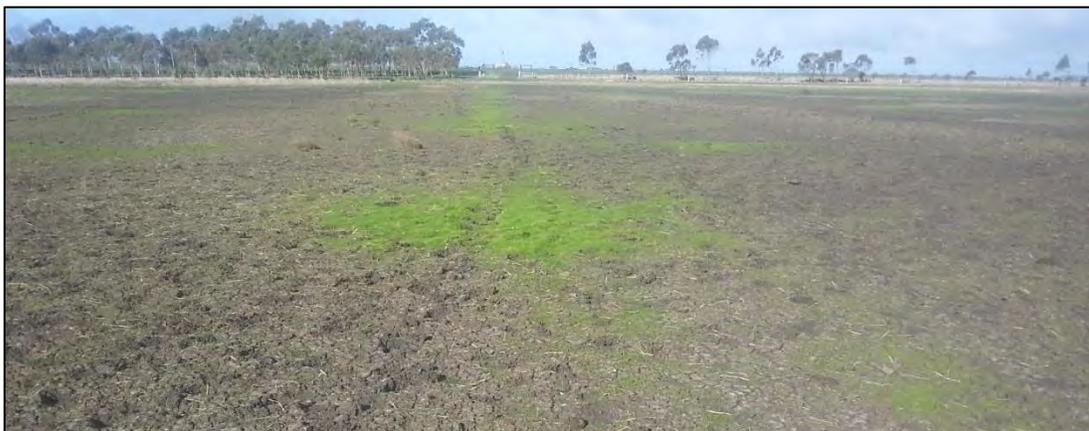
**Photo-point 1: Initial rapid death and displacement of introduced pastures occurred in Scale Swamp in winter 2014. This image was taken in November 2014, the first year when sustained shallow inundation occurred after hydrological restoration, in an area previously dominated by introduced *Phalaris*.**

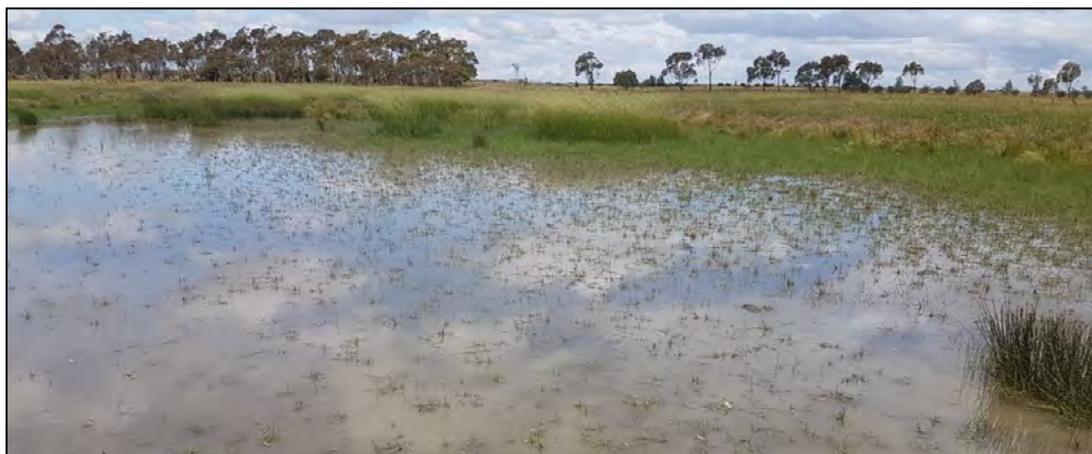
**Photo-point 1: Post-restoration recovery of native wetland habitat at Scale Swamp, 5 years later – after hydrological restoration, fencing and destocking – in November 2019.**

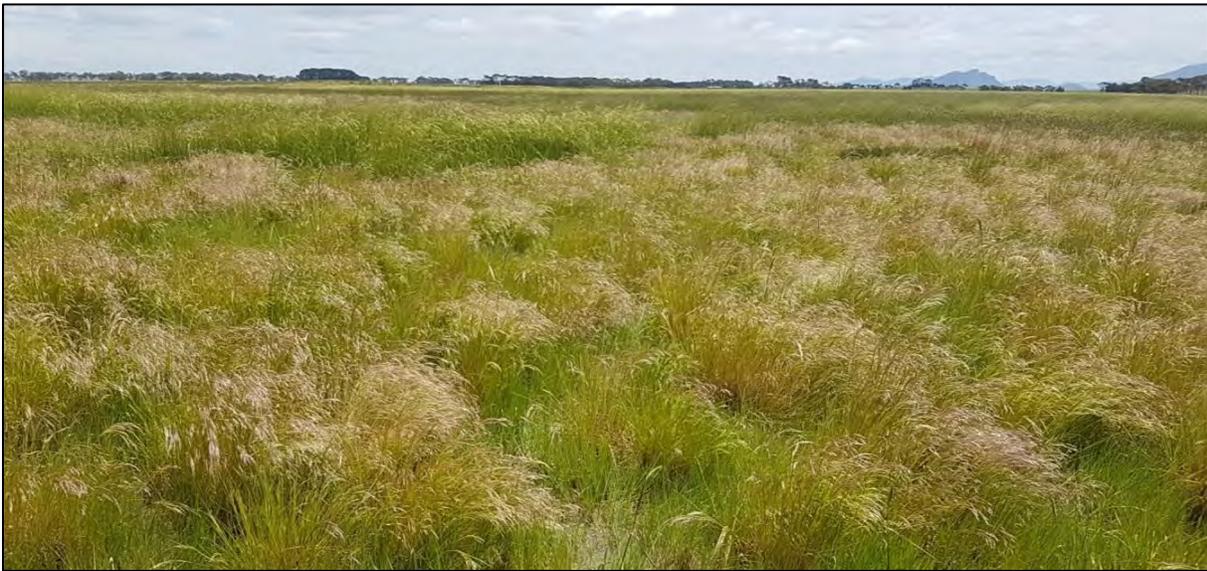
**Photo-point 2: Post-restoration recovery of native wetland habitat 5 years later in November 2019. The initial response was dominated by hardier and more common native wetland plants at Scale Swamp, as the ecosystem adjusts to the new hydrological regime after reinstatement of water levels and destocking.**

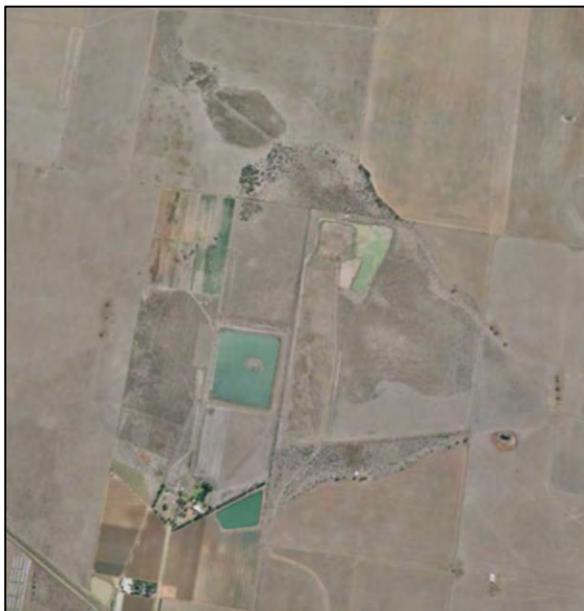
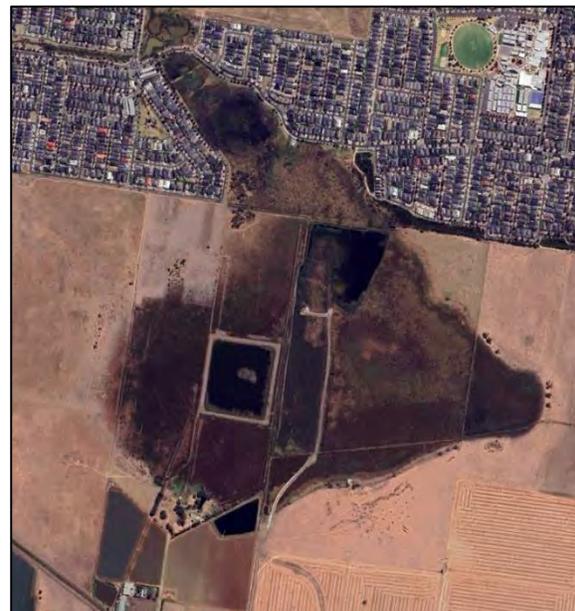
**The stark difference in the appearance of Cunningham Swamp over a 15 year period, between the Millennium Drought and a later wetter climatic phase. Note urban encroachment from the north over this time.**

On the ground, the stark difference in the appearance between the dry phase and wet phase at Cunningham Swamp – despite still being artificially drained and farmed for decades – illustrates the complexity of assigning a notional ‘value’ to a modified wetland at a single point in time, when it can be reasonably assumed that residual values (in the form of a dormant seedbank, tubers or rhizomes) will still occur at the site.

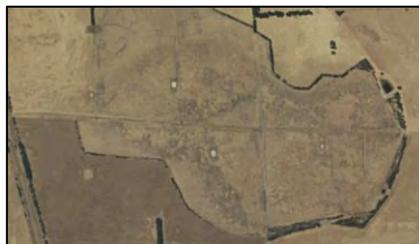
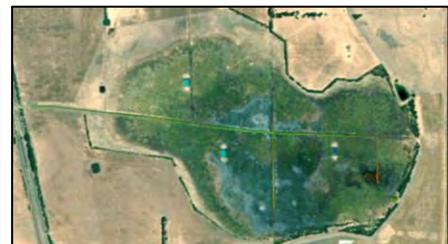
**The trajectory of change at Scale Swamp over the past 75 years, based on aerial photography.**

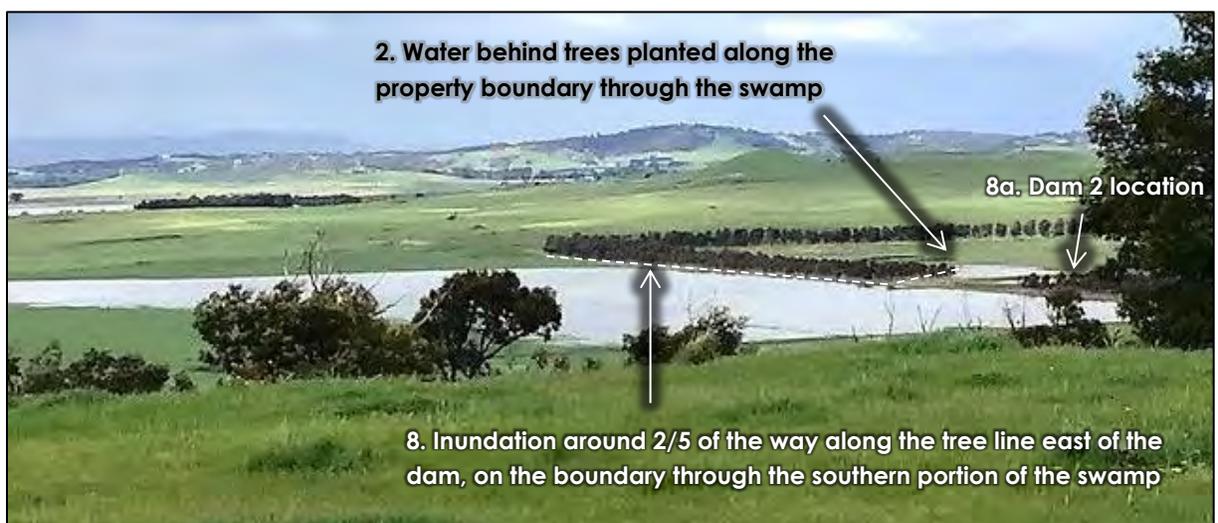
We also have access to a further photo of the same inundation event, also taken on the morning of the 14<sup>th</sup> October from a different angle, as shown below. In conjunction with the previous perspective, this can be used to identify additional landscape features and calibrate their position relative to the water extent at that time.

The view of burring buluk (Hanna Swamp) looking south-east across the wetland towards Spring Hill from Old Sydney Road on the 14<sup>th</sup> October 2022. Photo: Claudia James.

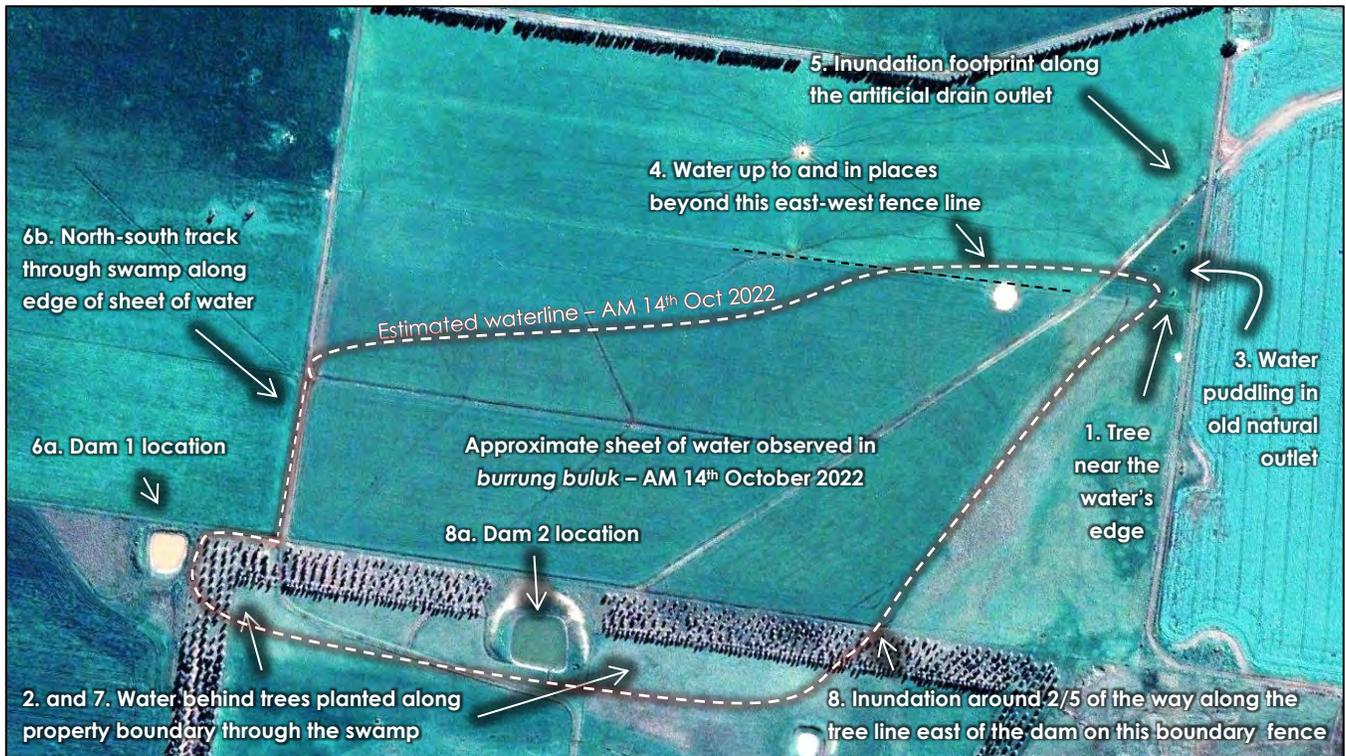
Next we can identify all of these same features on a standard aerial image from above, which allows us to mark up an estimated waterline.

Standard Google Earth aerial image of burring buluk (Hanna Swamp) with features identified in the 14<sup>th</sup> October 2022 inundation photos marked up.

Finally, we can now compare this spatial information with the Digital Elevation Model inundation scenarios, locate the various markers in the previous images, and combine and compare them, to more accurately determine the inundation footprint on the morning of the 14<sup>th</sup> October 2022.

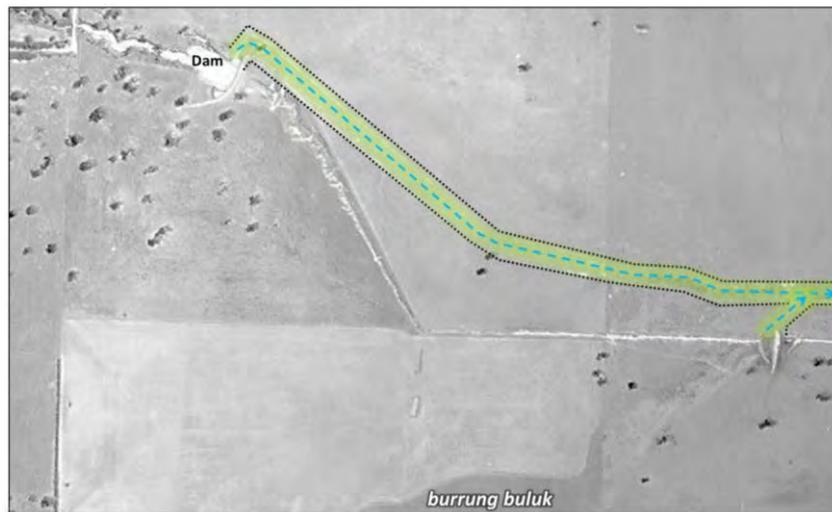
**The second diversion of Strathaird Creek utilised a check dam and banded channel at natural surface.**

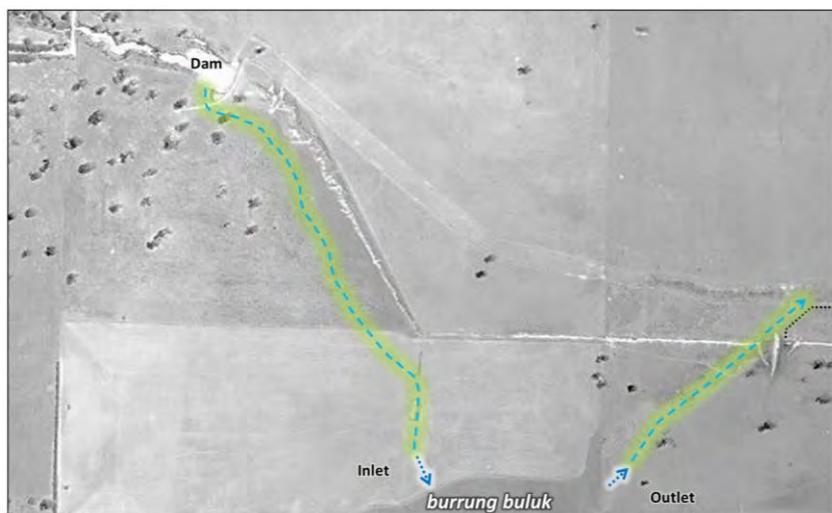
**Reconnection of Strathaird Creek to *burrung buluk* could utilise similar methods via an alternative alignment.**

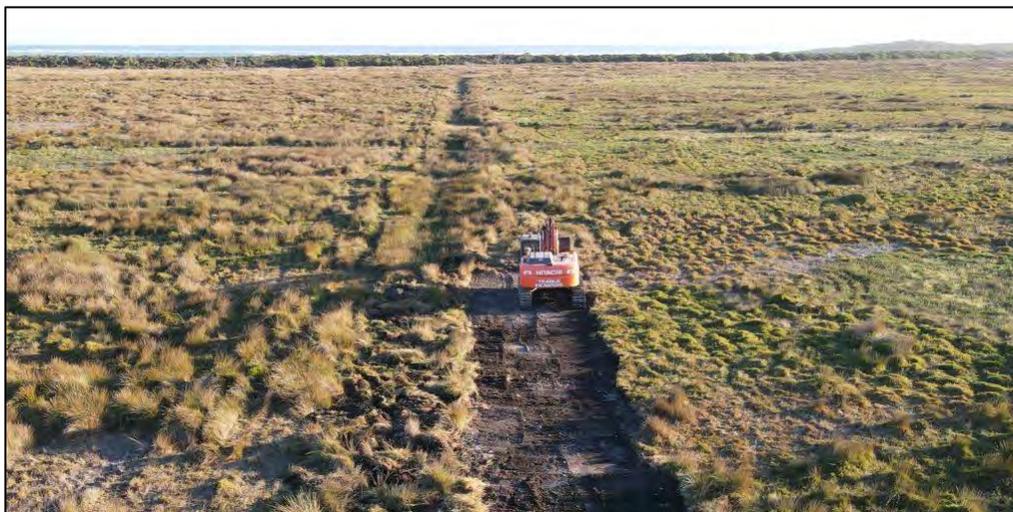
**A recent example in autumn 2022 of NGT supervised bulk earthworks (drain backfilling) to remediate a modified wetland.**
