Glenshera Swamp hydrological restoration field notes – May 2023

Summary of 2017 Restoration Works on Private Land

Summary of 2017, 2020, 2022 and 2023 Restoration Works on Public Land

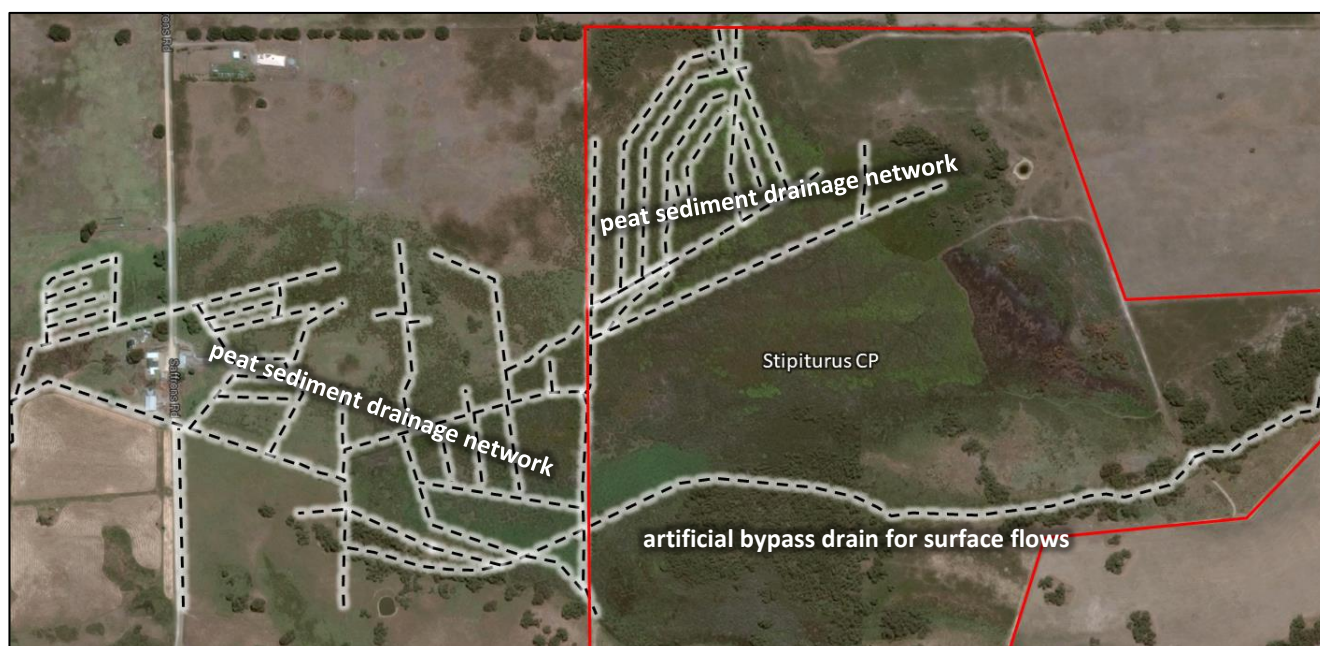
September 2014 aerial image of Glenshera Swamp, with artificial drains (black dashed lines) that had been constructed since the 1940s highlighted, and the Stipiturus Conservation Park boundary (red line)

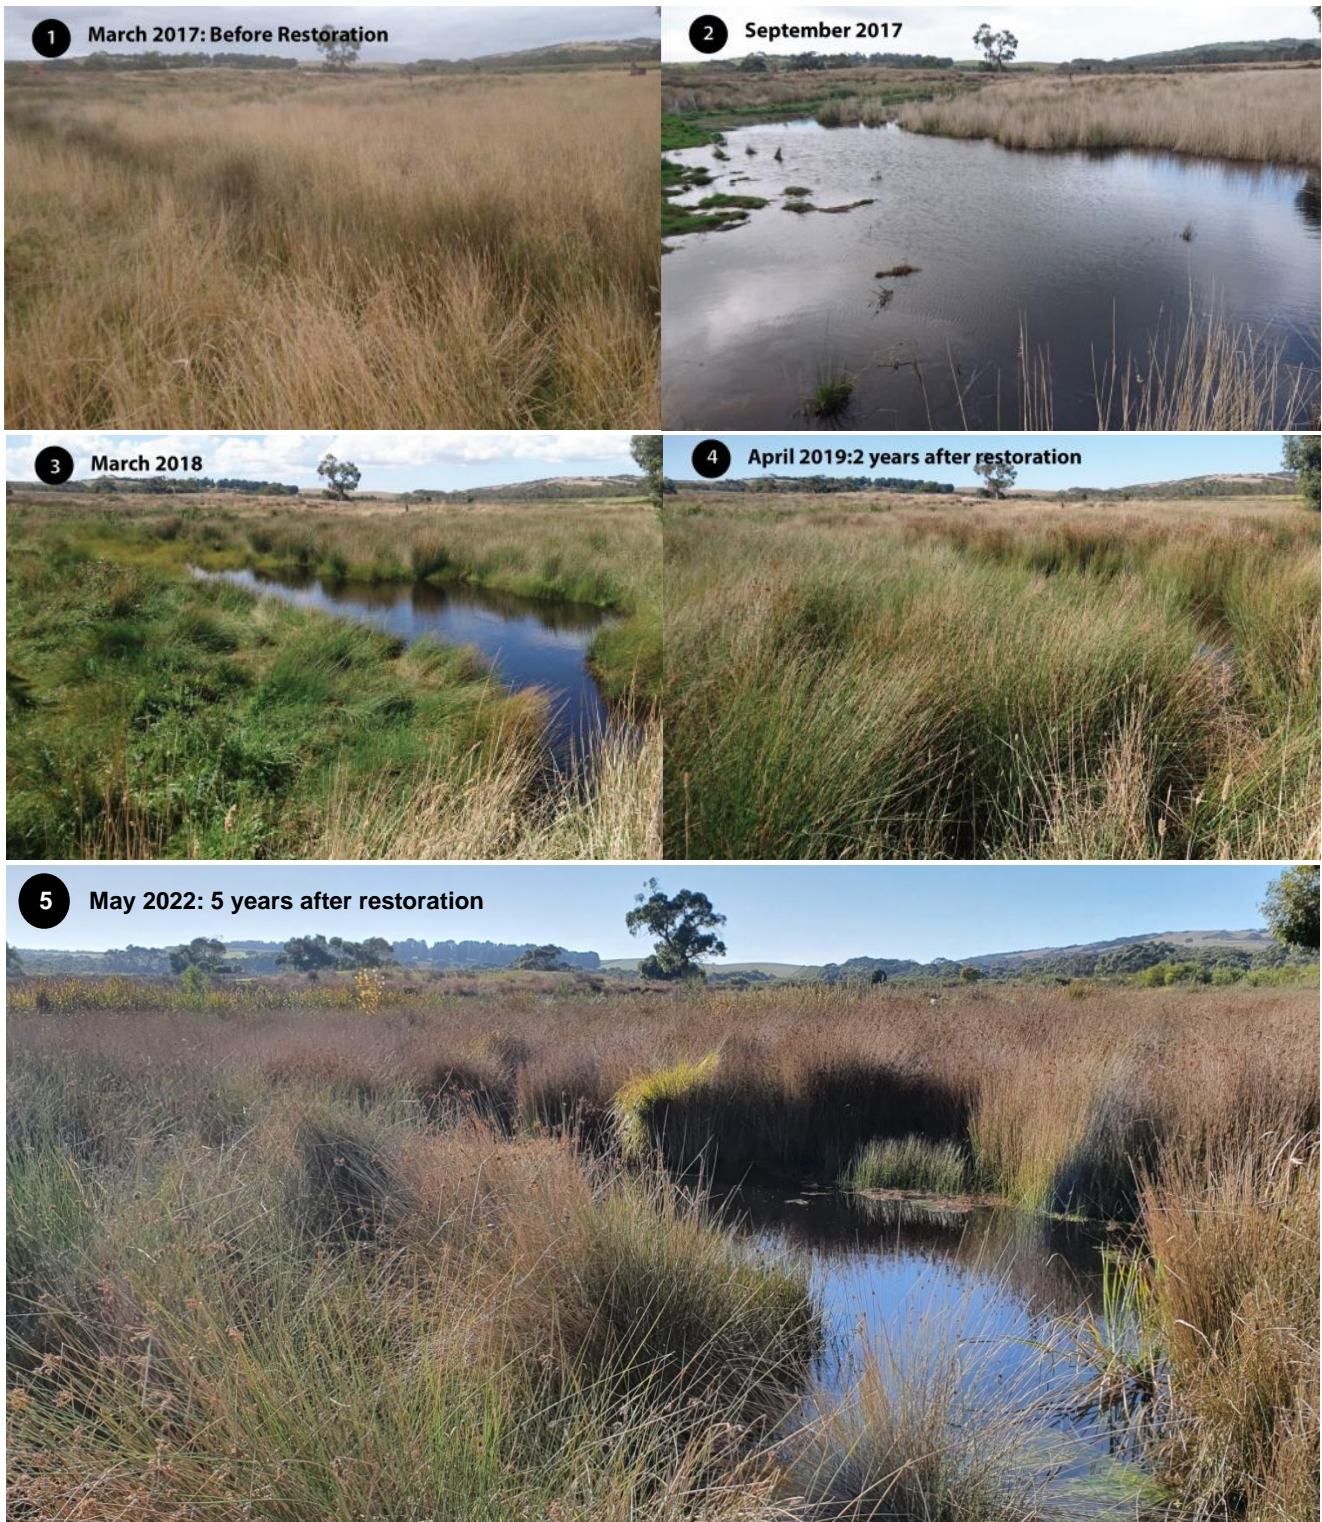
A photo-point in the private portion of Glenshera Swamp, which can be seen to the east of Saffrons Road, showing habitat recovery after peatland rehydration between 2017 and 2022. Photos: Mark Bachmann

Overall, the first phase of peatland restoration on the private portion of Glenshera Swamp was highly successful. This is illustrated by the photo-point sequence below, where a weedy, Phalaris dominated area of drained peatland was re-saturated, triggering spontaneous and sustained recovery of native wetland flora. This is just one example that is representative of changes unfolding in this part of Glenshera Swamp. This outcome is also being complemented by Hills and Fleurieu Landscape Board supplementary infill revegetation works and kangaroo exclusion fencing in this area and beyond, to re-establish missing peatland flora species, and in doing so increasing the diversity and quality of the regenerating wetland habitat.

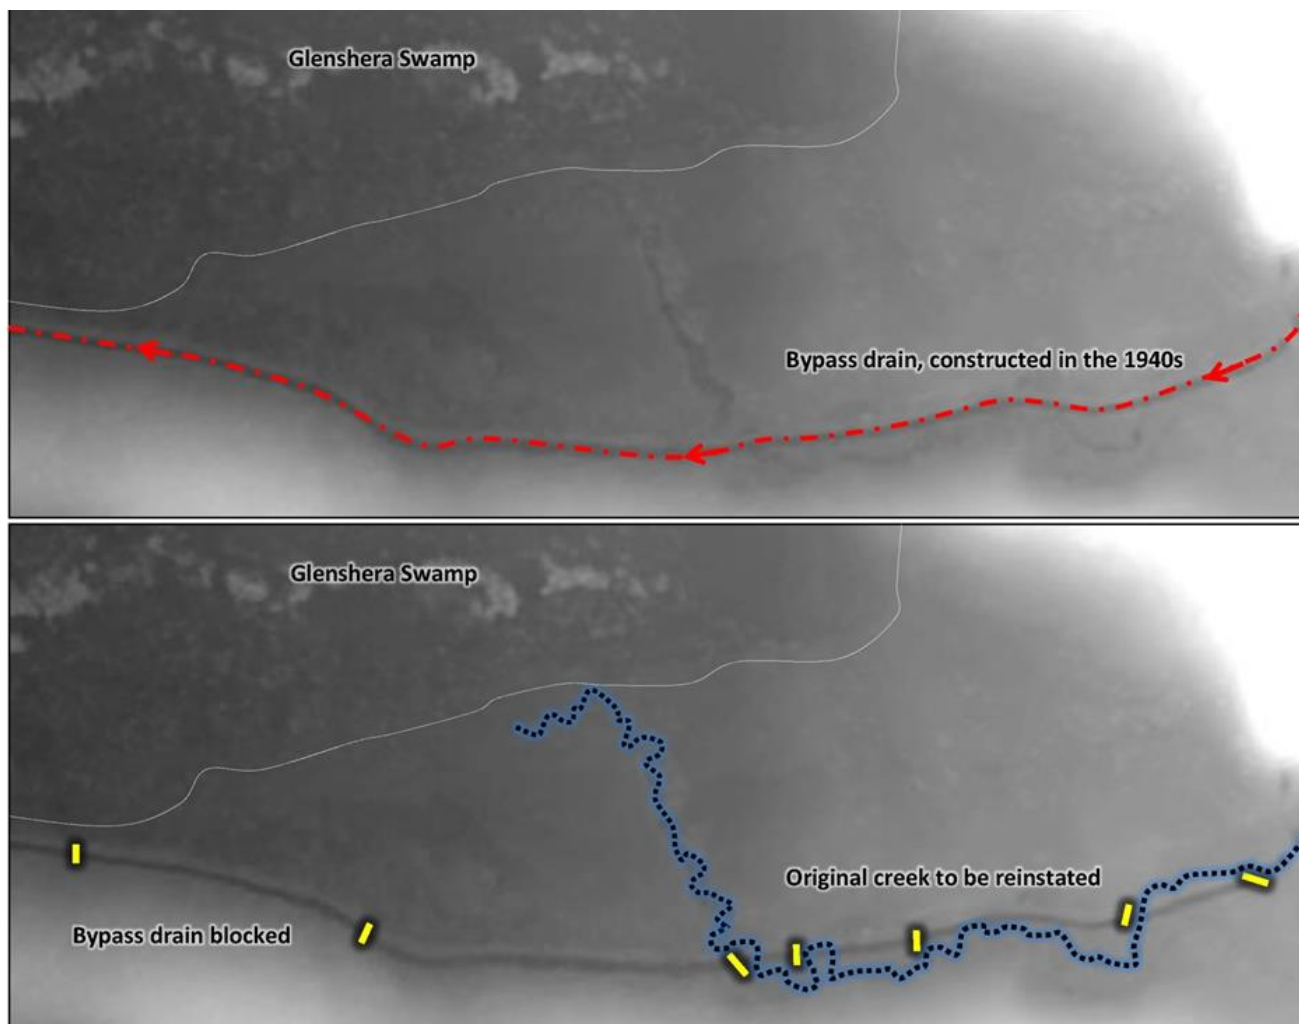
LiDAR (elevation) data showing the location and impact of the bypass drain (above) and the reinstatement of meanders in the creek (below) by installing trial weir structures to reduce the impact of the bypass drain

Addressing alterations to hydrology caused by the bypass drain, which was constructed in the 1940s to convey surface flows around the swamp, was the initial focus of restoration work in the Conservation Park in 2017. These initial trial works aimed to reinstate inflows to the swamp and reactivate stranded sections of the original meandering creek line. Additional works included weirs downstream of the original creek, to slow flows and/or prevent lateral water drawdown from the swamp margin.

With the support of a range of volunteers over several days in April 2017, including the CCSA supported CVA Green Army Team, the YACCA group and a range of other helpers, NGT completed the construction of a series of eight restoration trial structures along the drain (seven are shown above).

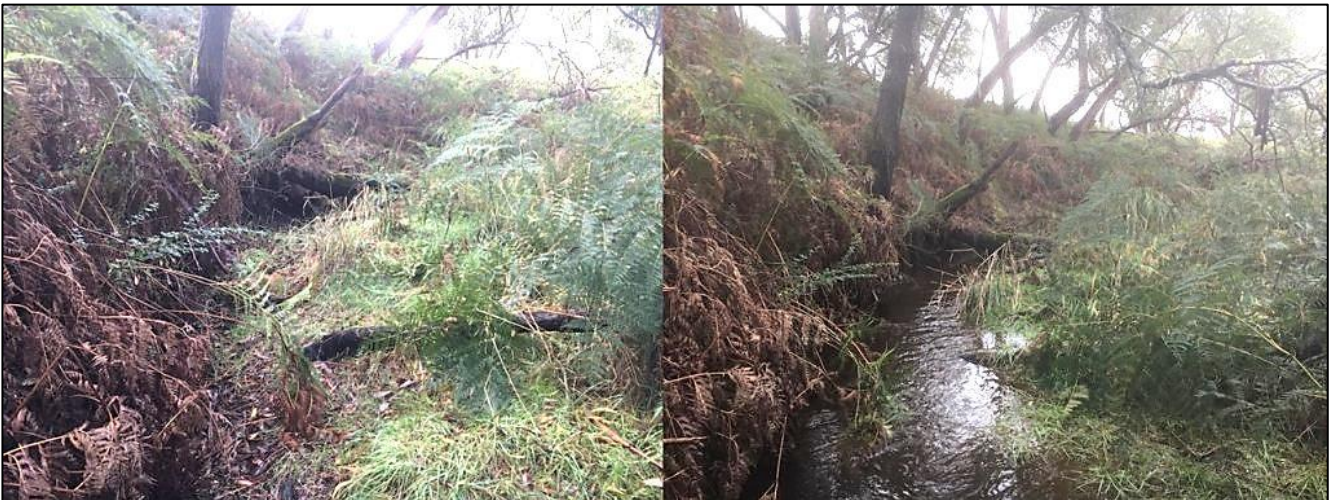
Upstream of Glenshera Swamp, this section of the natural creek line (left) was denied water for decades due to the artificial bypass drain that cut off this section of the creek (about 20 metres away), leaving it high and dry. Backfilling the drain in 2020 has resulted in water flowing back down the natural creek line (right) for the first time in over 70 years. Photos: Ben Taylor

In autumn 2020, three shallow sections of the bypass drain were fully remediated by NGT (labelled 1, 2 and 5 in the map on the next page) using adjacent spoil piles available from the time of construction in these locations. This work has successfully lifted flows back to natural surface and reactivated portions of the creek line and/or floodplain. An example of the restored natural flow path is shown.

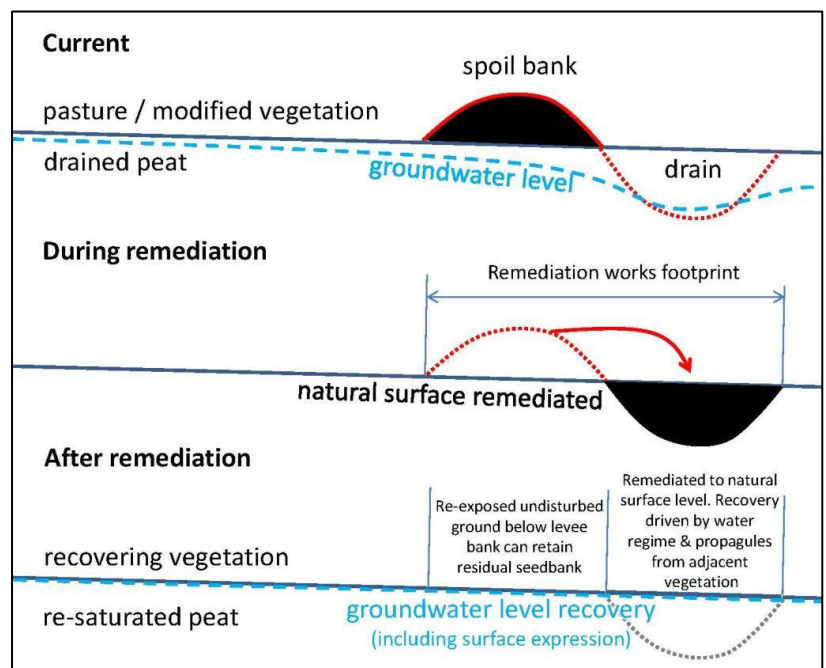
Right: Cross-section to illustrate the peatland restoration process at Glenshera Swamp. Revegetation of remediated areas will accelerate the recovery process.

This particular method was especially important in this situation, because the steepness of the slope means that nothing less than continuous backfilling would achieve the full re-saturation of the peat profile up the bank. The drains were dug to draw moisture out of the saturated banks, to make them suitable for establishing pasture for grazing, and we wanted to fully reverse that impact, giving us the greatest chance to significantly expand the footprint of the swamp and recover the original extent of swamp vegetation.

The cross-section shown explains the recovery process triggered by backfilling the drains through the peatlands in this part of Glenshera Swamp, followed by actual images from May and June 2022.

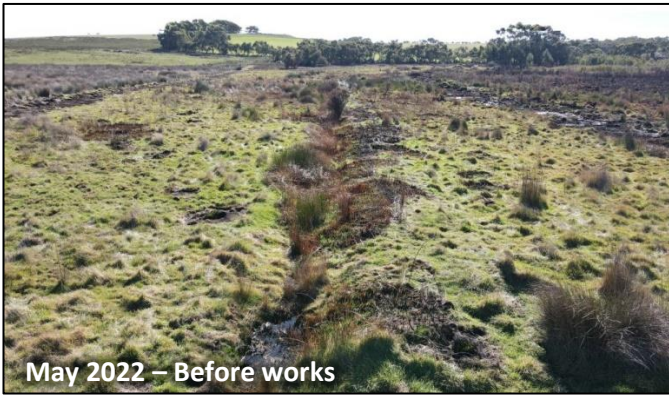
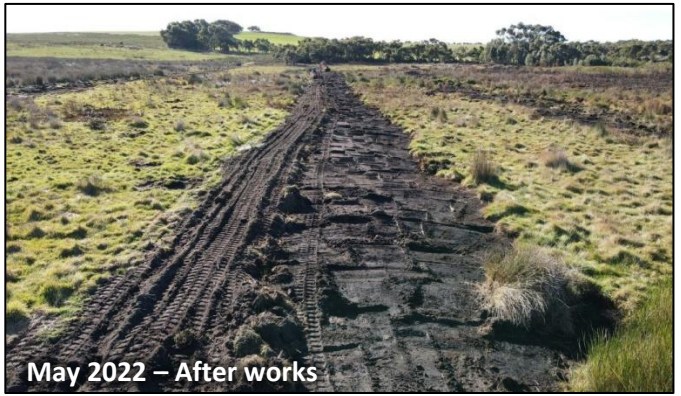
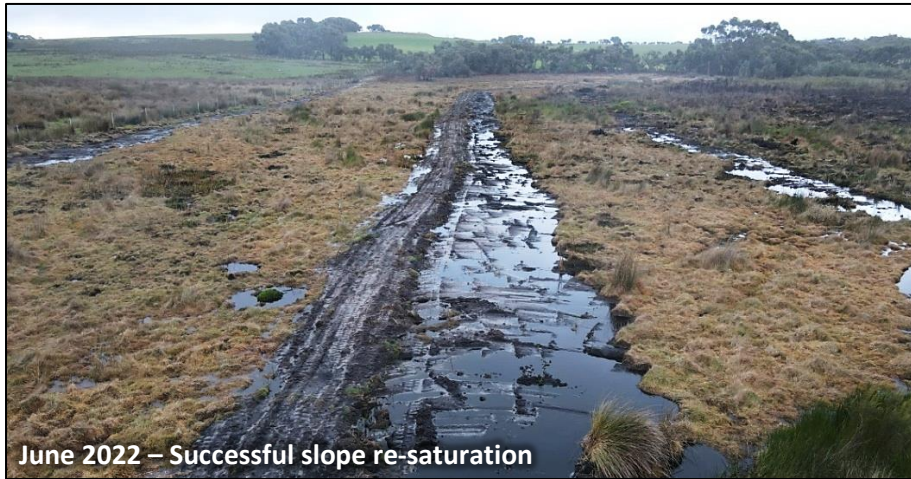
Before and after images show the impact of remediation works along the drains up the northern slopes of Glenshera Swamp, within Stipiturus Conservation Park. Photos: Mark Bachmann

As the previous images show, in terms of the impact of the works, the outcomes on groundwater and peat saturation levels have been both immediate and stark. One of the benefits of working in an environment with regular rainfall and reliable groundwater seepage is that results don't take long!

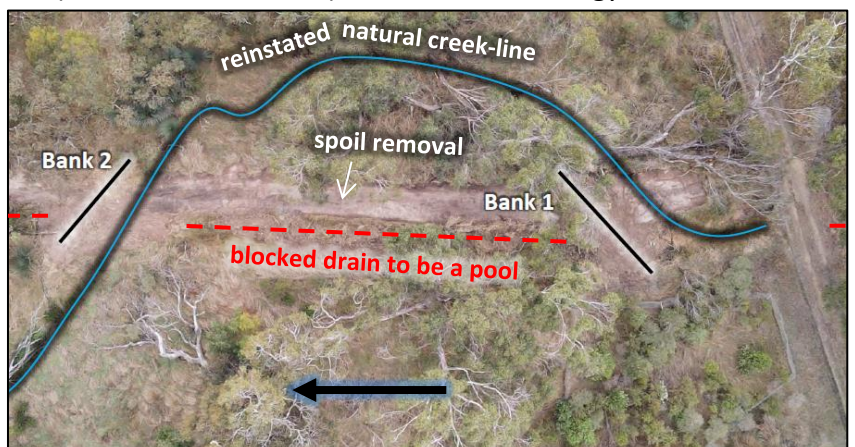
Right: Example image showing the removal of spoil banks and the replacement of the trial structures with earthen banks in April 2023, to restore the natural meanders of the creek below Barb's Track crossing. Arrow shows direction of flow. Photo: Mark Bachmann

An example of what the completed 2023 works look like on the ground is shown right, where a 2017 trial structure (designed to redirect natural flows away from the artificial drain and back along the natural flow-path to Glenshera Swamp), has been made permanent and spoil bank removed.

In April 2023, we returned to Glenshera Swamp to continue with the next phase of hydrological restoration works, by converting the 2017 temporary (and now failing) trial structures to a permanent solution. Due to the amount of erosion that has occurred along this drain, there was not enough material in the spoil bank for continuous backfilling of the channel. Further, to reduce damage to existing vegetation – especially larger trees – some sections of the spoil bank were left in place to avoid those impacts (and the roots of those trees). For the most part, the rest of the spoil bank was removed, and this material was arranged strategically to achieve two things:

1. To direct flows along the original meanders in the creek, and
2. To create a series of pools in the drain (where not backfilled), to reduce the energy of flows further, and to encourage wetting up of the adjacent riparian zone.
