Long Point and The Grange Wetland Restoration Field Day #2

11th May 2023

Field Day Handout

Overview of the 'Improving the Ecological Character of the Moulting Lagoon and Apsley Marshes Ramsar Sites' Project

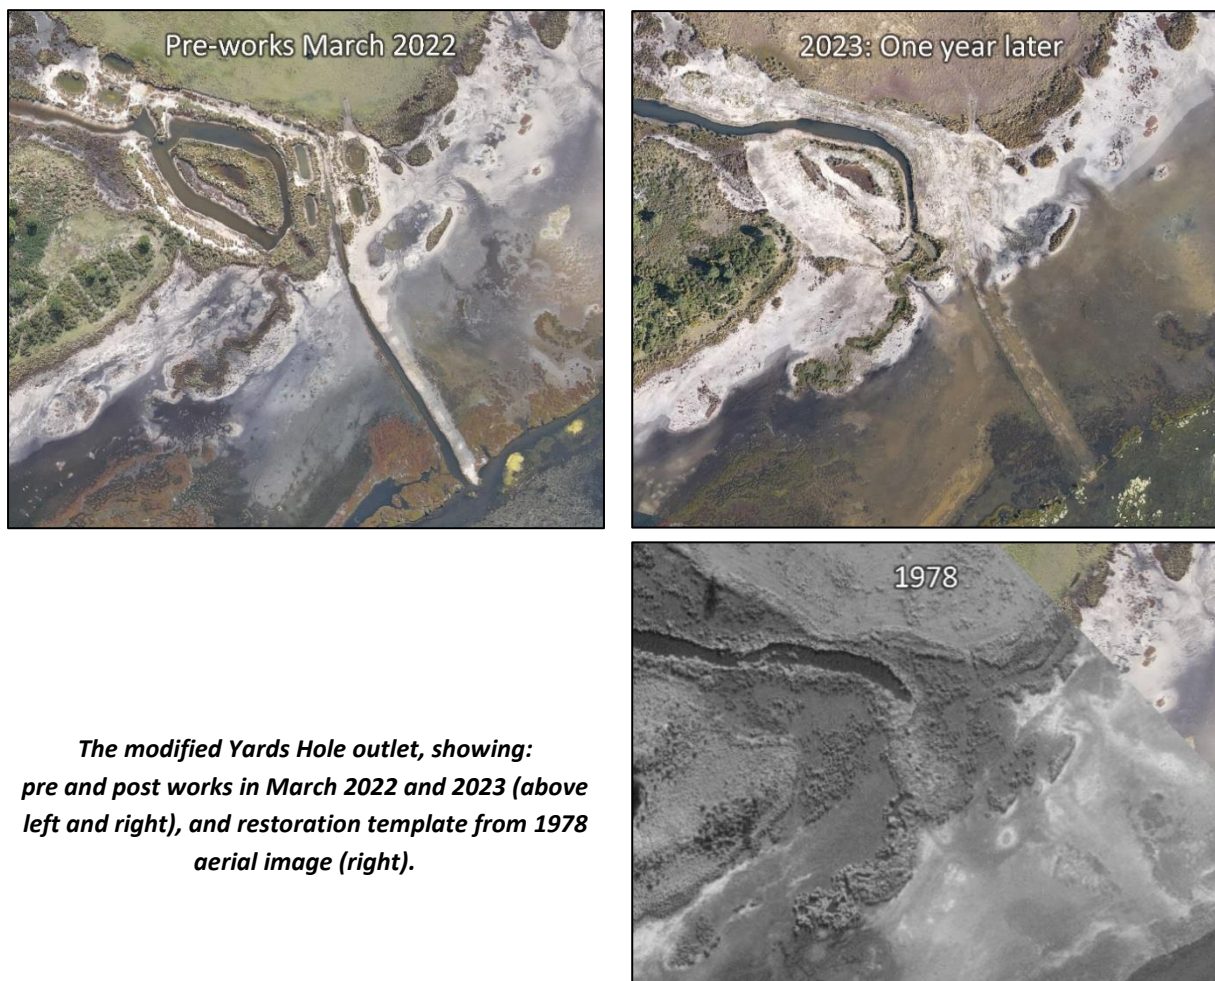
Site 1a. Yards Hole Outlet Restoration

The natural outlet from Yards Hole to Moulting Lagoon and surrounding area was significantly modified in the 1990s during the development of the unrealised aquaculture project. As shown below, restoration works were undertaken at this site in March 2022. The aerial images from 1948 and 1978 were used as a template for restoration, which aimed to restore the natural geomorphology and therefore hydrology of the site.

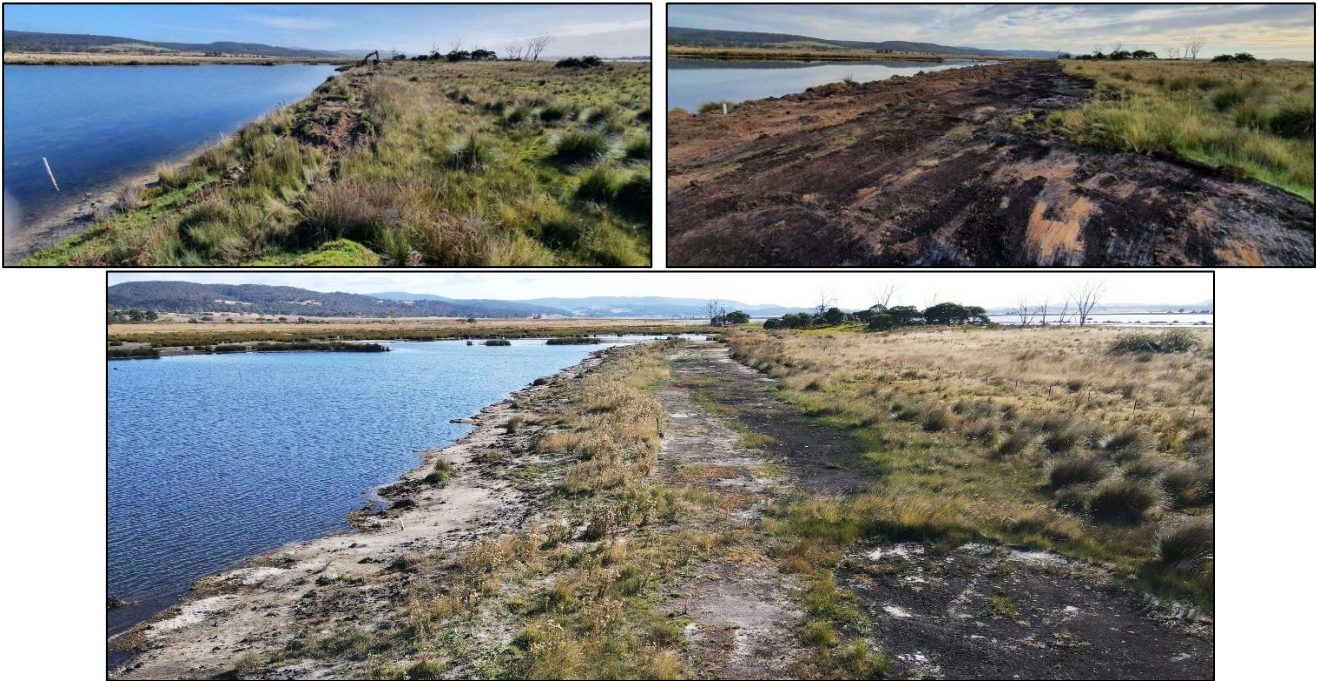
Site 1b. Yards Hole Perimeter Restoration

The historic aquaculture works also resulted in the entire perimeter of Yards Hole being modified with the construction of a deep channel which, in turn, left a steep artificial bank and a large spoil heap the whole way around the wetland margin.

The dark colour of the original surface level which has been re-exposed through the removal of the spoil heap provided a clear visual guide for the contractors to determine the natural contours and elevation of the surface during works.

Modified perimeter of Yards Hole showing the eastern bank before (left) and after (right) remediation March 2022 and recovery one year on in March 2023.

Bulk earthworks created this major change in the 1990s and were now also required to reverse that impact. The works undertaken in March 2022 redistributed the large spoil bank back into its former location within the artificial channel around the wetland edge, a zone where this material will slowly compact and settle to form a reinstated bank slope with a gentler gradient. This will provide fresh opportunities for fringing saltmarsh and sedgeland vegetation to re-establish in this ecotone (vegetation transition zone), as was already witnessed during March 2023 follow-up works.

Whilst we were unable to manually compact the remediated margin of redistributed spoil material effectively in 2022 or 2023 due to the water level, we expect this bank zone to continue to naturally settle and compact over time in response to rain and inundation events. As seen above, the wetland edges are gradually compacting over time and saltmarsh and fringing grassland communities have already started to recolonise the new surface.

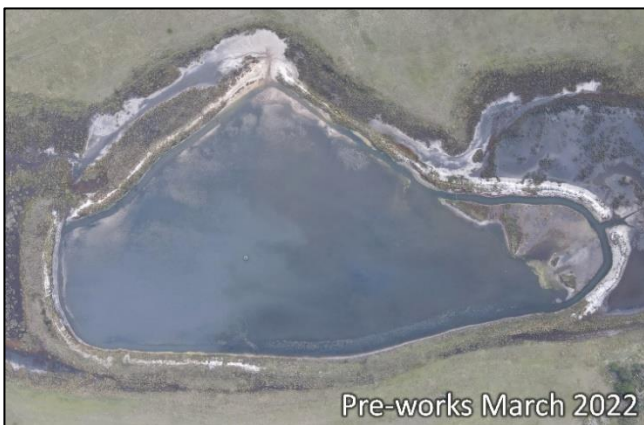
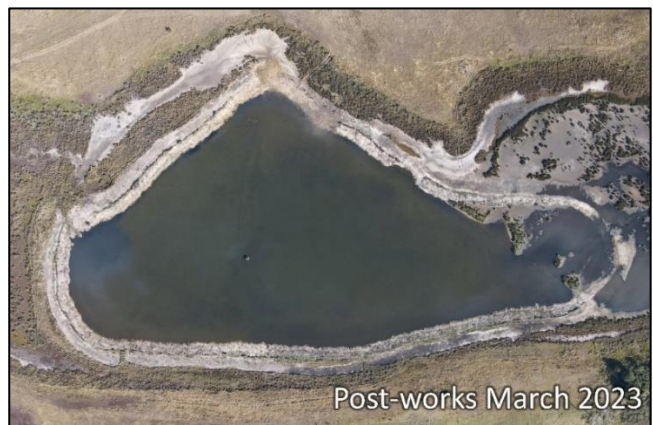
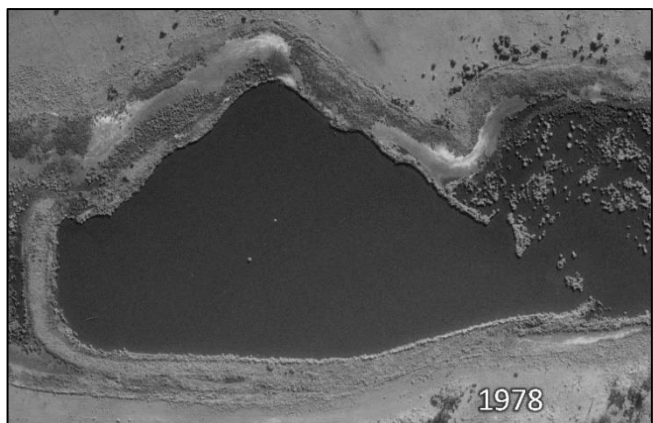
There was a small section of bank on the northern margin of Yards Hole left in 2022 that was remediated in March 2023, which gave us time to assess a rare species of saltmarsh growing in that area, *Wilsonia rotundifolia*, before determining the best approach for continuing works.

Completed restoration works around the margins of Yards Hole (pre and post works) with 1978 image as a restoration template.

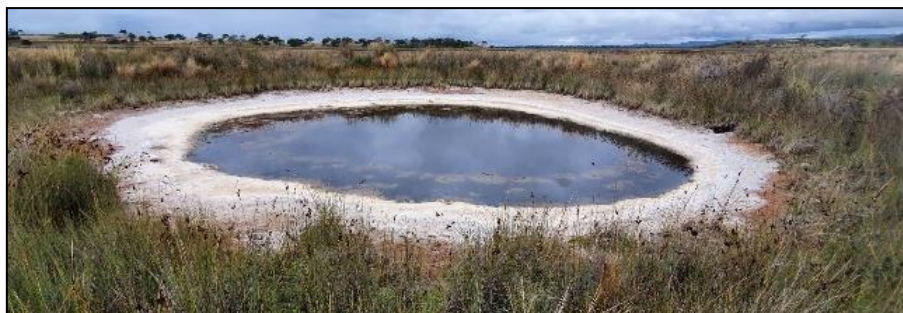
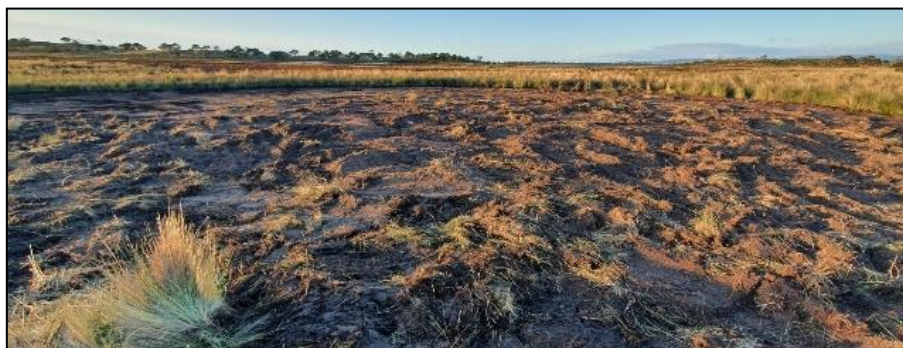
Site 2a. Small Dam near Entrance Gate

Looking south across the site where a small dam was situated by the TLC entry gate to the Long Point Reserve, before and after works in March 2023.

Based on discussions with TLC staff regarding the various artificial dams at Long Point, the decision was made to remediate the small brackish dam near the entrance gate. All other dams were left in their current condition to provide drinking water and habitat for fauna.

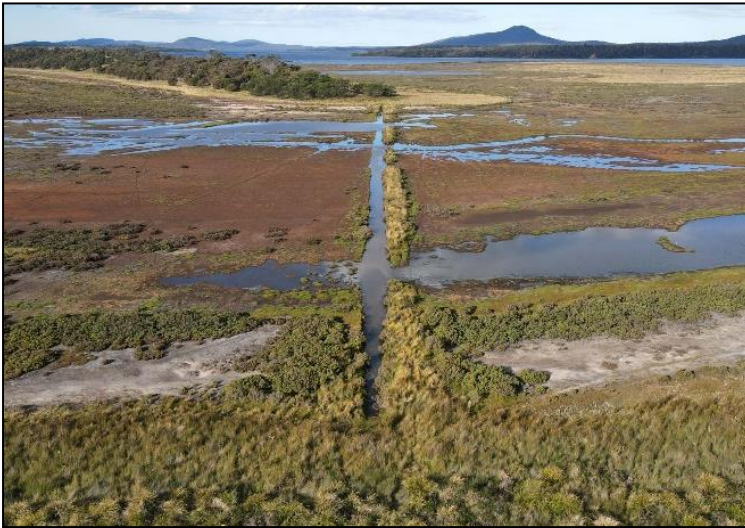
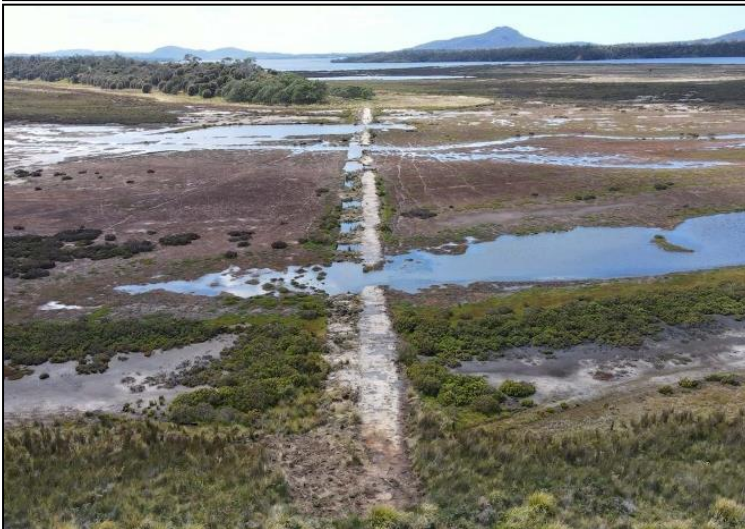
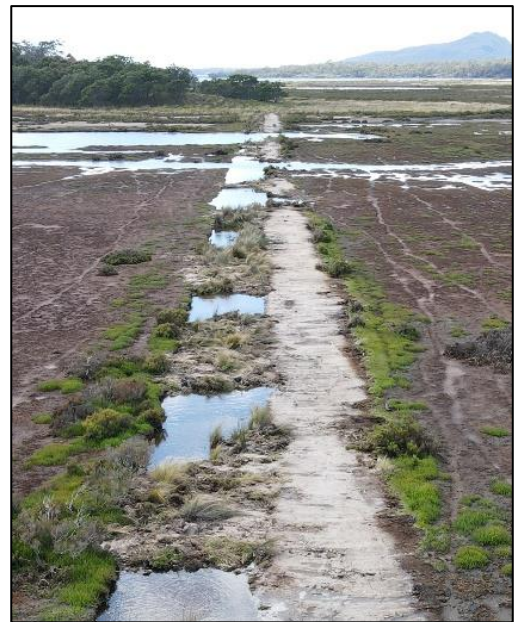
Site 2b. Western levee

The small (300m) western levee was likely built in the early to mid-1800s as part of the early colonial attempts to modify site drainage to benefit livestock grazing by reducing the area subject to inundation. The levee intersects a floodway connecting Little Bay to Moulting Lagoon, across the low-lying southern saltmarsh area of Long Point.

Looking north towards Long Point along the shorter (western) levee before and after the completion of remedial works in autumn 2023 (left). Right shows a close-up view of the way the spoil was arranged to prevent the channel from flowing in future and allow some saltmarsh re-establishment near natural surface.

Whilst the bank of this levee had already been breached and/or washed away in some places, the opportunity to remove the residual bank entirely presented itself in March 2023, due to drier conditions to those experienced in March 2022. The remaining spoil material was arranged into a series of backfilled sections to achieve our hydrological objectives (removing any impediment to lateral flow across natural surface) while also providing areas for potential saltmarsh re-establishment, as shown over the page.

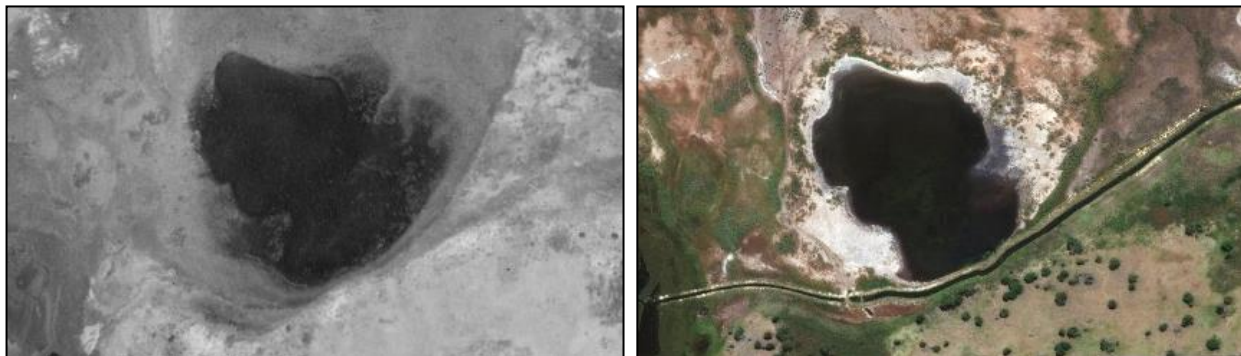
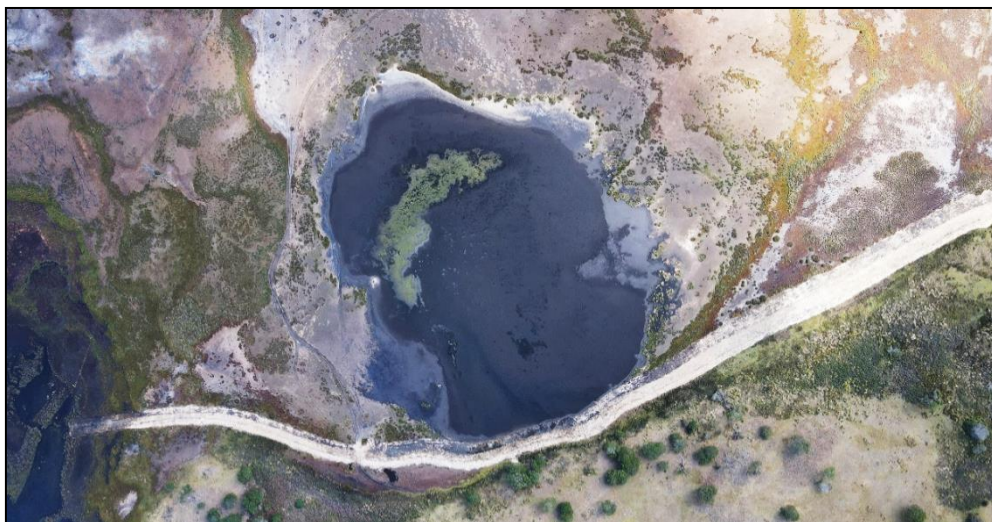
Barkstand gets its name from an industrial phase when black wattle bark was harvested for the Swansea bark mill in the late 1800s, through until the 1930s. This elevated area of dolerite is now completely cut-off from the rest of the property by a channel which was constructed as part of the aquaculture works undertaken in the 1990s.

This artificial channel has extended and deepened a natural shallow watercourse and several other smaller depressions were connected to it via the aquaculture works. The water regime of all of these features had been artificially altered. It is likely that the channel is also intercepting shallow groundwater flow or seepage from the higher Barkstand Point onto the lower saltmarsh areas.

The western end of the Barkstand channel: unaltered in 1948 (top left), with aquaculture works in place in 2020 (top right) and after saltmarsh remediation works in 2023 (below).

Bulk earthworks, similar to those undertaken at Yards Hole, were undertaken at this site in March 2023 and aimed to restore the channel and associated drainage areas to their original topographic form. The 1948 aerial image was used to guide on-ground works as a remediation template. Remediation of this site involved disconnecting the channel from Moulting Lagoon and remediating the adjacent saltmarsh surface.

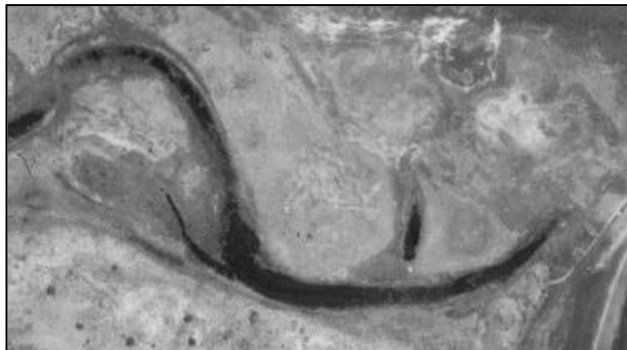
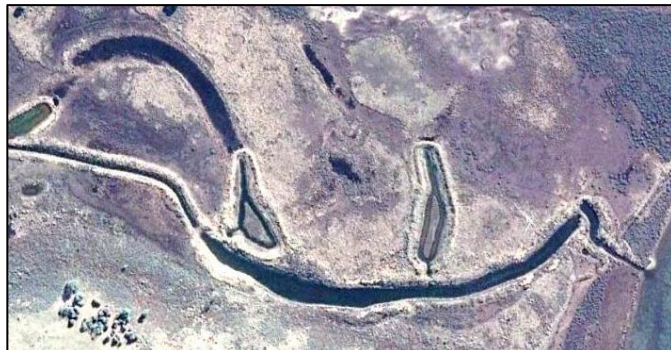
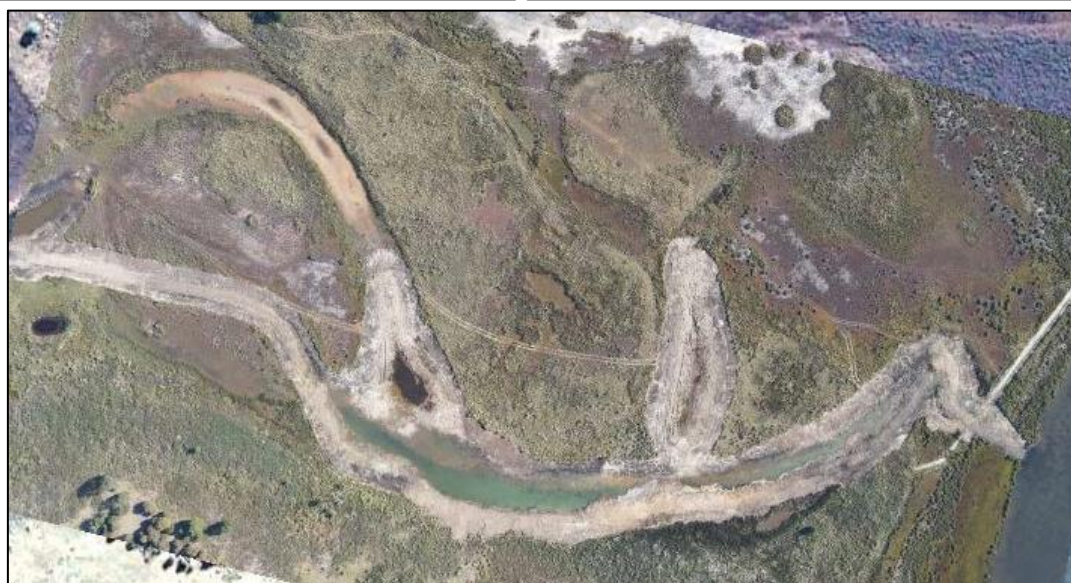
The eastern end of the Barkstand channel: unaltered in 1948 (top left), with aquaculture works in place in 2020 (top right) and after saltmarsh remediation works in 2023 (below).

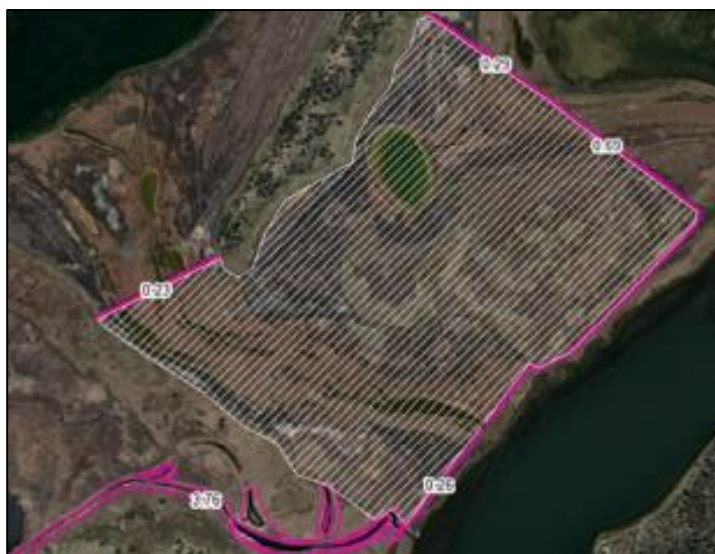
The main L-shaped (eastern) levee and adjacent drain have not only compromised the saltmarsh habitat along its length by creating a disturbance footprint with an altered elevation profile, but the levee system appears to be having an ongoing impact on contemporary hydrology and saltmarsh condition, including flood flows, attenuation, and natural drainage across the saltmarsh.

We collected evidence that indicates the levees were still impeding the movement of water (north-eastern arm) and altering the mixing of fresh and saline water (south-eastern arm) across the eastern area of Long Point, despite these banks being breached in many places. This is due to the substantial impact that any barriers to flow can have in tidal saltmarsh communities, where the extremely flat terrain, combined with the low-energy and temporary nature of tides, prevents efficient equalisation of water levels either side of such barriers, even if breached at some locations.

Long Point drainage/levee disturbance footprints (marked in pink). Hatched area represents an additional 80-hectare zone that was hydrologically impacted by the construction of the western levee and longer eastern (L-shaped) levee in the 1800s.

The entire 'L-shaped' levee and associated drains were backfilled in March 2023. Due to wet conditions experienced in March 2022, restoration works were only completed at the southern end of the eastern levee, south of the floodway in that first year of works.

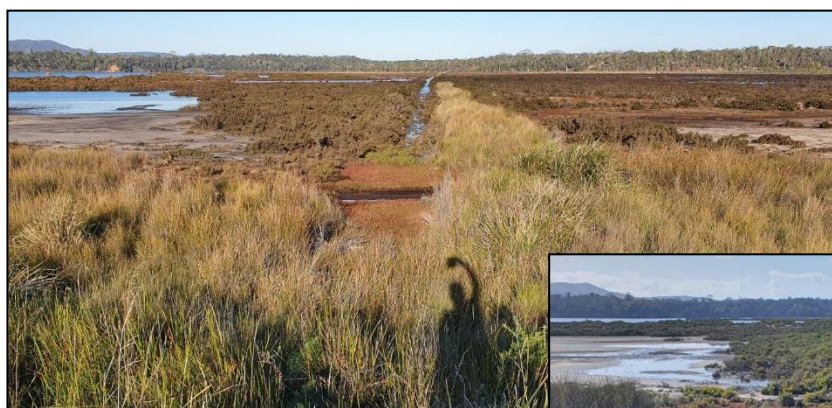
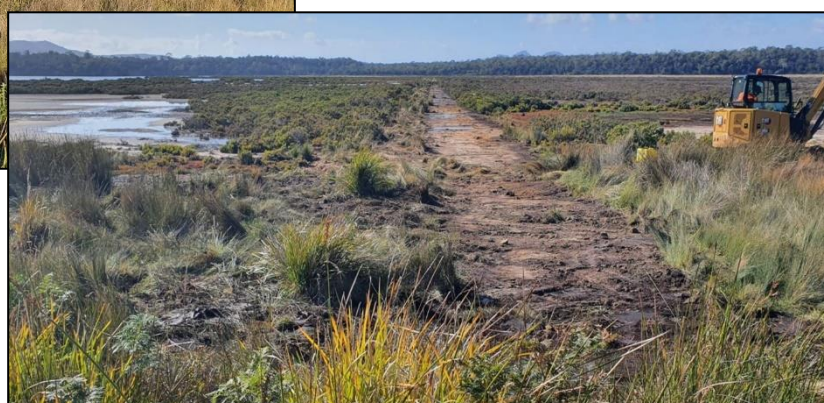
Looking east from Long Point along the main L-shaped (eastern) levee in 2021 (above) and after the completion of remedial works in autumn 2023 (right).

The work required along this levee bank was more sensitive in nature than the bulk earthworks at Yards Hole and Barkstand and needed to occur within a narrower disturbance footprint due to the smaller scale of these hand-excavated banks and voids. As a result, earthwork was undertaken with a much smaller and lighter excavator, with rubber tracks, to minimise disturbance. Note that the present-day disturbance, as part of the remediation process, is limited to the narrow, original disturbance footprint.

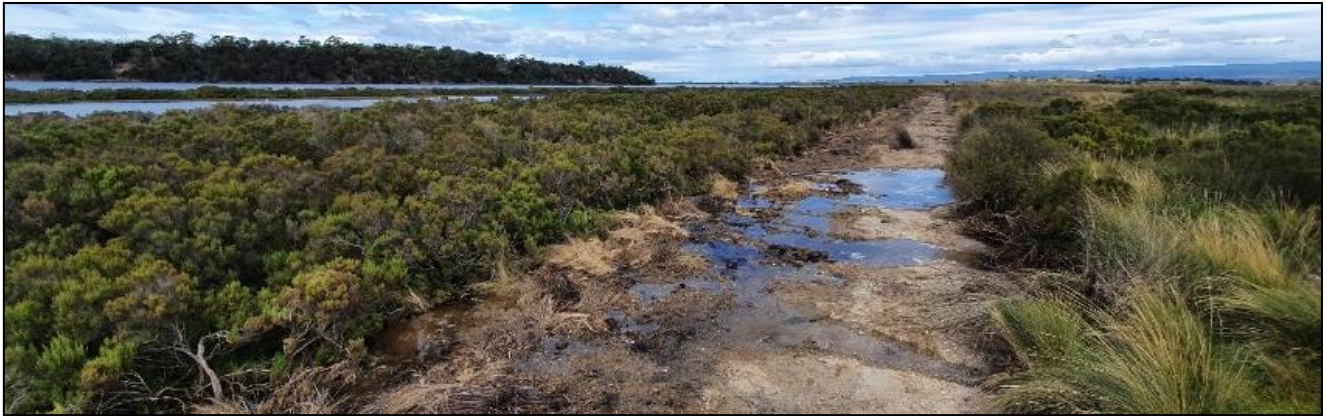
This was an incredibly interesting thing to witness so soon after the works, as we could see the rising water level beginning to seamlessly equalise, pushing flows through the saltmarsh in places where the levee bank had been in place only a few days earlier, validating the efficacy of the works.

Looking south at two points along the main (eastern) levee on the 9th March 2023.

Above is an area which was remediated only a few days earlier, with Moulting Lagoon floodwaters breaching the position of the former levee bank for the first time at this location. Right shows the same process underway at a site where a portion of the levee was removed a year earlier.

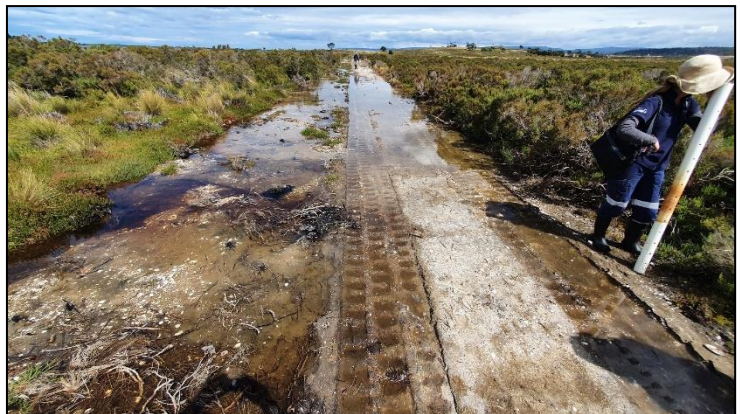
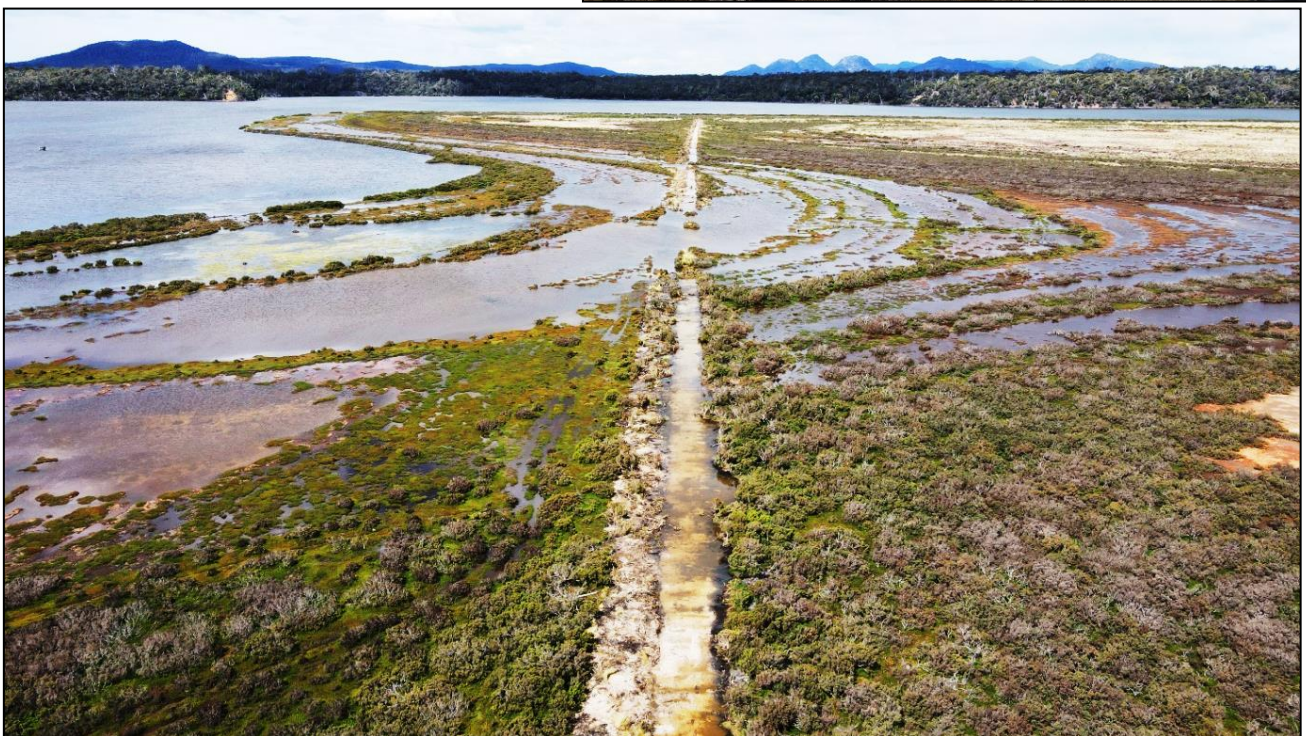
Looking east along the main (eastern) levee on the 8th March 2023, which was remediated only a few days earlier, with Moulting Lagoon floodwaters equalising in the saltmarsh area north of Round Hole.

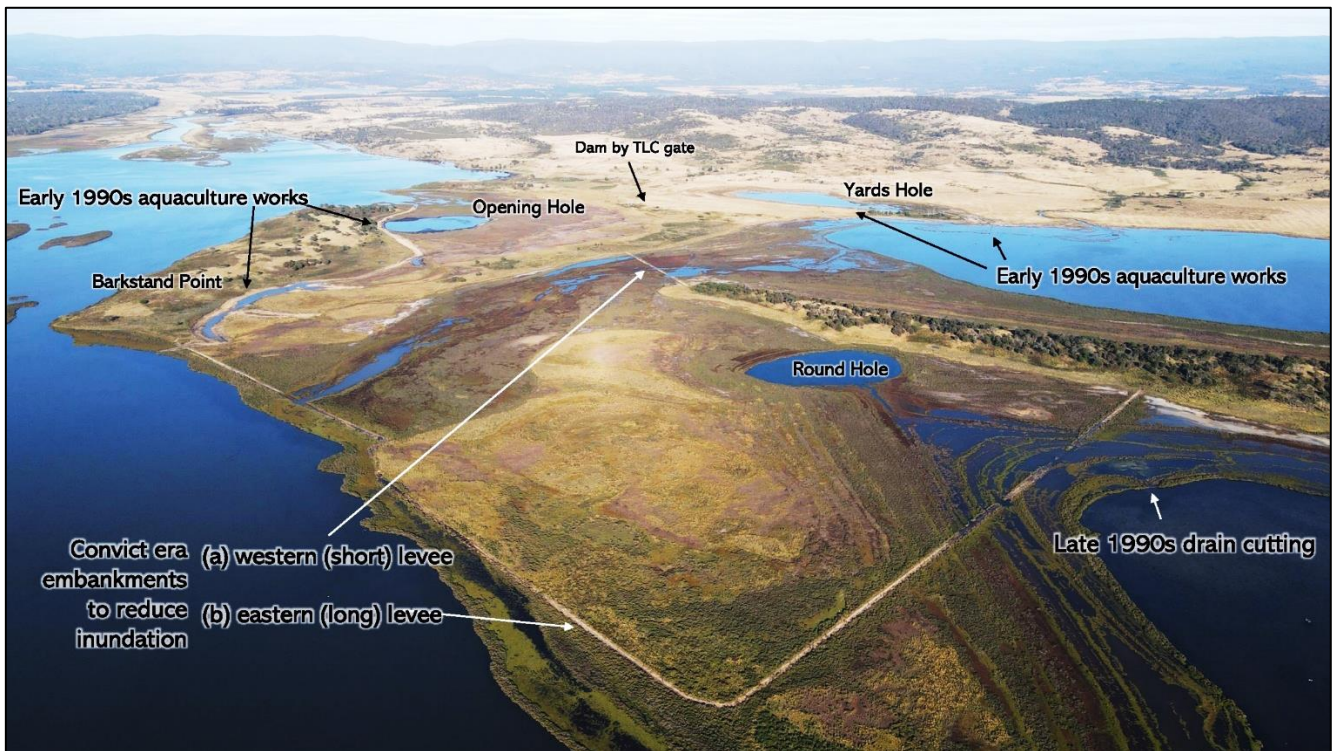
In addition to the large existing saltmarsh areas that will benefit from an improved hydrological regime (through restored connectivity of flows with Moulting Lagoon), a further **9.35 hectares** of land (the remediation works footprint) is now available for saltmarsh regeneration.

To see the breakdown of this total area by works location, please refer to the table right and the image below.

Remediation Works	Area (Ha)
Barkstand artificial channel	4.62
Eastern (long) levee	1.30
Yards Hole	3.10
TLC Gate Dam	0.10
Eastern (short) levee	0.22
1990s drain cutting	0.01
TOTAL	9.35
