Wetlands Australia 37: The Rowan Swamp Restoration Trial: reversing the impacts of creek line erosion on an important in-stream wetland in northern Victoria

Author: *Mark Bachmann, Nature Glenelg Trust*

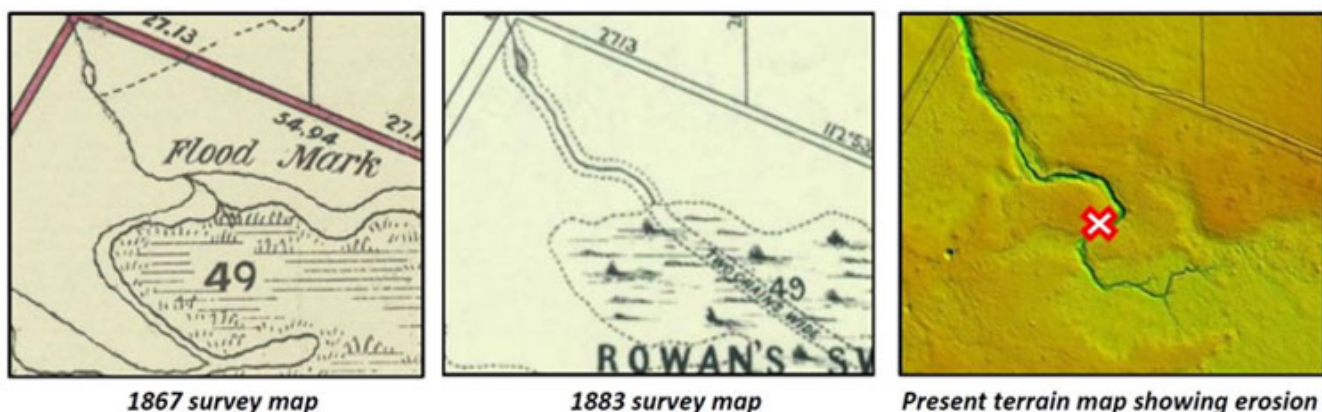
The trial structure location is marked with an X, on the modern digital terrain model (right). Note the significant erosion into the wetland bed that has occurred since the 1880s.

The most suitable location determined for the installation of a trial structure was at the location where the edge of the wetland was mapped in plans drawn in 1867 and 1883, as shown below. Also shown below is the significant erosion and migration of the creek channel in the modern digital elevation mapping, compared to the location of the waterway in the 1800s.

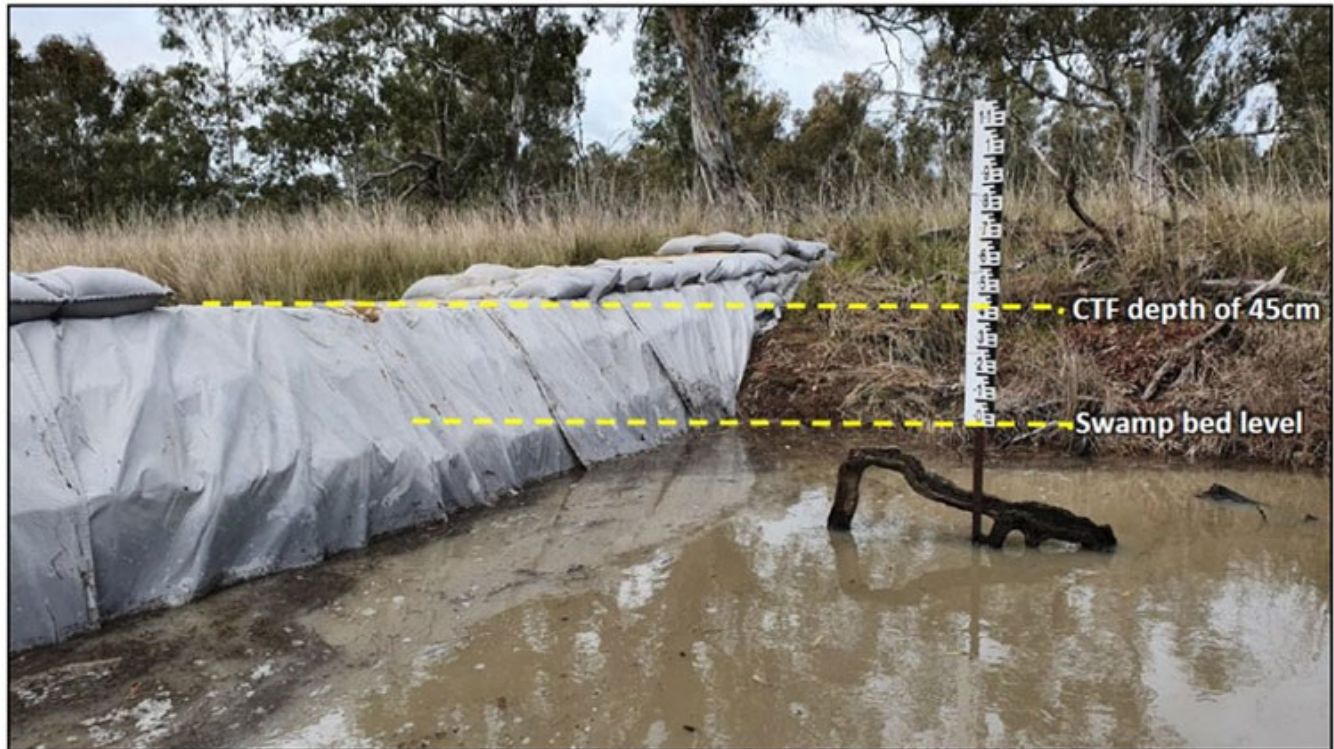
The completed restoration trial structure, showing how the channel at this location has eroded below the bed level of the swamp, and the restored CTF level. Photo: Mark Bachmann

To make it easier to keep track what is going on in the swamp, we have placed a gauge board in the channel immediately upstream of the structure (next to some Red Gum roots now exposed due to erosion). As shown below, the 0 cm level of the gauge board corresponds to the bed level of Rowan Swamp upstream, while the spillway cease-to-flow (CTF) level has been set 45 cm above this level (at 135.05 m AHD).

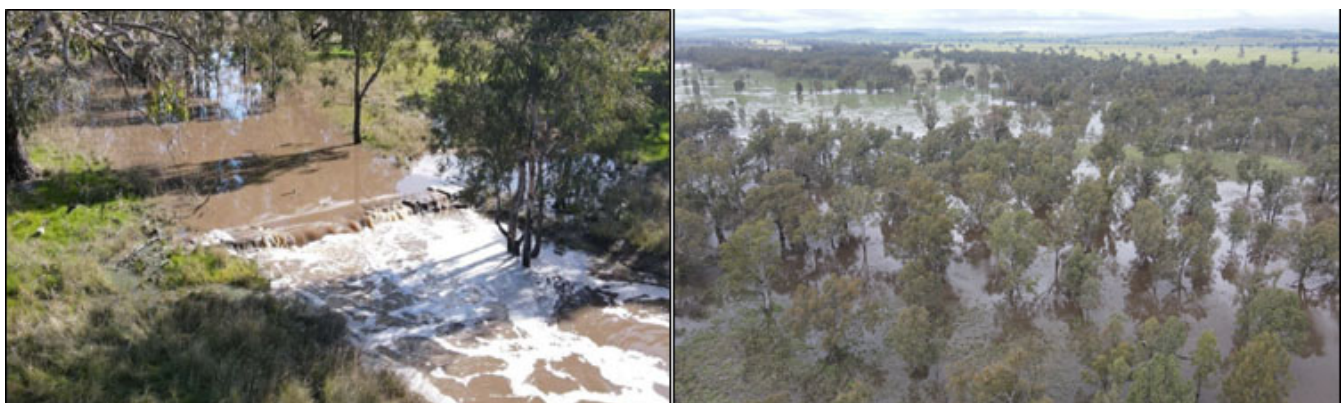
Rowan Swamp restoration trial structure in September 2022 (left) and the wetland upstream (right). Photos: Mark Bachmann

In a fortuitous quirk of timing, a couple of rainfall events in the Boosey Creek catchment in the two weeks after the structure was completed generated sufficient flows to fill Rowan Swamp to the new spillway depth, and the catchment has received regular flows throughout the latter part of 2022 as a result of the combined La Niña and Indian Ocean Dipole weather patterns which have driven above average rainfall in south-eastern Australia.
