# Eco-hydrological Assessment and Restoration Plan for Burdens Marsh, Sloping Main Reserve, turrakana/Tasman Peninsula

**FINAL - 13<sup>th</sup> July 2024**

Report to the Tasmanian Land Conservancy

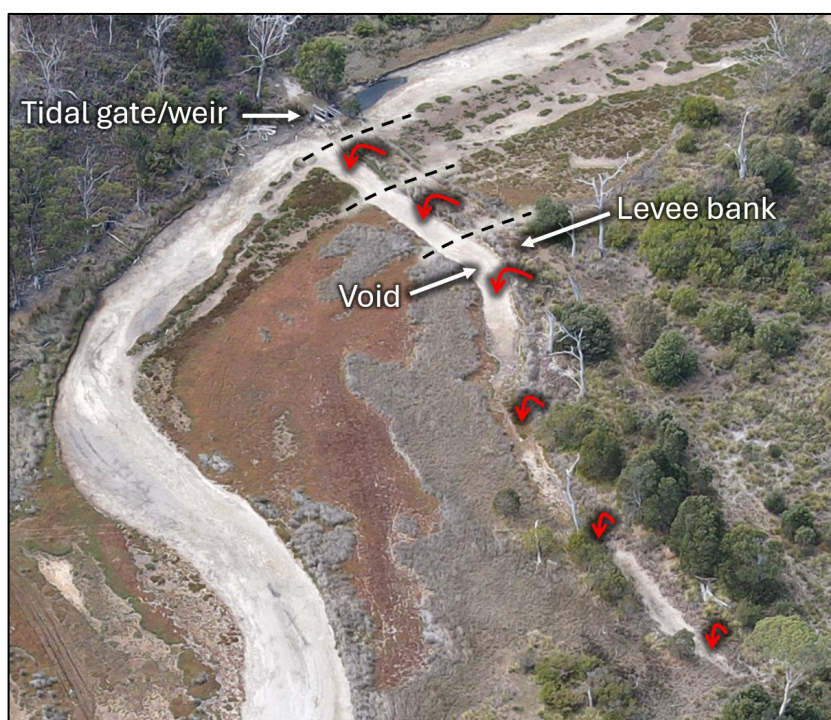
- (1) **Tidal weir and levee removal** – to restore the condition / function of the saltmarsh natural outlet

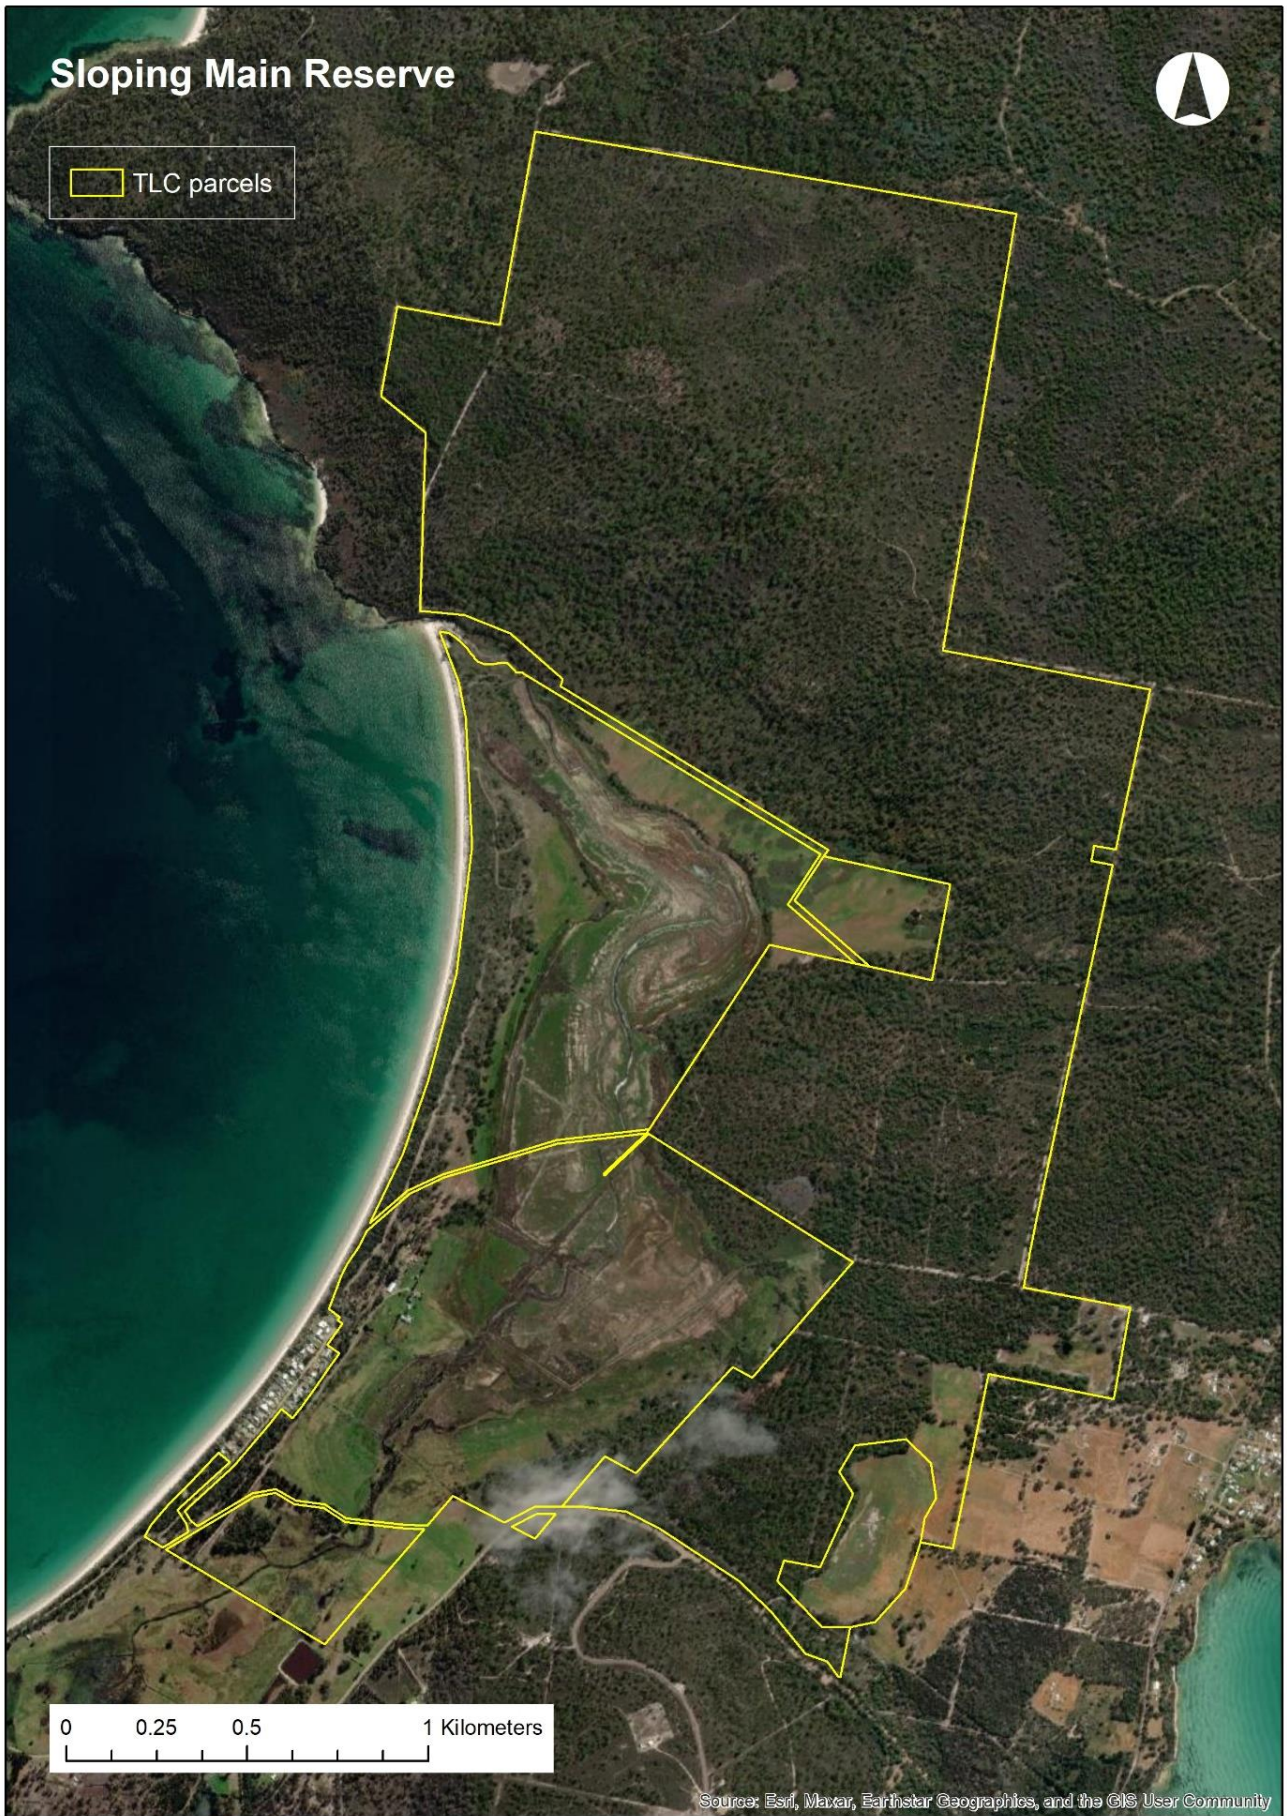
Figure 1. Map of TLC's Sloping Main Reserve and associated land parcels.

In July 2023, the Tasmanian Land Conservancy (TLC) extended the Sloping Main Reserve on turrakana/Tasman Peninsula via the purchase of Burdens Marsh, adding a further 235 hectares to the original 425-hectare reserve, with the reserve now totalling 660 hectares (Figure 1). Together with neighbouring Lime Bay State Reserve and the Coal Mines Historic Site, Sloping Main Reserve forms part of 2,220 hectares of contiguous conservation reserves on turrakana/Tasman Peninsula (Figure 2).

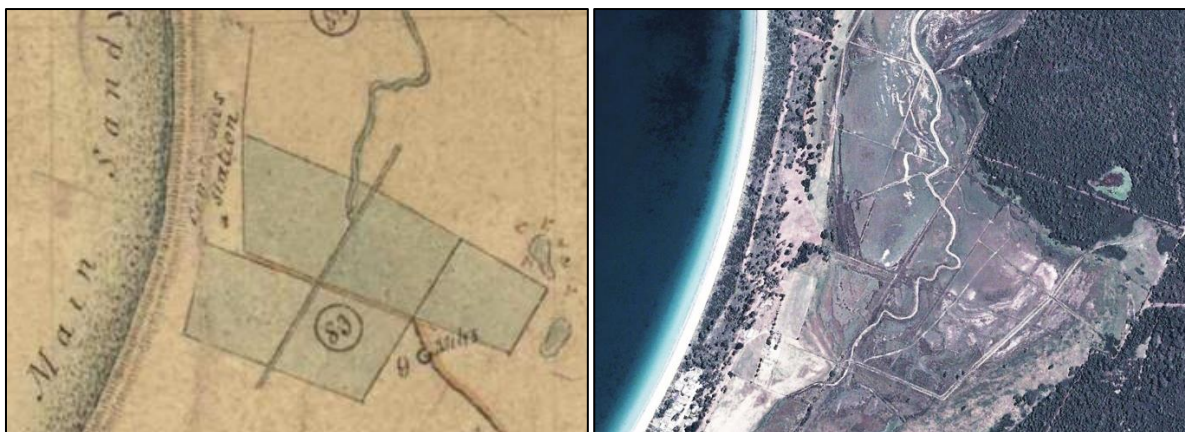
**Figure 6. Gellibrand's farm paddocks at Sloping Main, as mapped in 1833 (left), and the aerial image of this area today (right), where some drainage features and paddock boundaries are still evident.**

Interestingly, some form of evidence for almost all of these original drainage and/or fencing works remain evident in the landscape today (Figure 6, Figure 7).

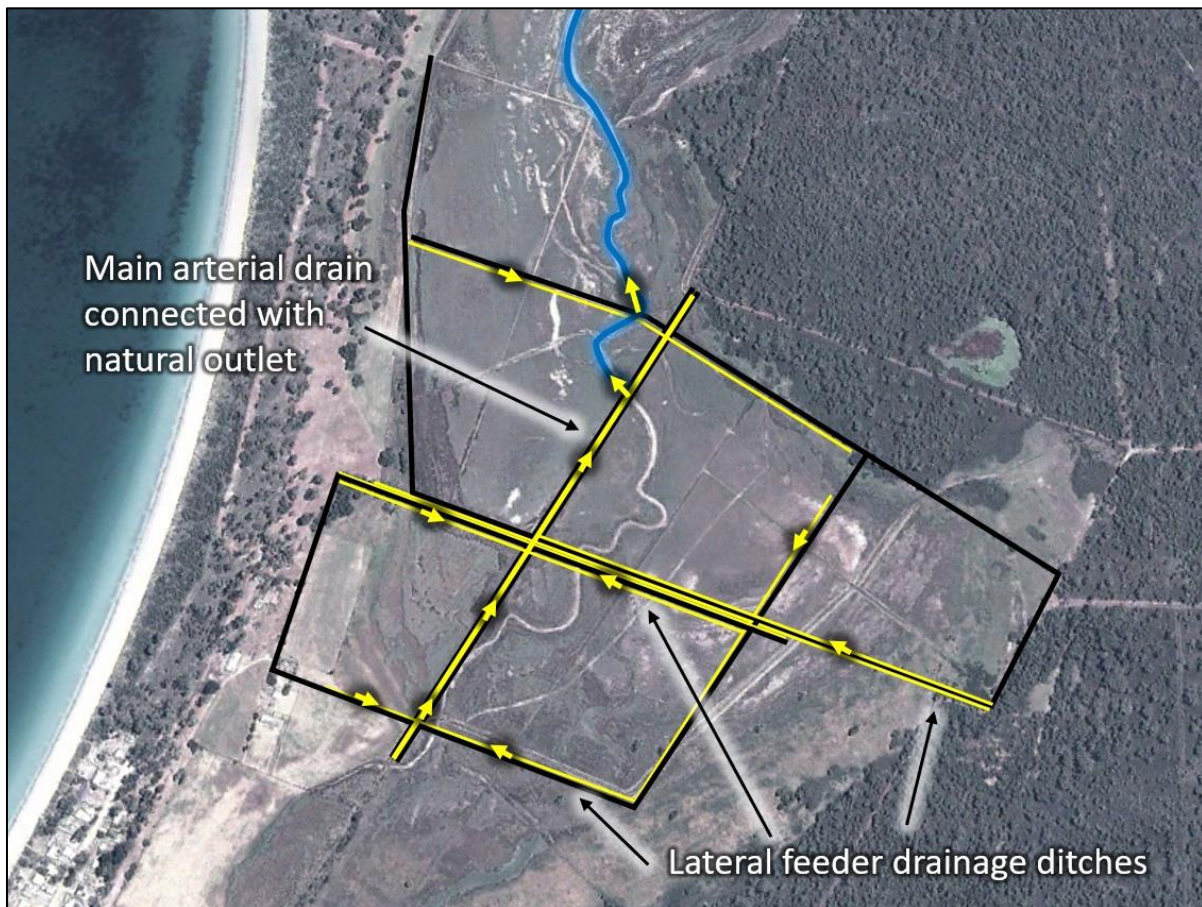
**Figure 8. Likely drainage configuration established by Gellibrand before 1834. Paddock boundary fences are marked in black, while inferred locations of original drains based on modern observation and LiDAR data are marked in yellow. The saltmarsh outlet is marked in blue and yellow arrows indicate direction of flow.**

The intent of this initial pattern of development by Gellibrand, appears to have been to begin to modify the hydrology of the central saltmarsh area, using methods of land reclamation widely implemented across Europe (and various colonial settlements around the world) during the 1800s. As shown in Figure 8, a series of feeder drainage ditches, either side of a main arterial drain were dug, providing both a land drainage service and generating the physical material required for creating raised embankments alongside each drain. These embankments provided a location around each paddock where fences could be established, and also serve to better control inundation of the reclaimed area, by seeking to confine the movement of water in low-medium flows events and/or tidal movements to the channels rather than across the wider saltmarsh surface. Reducing the frequency, duration and extent of inundation using these techniques, in some cases aided by the use of tidal gates and pumps, allowed for the conversion of vast areas of former natural saltmarsh globally.

Given the almost 200 years that have passed since these works were first completed (along with factors such as a minor increase in sea level, likely subsidence of the saltmarsh bed level due to trampling and oxidation of organic material, plus a lack of maintenance of the drains and embankments), it is very difficult to judge whether Gellibrand's original works can today be deemed a success. This question is also complicated by the fact that we don't actually know for certain what Gellibrand's original goal was for his land development project. Was it to improve the value and reliability of the area for grazing alone, or was he attempting to make it available for other forms of cultivation, or both? The suggestion that we have seen written by some authors that a dairy may have been envisaged for the area seems highly unlikely, given that people with this particular land use in mind tended to target the drainage of fresher wetlands (especially permanently wet, fresh groundwater dependent peatlands) rather than

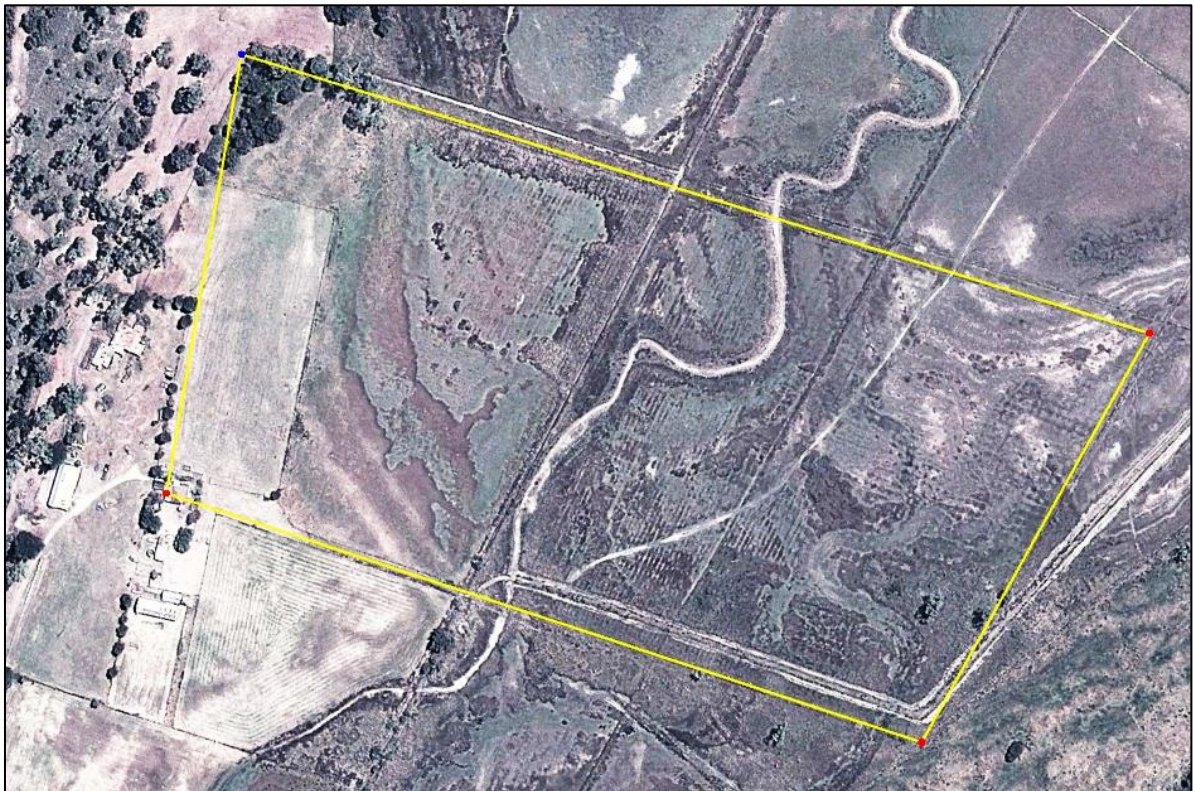
**Figure 9. Evidence of soil cultivation (linear ploughing) that can still be seen in some aerial images, under the right light conditions, within the southern two paddocks set up by Gellibrand prior to 1834. The yellow line shows the outer boundary of the two paddocks and measures exactly 40 acres in area.**

While the saltmarsh has only been used for grazing over the past century (F. John Price, pers. com. 2023), it is interesting to note that the two southern paddocks from this original c.1830 farm area retain visual evidence that is suggestive of past cultivation, as shown in Figure 9. Could it be that these two paddocks, which together measure exactly 40 acres in area and are situated immediately adjacent to the original location of Gellibrand's farm buildings, correspond to the area that he indicated had been planted to wheat, as referenced from the archives by Ward (2023)? The lack of other cleared land in the vicinity at the time is reasonably compelling evidence, noting that at the time – in attempting cultivation (and whenever that occurred in the 1800s) – this area must have appeared to have very different agricultural potential compared to its appearance today.

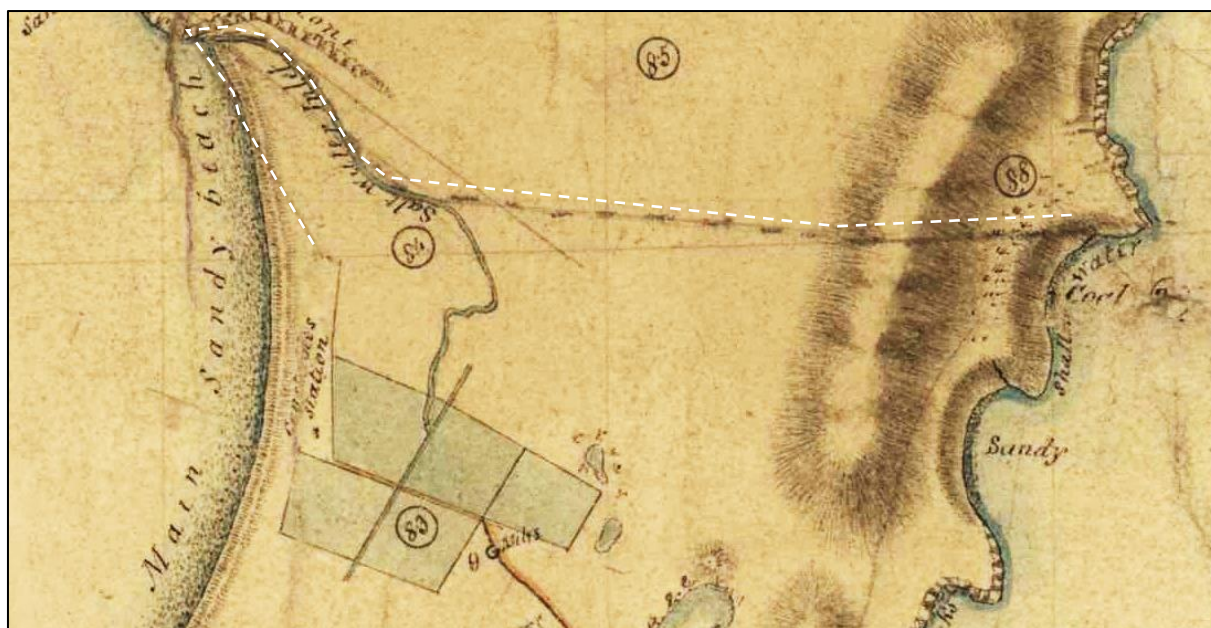
**Figure 11. Inset of Tasman Peninsula map by James Hughes in 1833, showing the first path established between the Sloping Main Constable Station and the coal mines. The path travelled around the northern side of the saltmarsh. A dashed white line has been placed above this route to highlight its location.**

Firstly, James Hughes' map from 1833 has an interesting sketch on it – a dashed line inserted after the map was completed – which shows an additional early path used to allow for direct travel between the Constable's Station at Sloping Main, and the new coal mine (Figure 11).

We can interpret from this 1833 map that a more direct route across the saltmarsh to the coal mine was not immediately in place. This means that a crossing specifically for this purpose was not built until sometime after the first phase of drainage works and farm development.

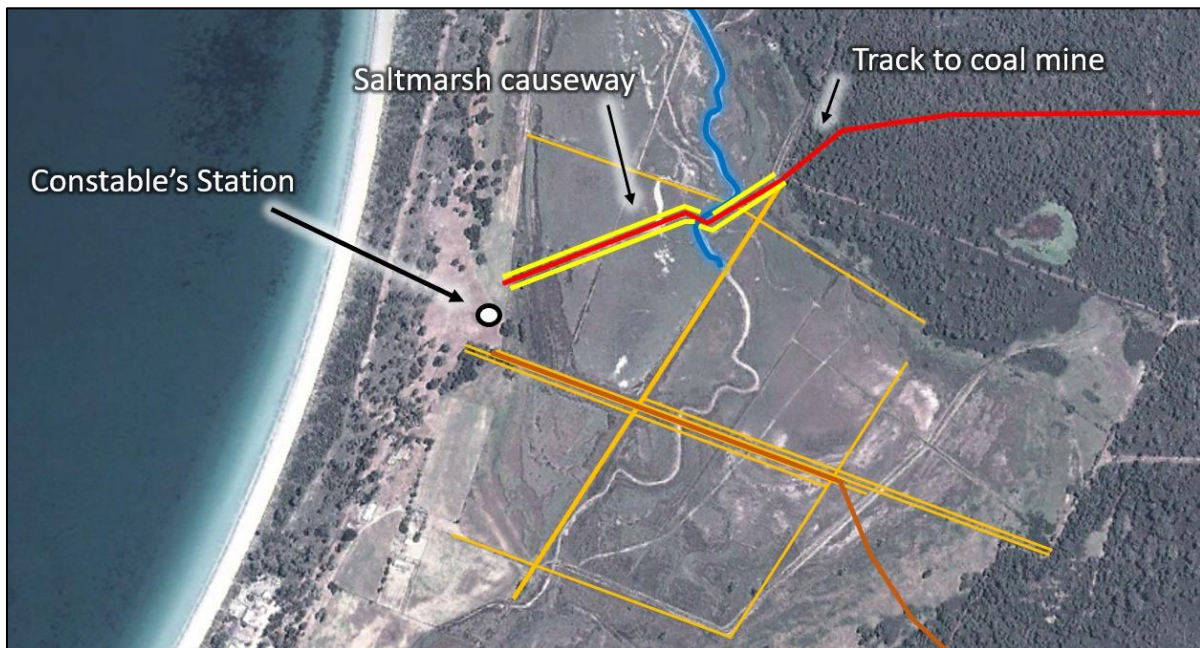
Figure 13. Works that date to the mid-1830s through the saltmarsh, providing more direct access to the coal mines. The red line indicates the location of the new track, and the yellow lines are the ditches that were dug either side to gain the material required to create the causeway. Earlier works are marked in orange (drains) and brown (roads).

The location of the causeway that was excavated (using material gained by digging ditches either side of a raised mound) to create this diagonal track crossing is still evident today on the ground, as well as in the aerial imagery (Figure 13) and elevation data.

We can readily infer that the primary purpose of these works was not further drainage, based on the alignment of the causeway relative to other surrounding works. However, despite not being its main purpose, the causeway embankment did serve to create an additional impediment to surface flows

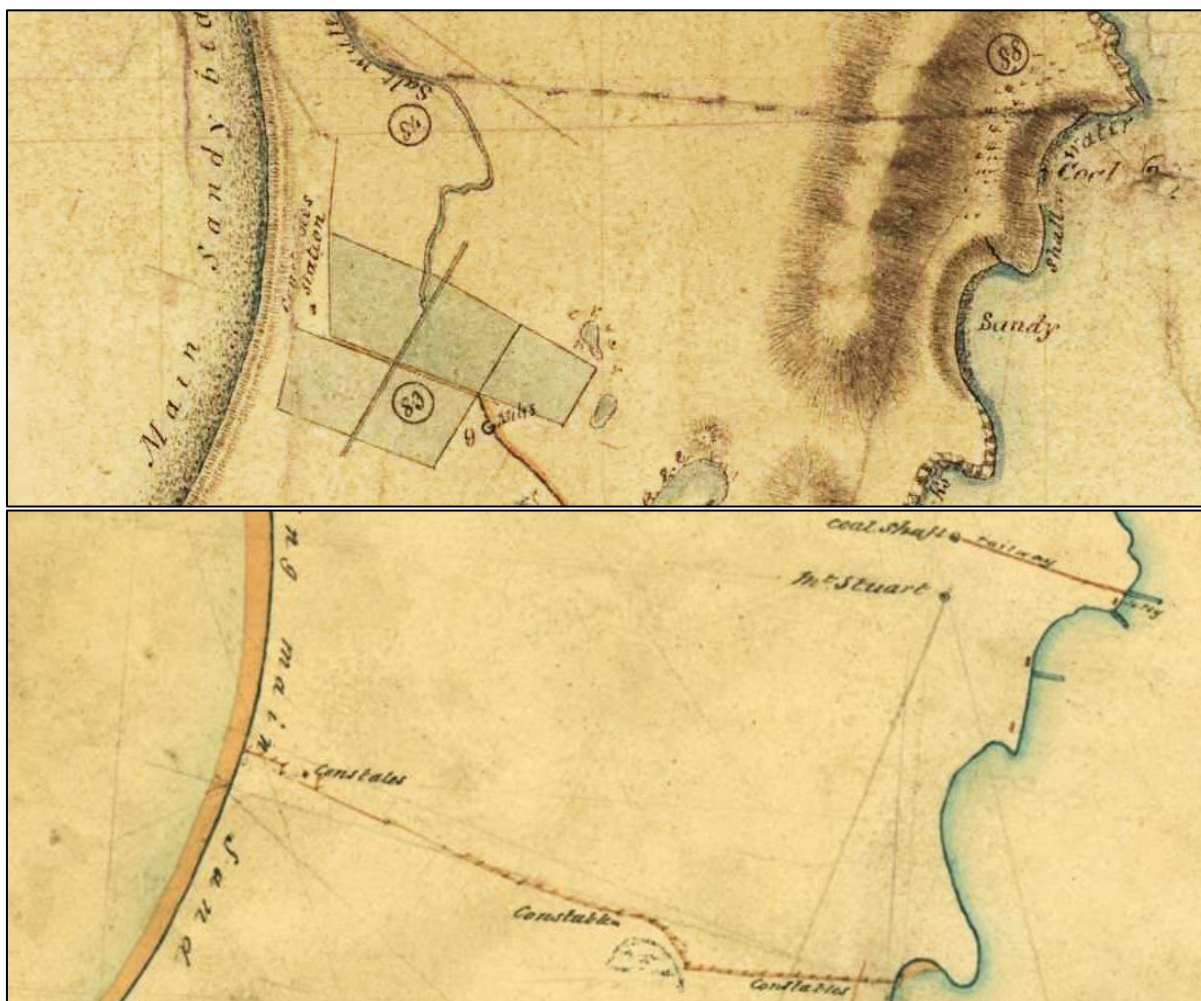
**Figure 14. Inset of Tasman Peninsula maps by James Hughes in 1833 (above for reference), and James Calder in 1849 (Calder 1849) (below), showing the location of the fencing (hatched line) that was installed either side of the saltmarsh paddocks at Sloping Main. This created a fenced cordon with three Constable Stations spaced between Sloping Main Beach and Salem Bay.**

Although not having any apparent relevance to the hydrology of the saltmarsh at Sloping Main, it is interesting to note that a map produced in 1849 by James Calder (Figure 14), shows how a revised track and a fence was installed from coast to coast across the peninsula of land at Sloping Main, running east-west from Sloping Main beach to Salem Bay (south of the coal mine). This new boundary incorporated a further two Constable Stations in addition to the one already in place at Sloping Main Beach. A photograph of the modern ruins of the middle station, situated on the northern side of Turners Lagoon, can be found on page 230 of John Thompson's book (Thompson 2007).

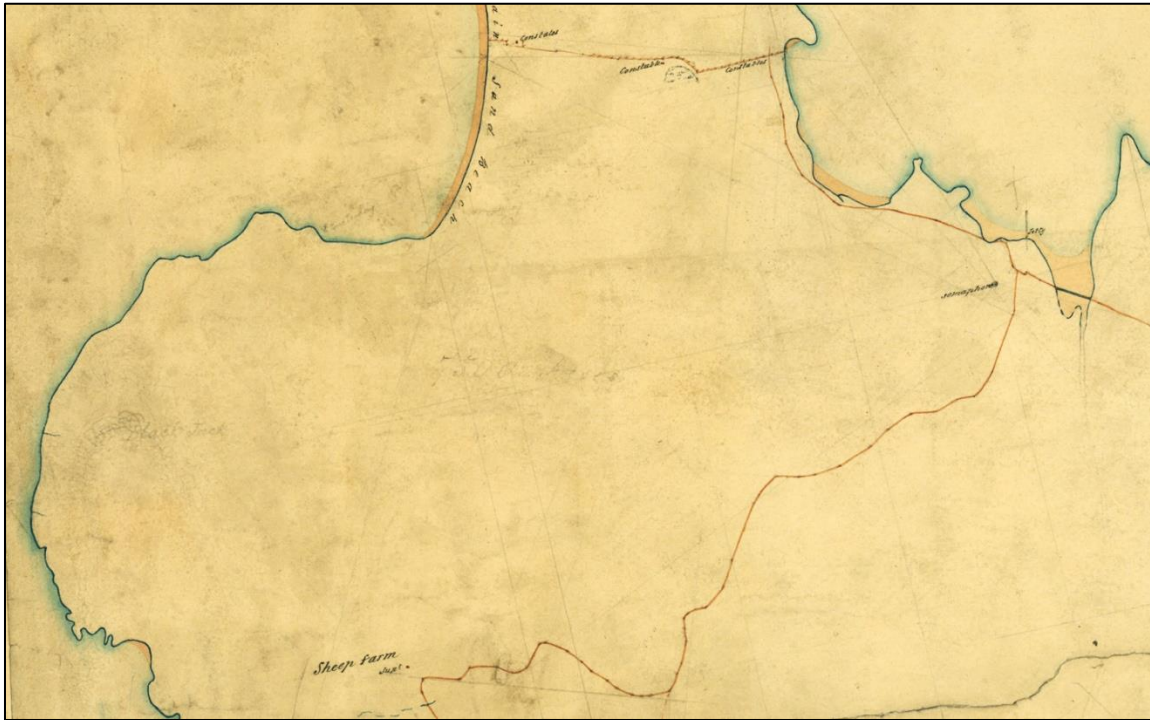
**Figure 15. Inset of James Calder's 1849 map. Showing the location of the sheep farm outstation buildings relative to the fence at Sloping Main. Written in faint lead pencil in the centre of this image is a notation saying "7500 acres". Note that the road show here from the Sheep Farm to Saltwater River was called "Woolshed Road" and provided the overland point of connection during the convict era for movement between the coal mine in the north and Storm Cove to the south (off image) (pers. comm. F. John Price, 2024).**

According to Calder's survey however, the sheep farm buildings were situated well to the south of Sloping Main. Interestingly, only a few landmarks were recorded on this map; features such as the coastline, tracks, railroads, jetties, the coal mine and the sheep farm location and the new fence at Sloping Main (Figure 15). In lead pencil, there are also notations about the number of acres written on the map, either side of the new fence.

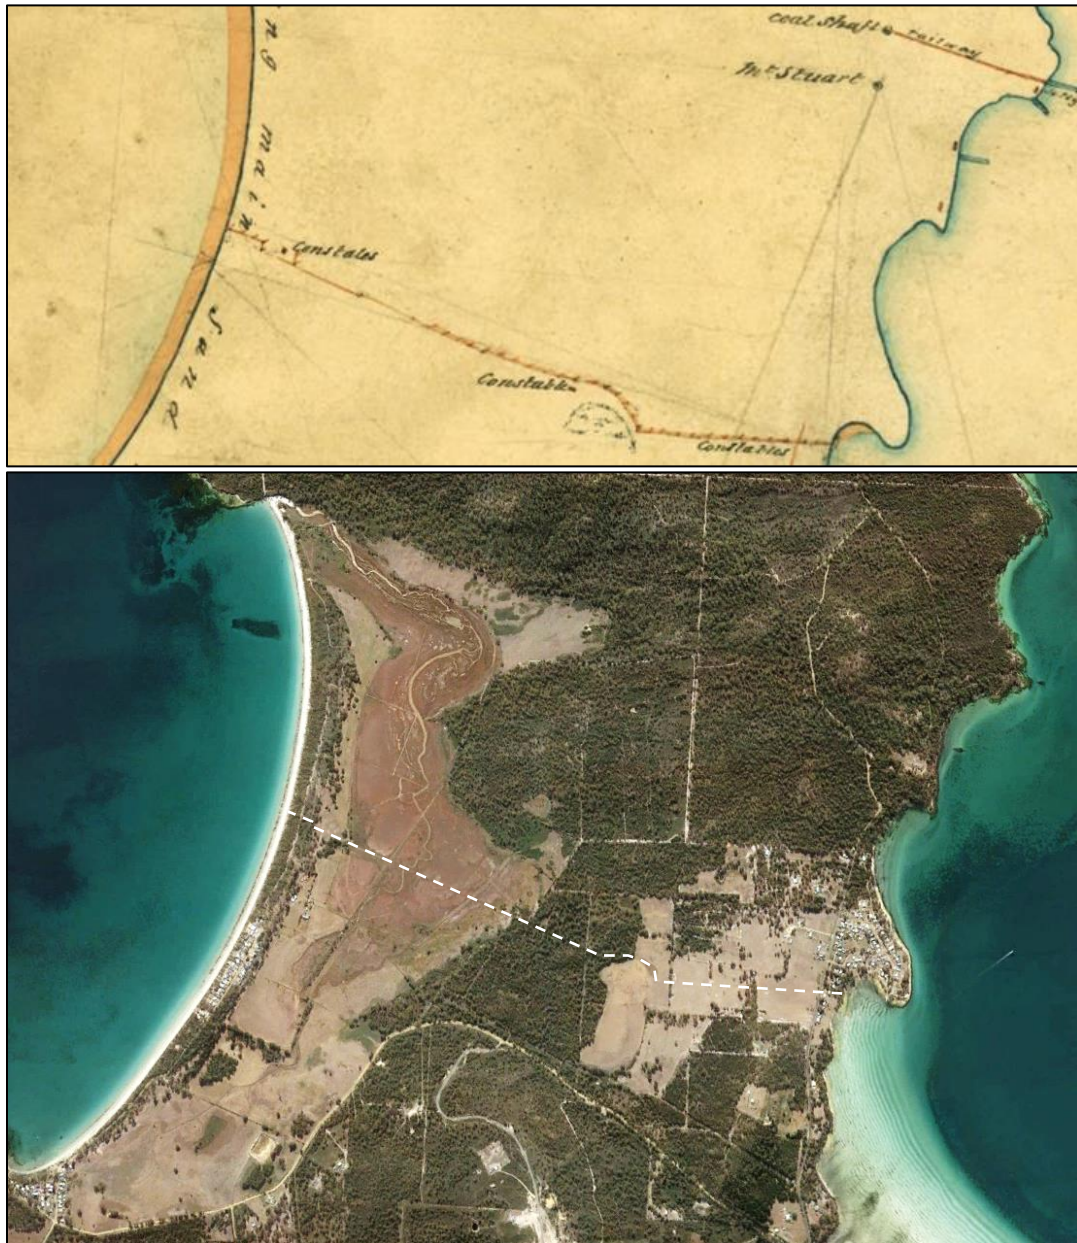
**Figure 17. Location of the boundary fence that once demarcated the coal mine lease (to the north) and the Penal Settlement managed land (to the south). Note how this divided the saltmarsh area at Sloping Main.**

This description indicates that the northern part of the saltmarsh within the coal mine lease area, as shown in Figure 17, continued to fall outside of the land utilised by and available to the Penal Settlement at that time. It also confirms that the saltmarsh has not been further developed (or the earlier works maintained) by this time, and also indicates that active management of the outlet probably did not occur during this period.

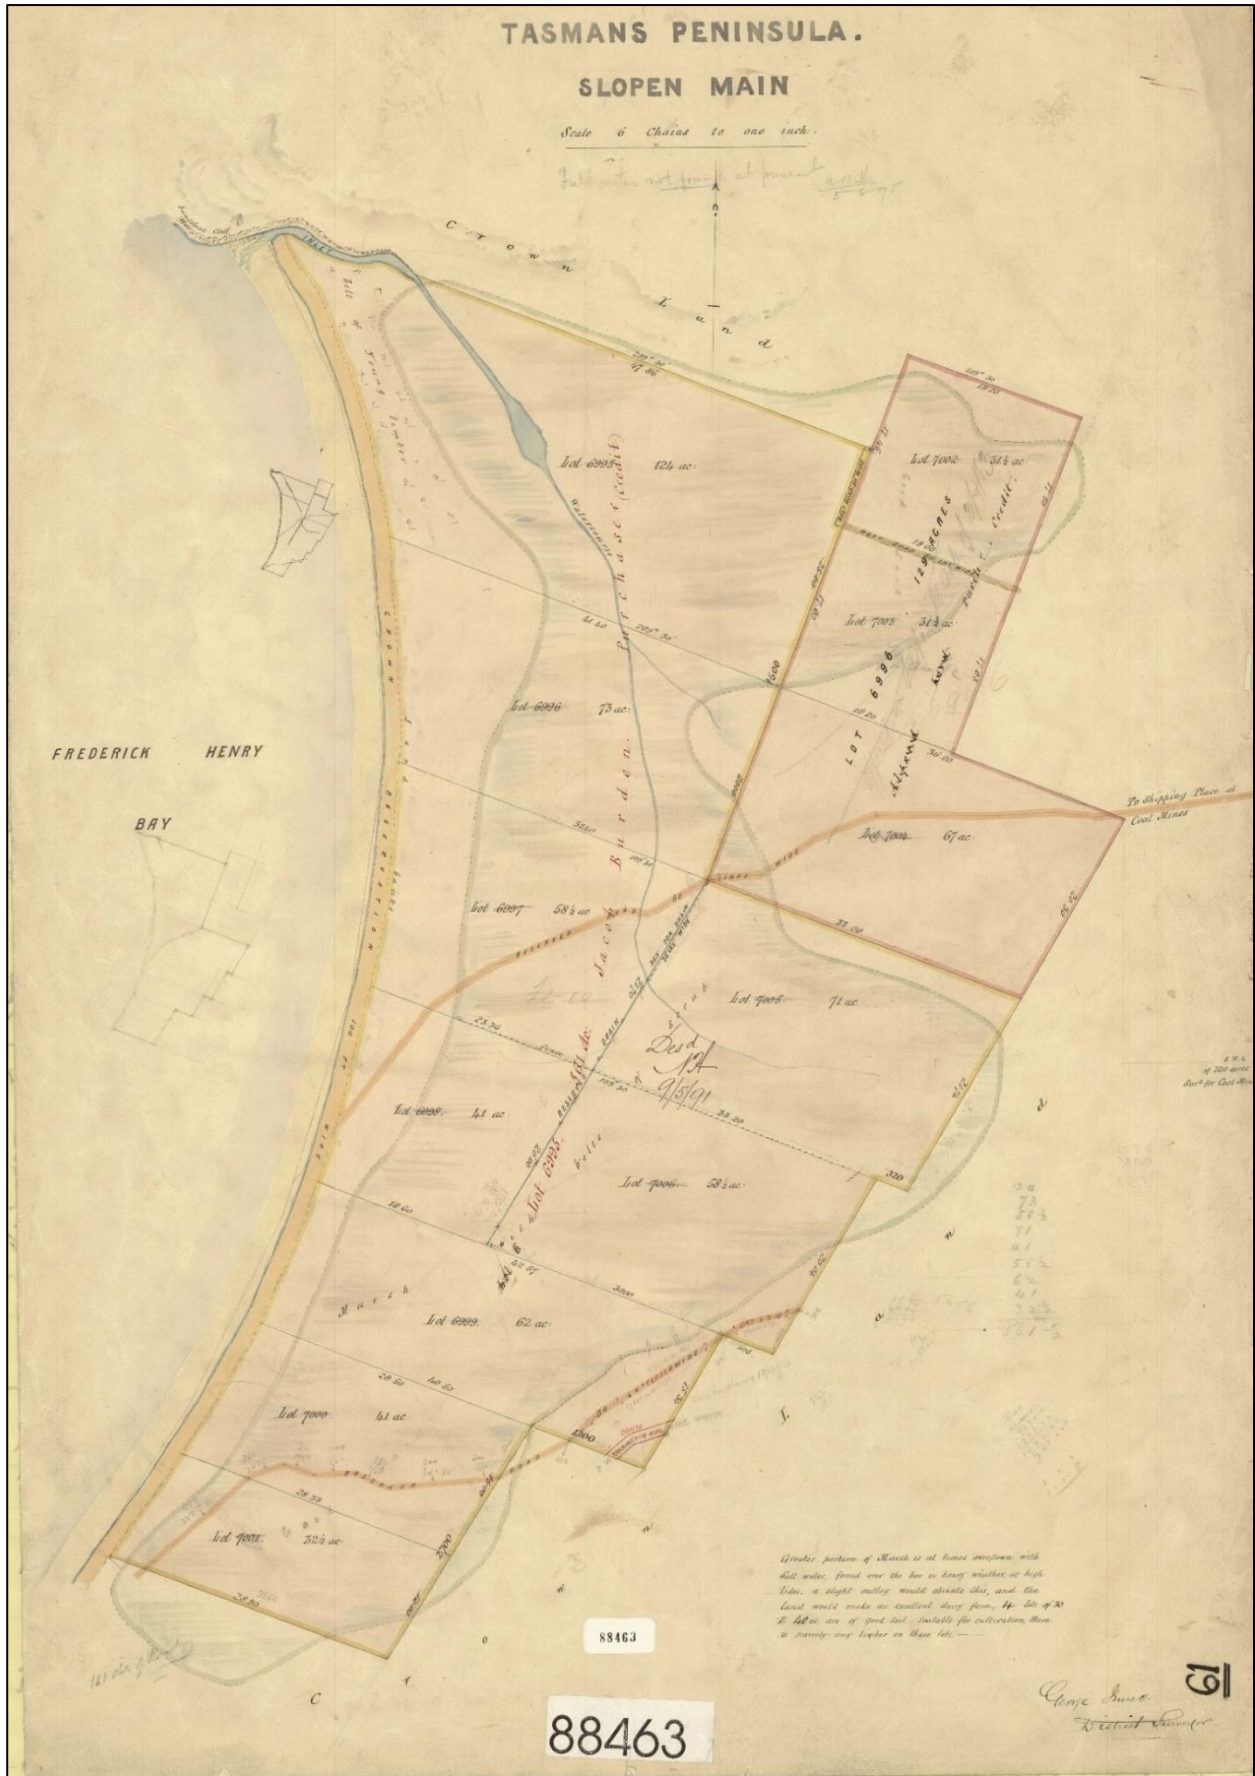
Figure 18. 1877 survey plan for the saltmarsh at Sloping Main.

In terms of features drawn on this plan, it provides a first detailed glimpse into the physical appearance and condition of the saltmarsh at Sloping Main, at the conclusion of the convict era in 1877. Key items of note include:

The survey plan that allowed for these lots to be auctioned was drawn by District Surveyor George Innes in 1877, and the purchaser details were entered onto this plan (Figure 18). We can also see that Alfred Lord's name was crossed out, presumably after he defaulted on the credit terms offered to him in 1877. When on the 28<sup>th</sup> April 1883, the Office of Lands and Works advertised for sale a large number of Crown Lands that were by then in default, the list included the property previously selected by Alfred Lord (Hobart Mercury 1883).

Written across these lots in lead pencil on the survey plan are the words "*offered in default sale of 3/7/83*", but these lots were not sold at the time and were later reconfigured, with 25 acres of the northern portion selected and purchased in the name of Margaret Burden, Jacob Burden's wife, in 1905, with the balance not purchased until 1964.

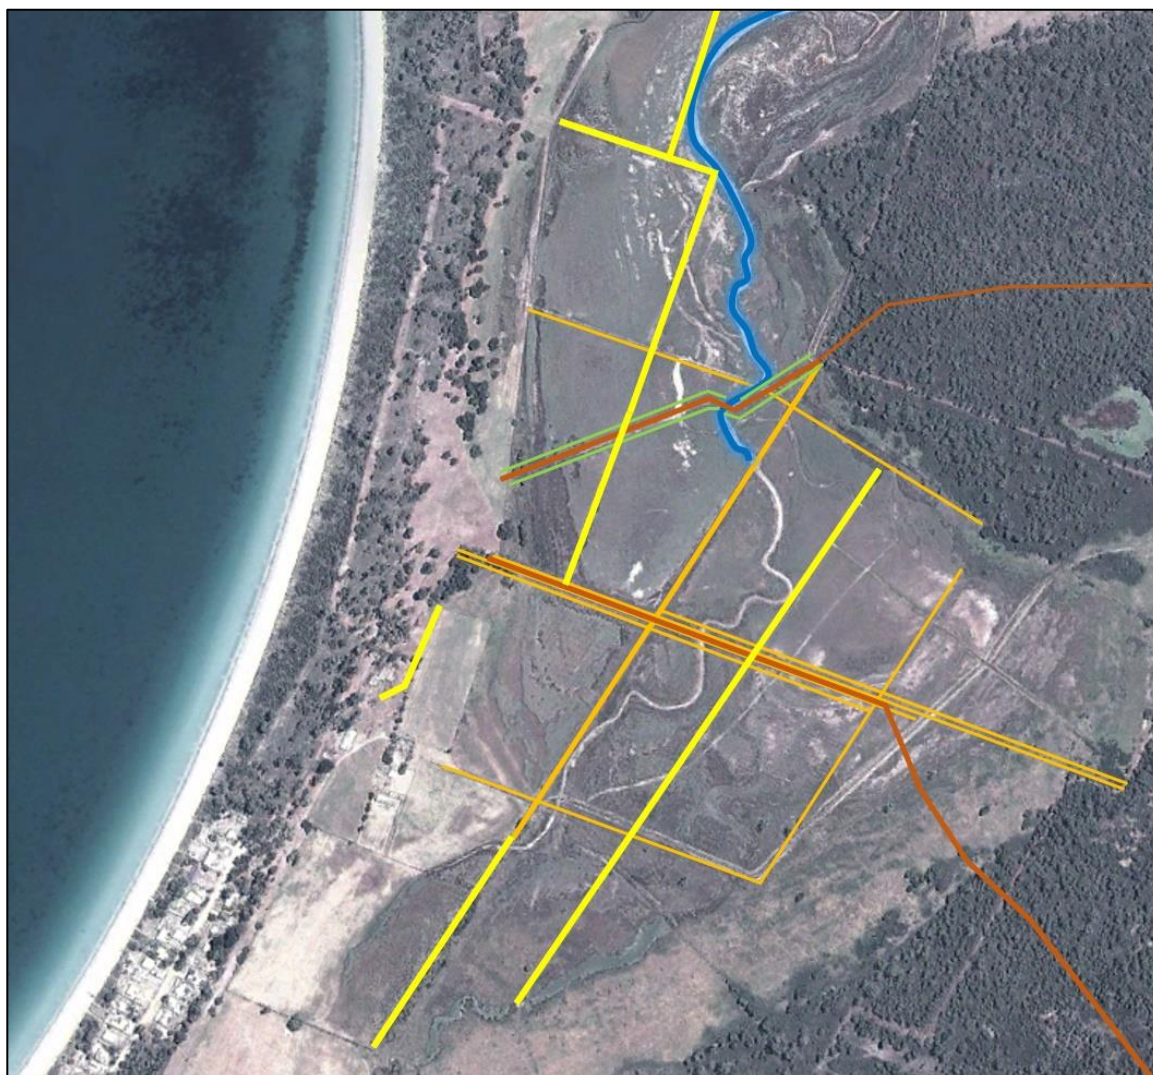
**Figure 19. Summary of drainage works prior to the 1940s in Burdens Marsh. The orange lines are the original pre-1834 drains, while the yellow lines are the additional drains probably excavated by convict labour between 1834 and 1847. After 1878, Jacob Burden likely reactivated all pre-existing drains (which were unlikely to have been maintained since their construction). The tracks from the 1830s are marked brown and the green lines are the ditches either side of the 1830s coal mine crossing.**

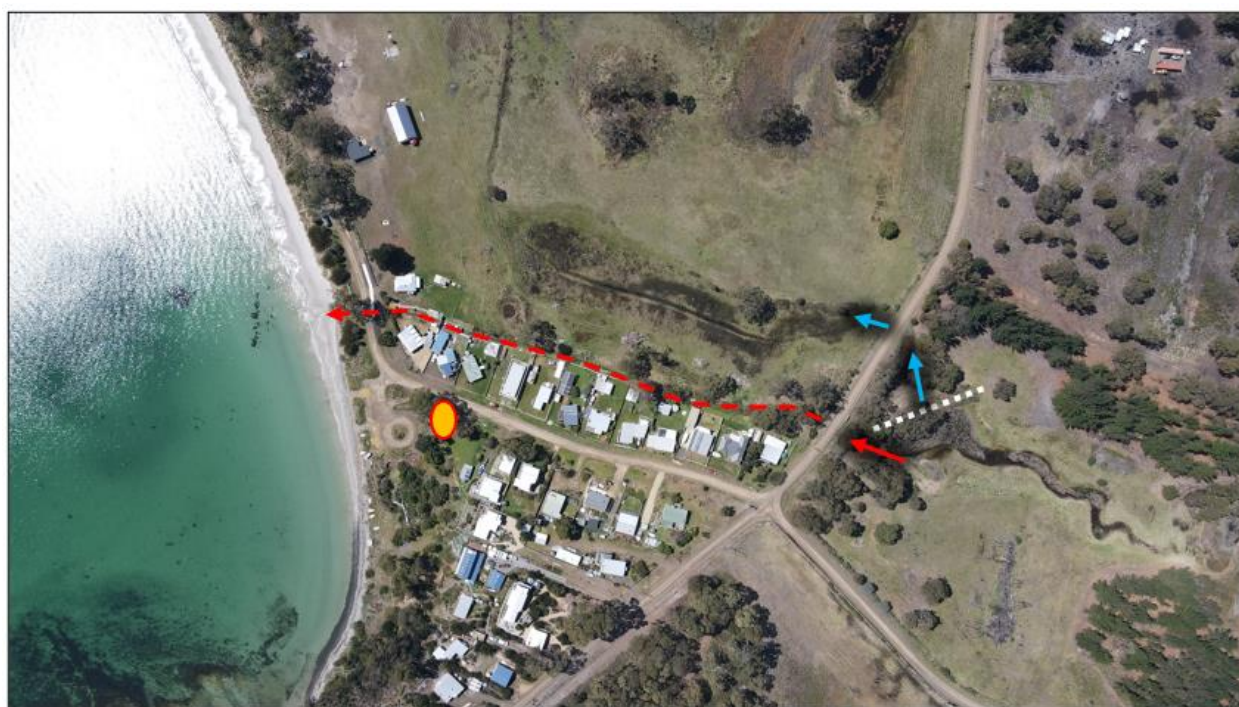
**Figure 22.** The original flow direction of the southern catchment into Burdens Marsh (blue arrows), was banked off (white dashed line), and this catchment has been diverted (red arrow) via an artificial bypass drain to the sea (red dashed line) since the early 1900s. The approximate location of the old waterhole/trench for the timber mill is shown in the orange circle. Photo: Mark Bachmann

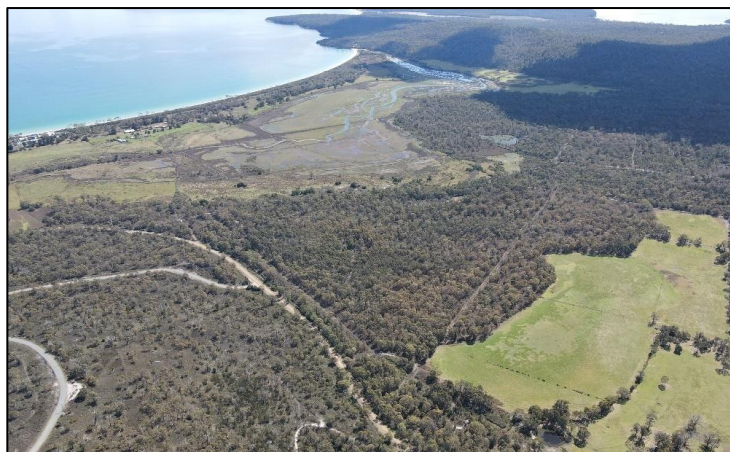
1. The drainage of Turners Lagoon (foreground below) c. 1965 by J W C Wyett (Figure 27).

**Figure 27. Turners Lagoon (foreground right) drained c. 1965 and Burdens Marsh (background).  
Photo: Mark Bachmann.**

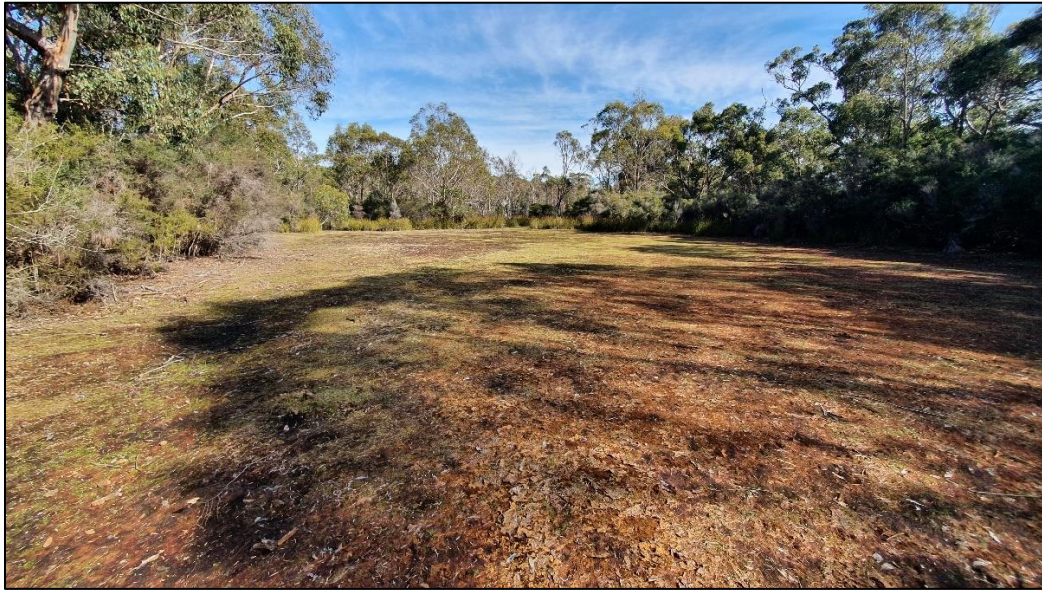
2. The subsequent drainage 10-15 years later of two further fresh wetland features (Figure 28) by J W C Wyett, now supplemented by the volume of water being discharged from Turners Lagoon.

**Figure 28. One of the fresh wetlands situated between Turners Lagoon and Burdens Marsh, drained c. 1980.  
Photo: Mark Bachmann.**

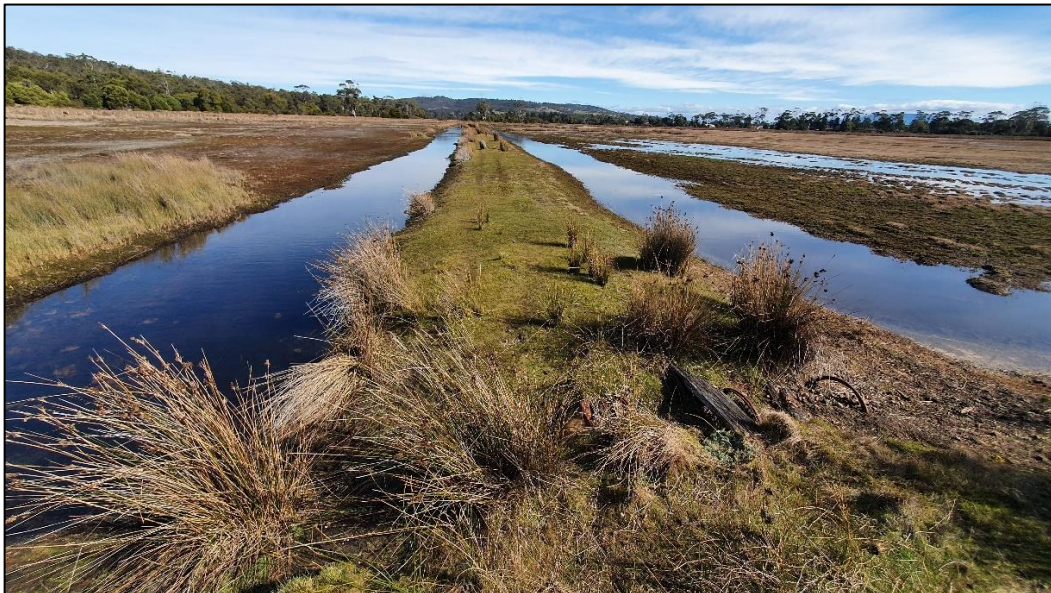
**Figure 29. Vehicle causeway / crossing, with drainage channel either side, constructed c.1990.  
Photo: Mark Bachmann.**

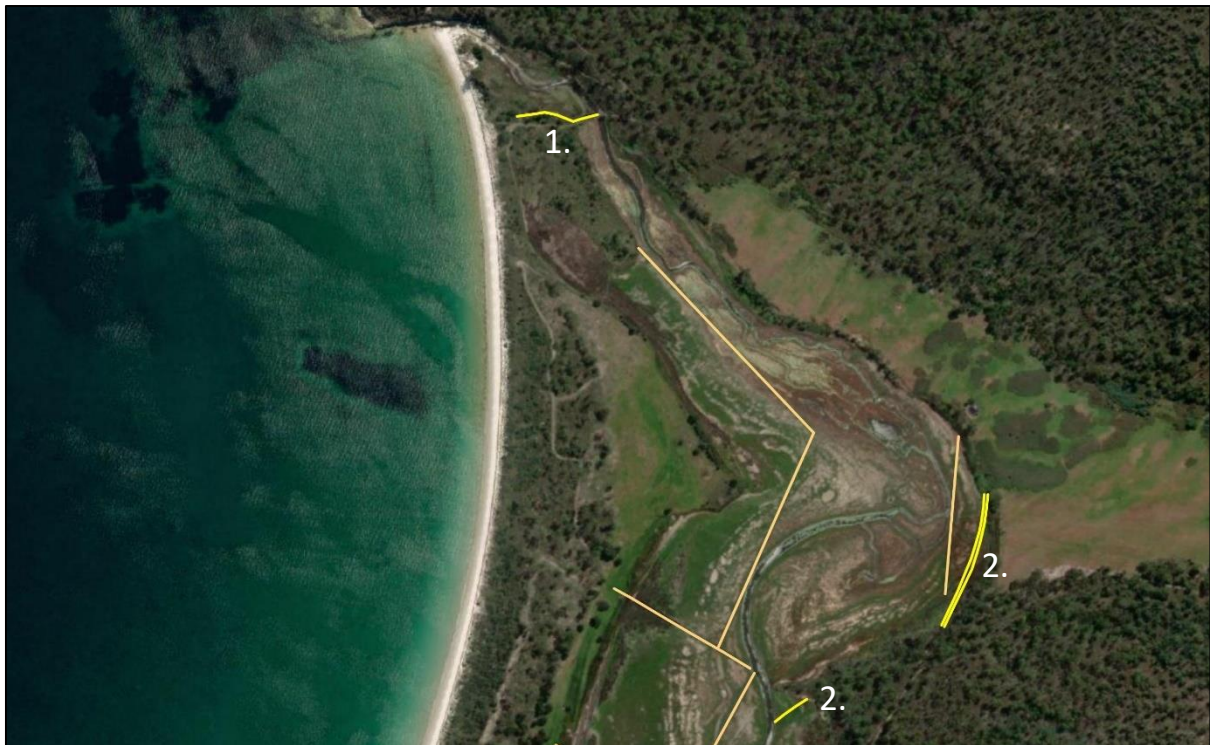
**Figure 30. Mapped drains in the northern area of Burdens Marsh (numbers referred to in text).**

An explanation for the main drainage features in the northern portion of Burdens Marsh labelled in Figure 30 is as follows:

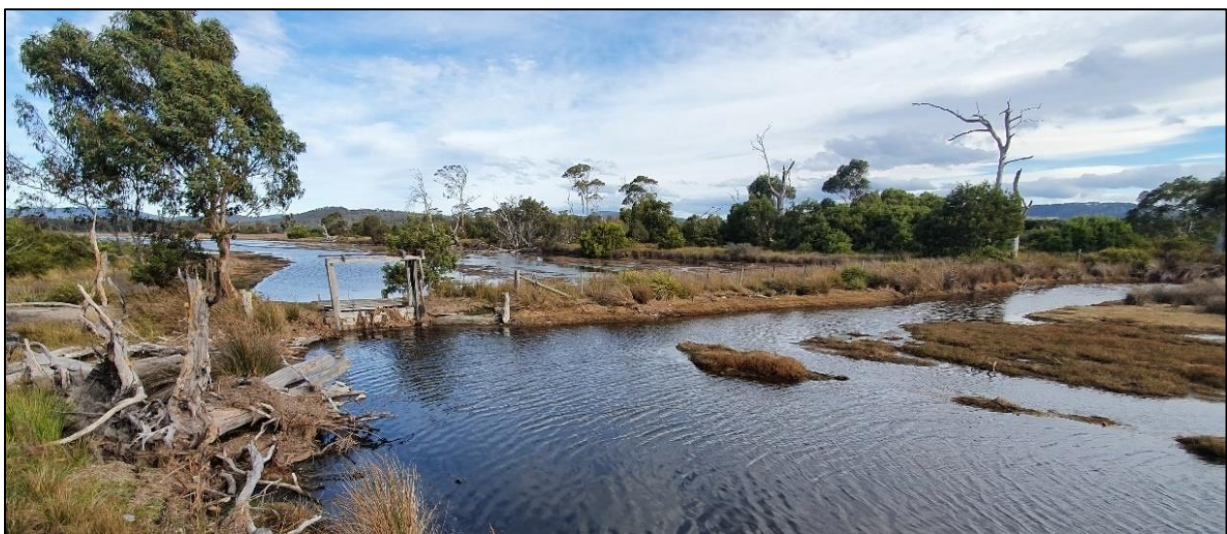
**Figure 31. Looking upstream over the levee bank and timber weir constructed c. 1990. Photo: Mark Bachmann.**

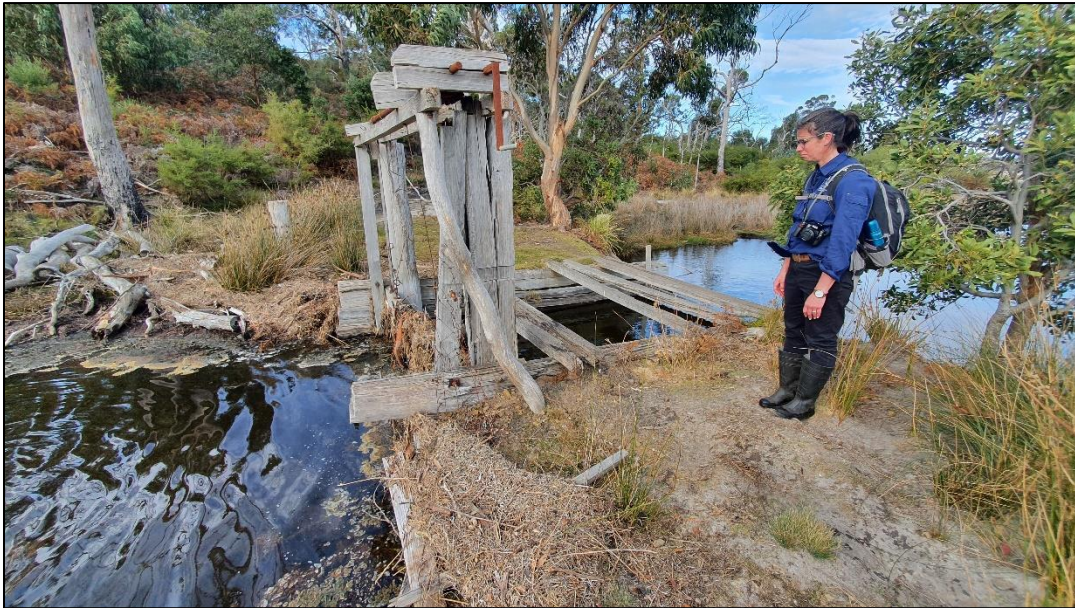
**Figure 32. Close up of the timber weir constructed c. 1990. Photo: Mark Bachmann.**

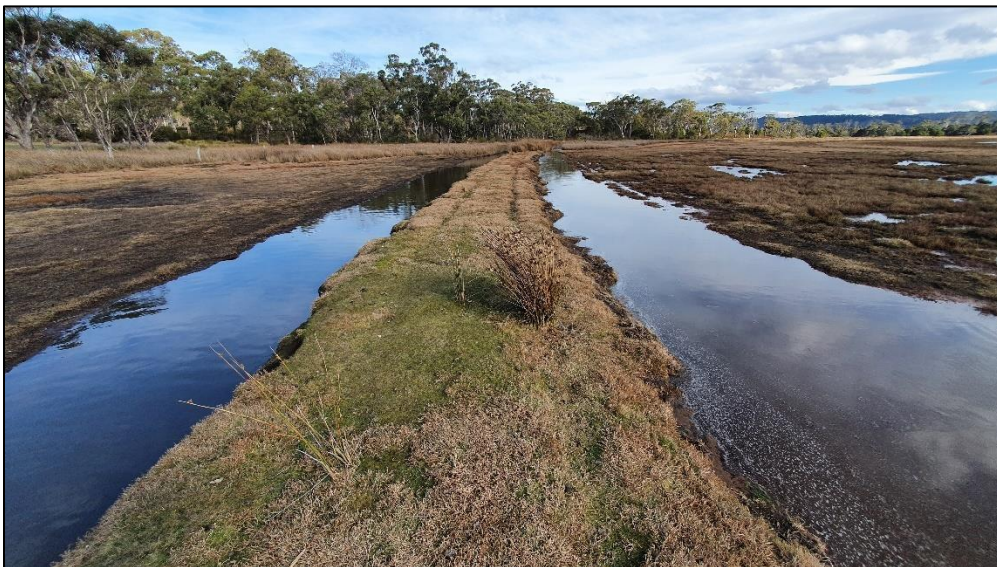
**Figure 33. Looking south along the vehicle access causeway constructed c. 1990. Photo: Mark Bachmann.**
