# Eco-hydrological Assessment and Restoration Plan for Burdens Marsh, Sloping Main Reserve, turrakana/Tasman Peninsula

**FINAL - 13<sup>th</sup> July 2024**

Report to the Tasmanian Land Conservancy

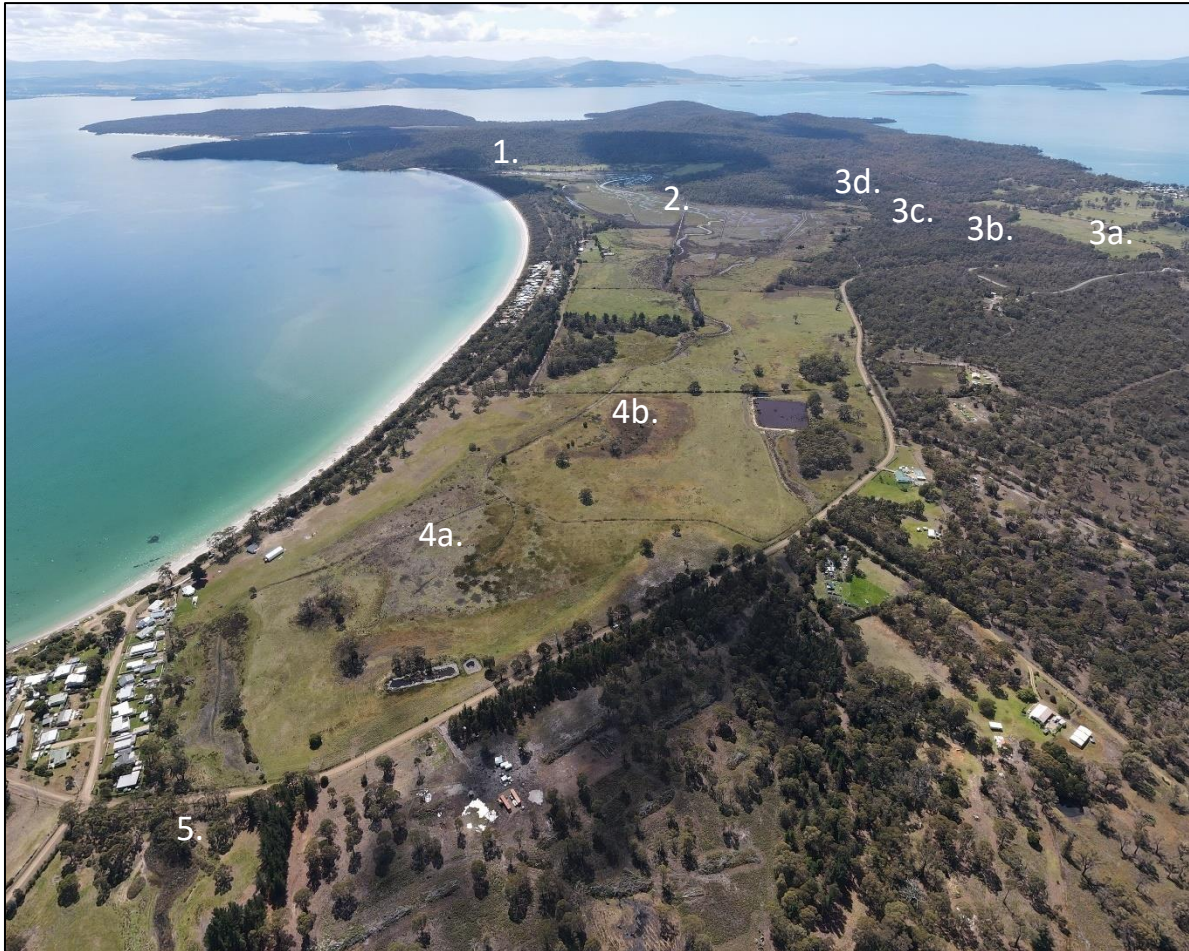
The main issues associated with land management interventions since European colonisation on the eco-hydrology of Burdens Marsh are summarised in Figure 34, across five themes.

**Figure 34. The key eco-hydrological issues: looking north over Sloping Main in 2023. Photo: Mark Bachmann.**

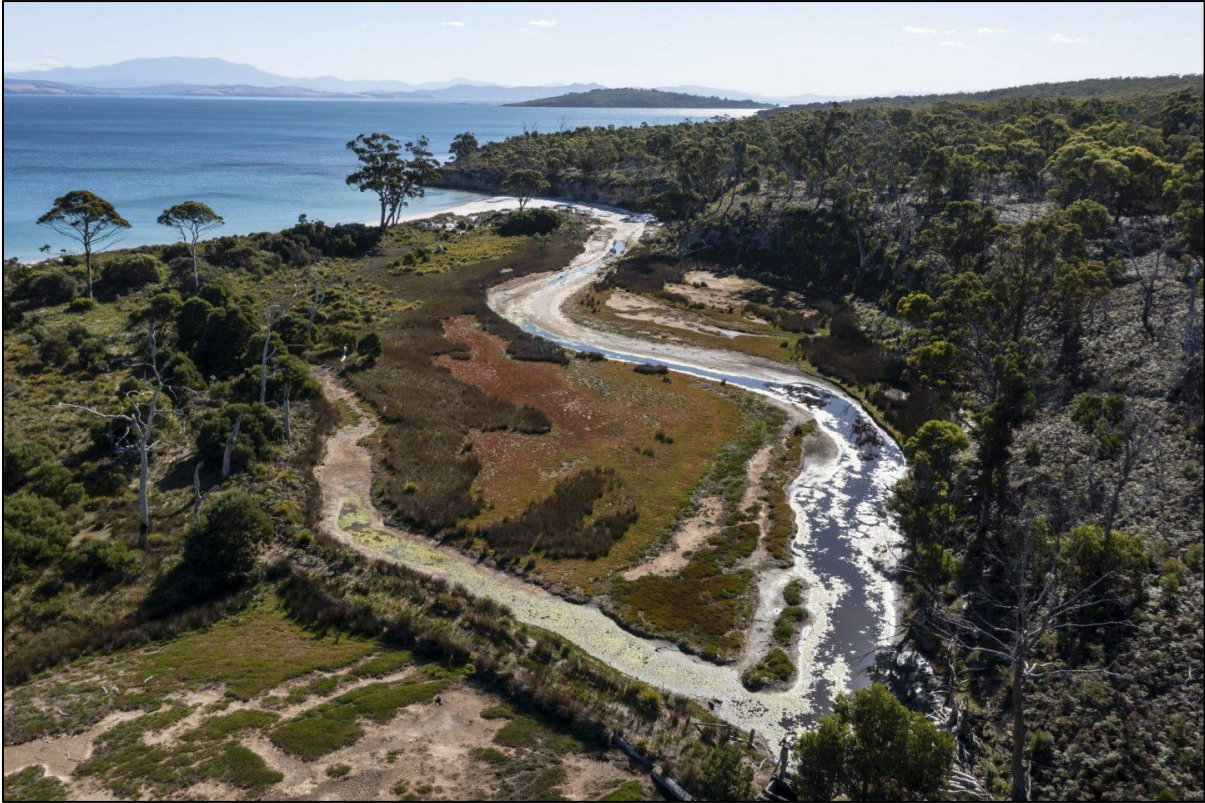
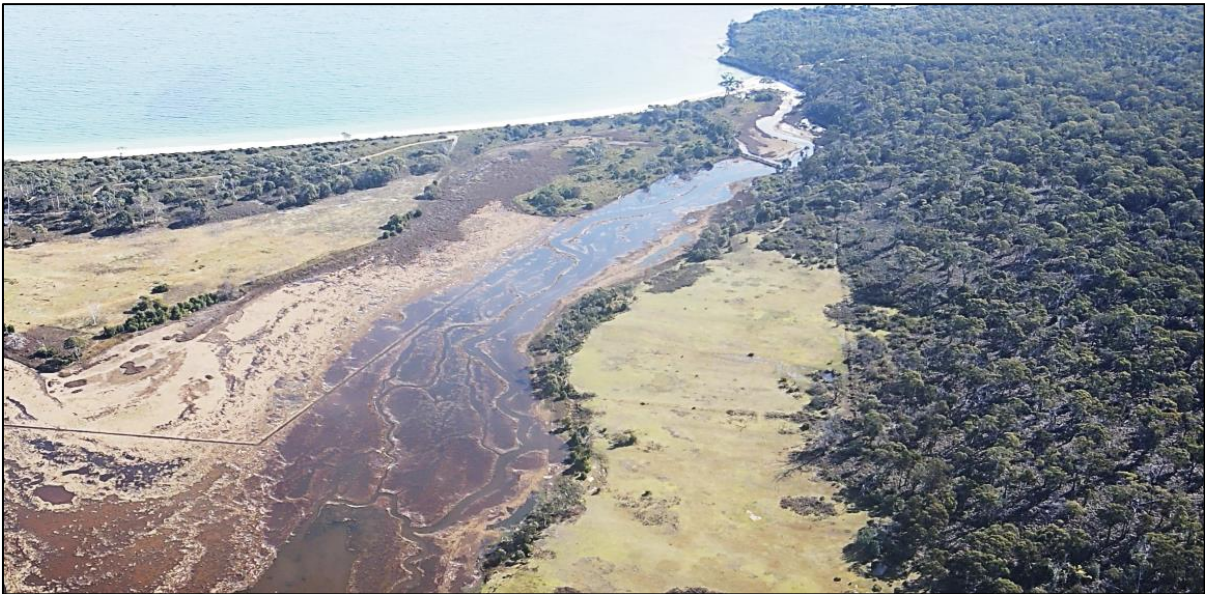
**Figure 35. The outlet to the sea at Burdens Marsh, showing the constriction caused by the levee and gate system.**

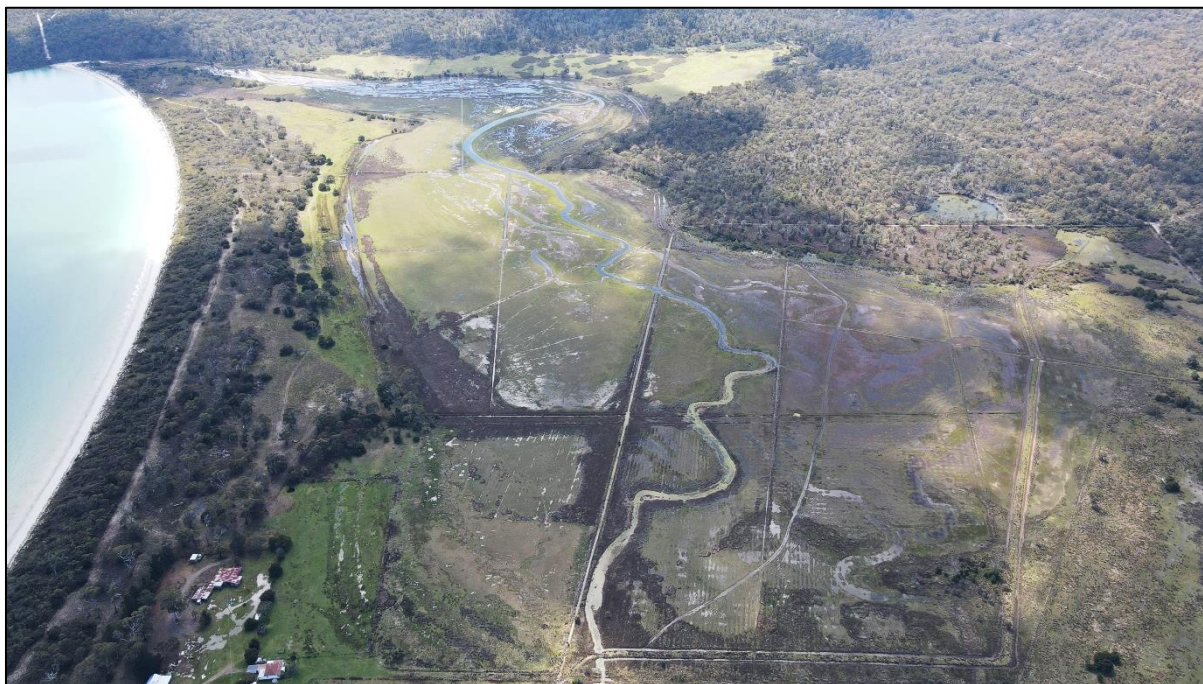
**Figure 36. The central portion of Burdens Marsh, impacted by drains, levees and causeway embankments, some of which date back to the early 1830s. Photo: Mark Bachmann**

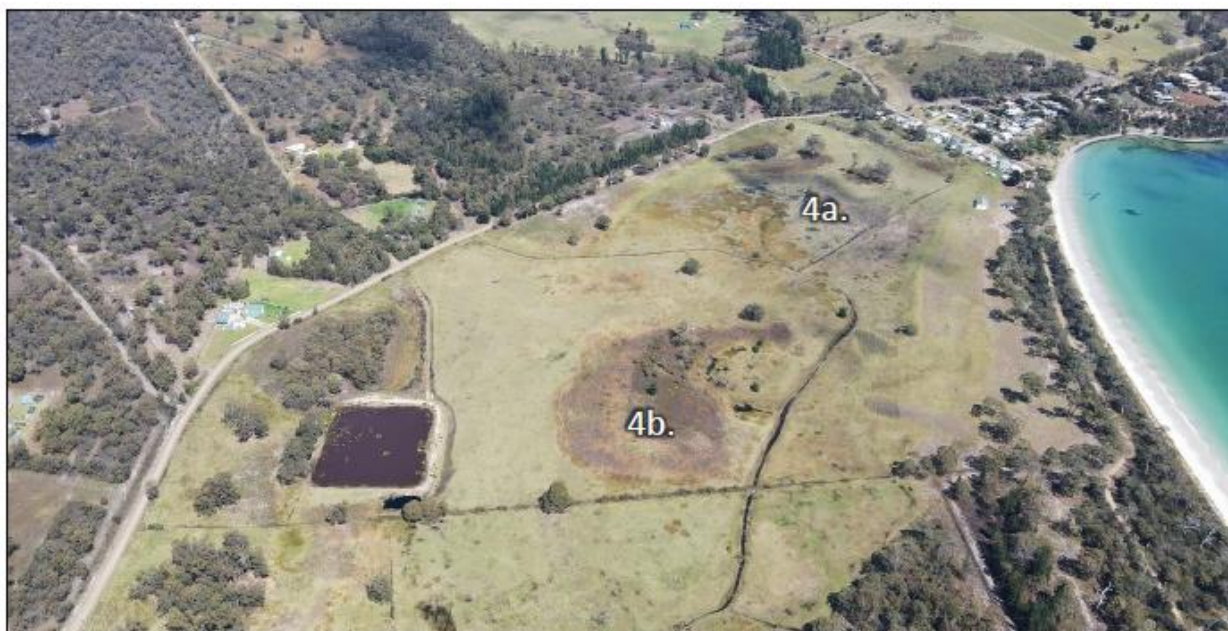
4. The artificial drainage of two fresher wetlands upstream (to the south of) Burdens Marsh saltmarsh. These are labelled 4a and 4b (Figure 38).

**Figure 38. The two artificially drained fresh wetlands situated south of the main saltmarsh area at Burdens Marsh (4a and 4b). Photo: Mark Bachmann**

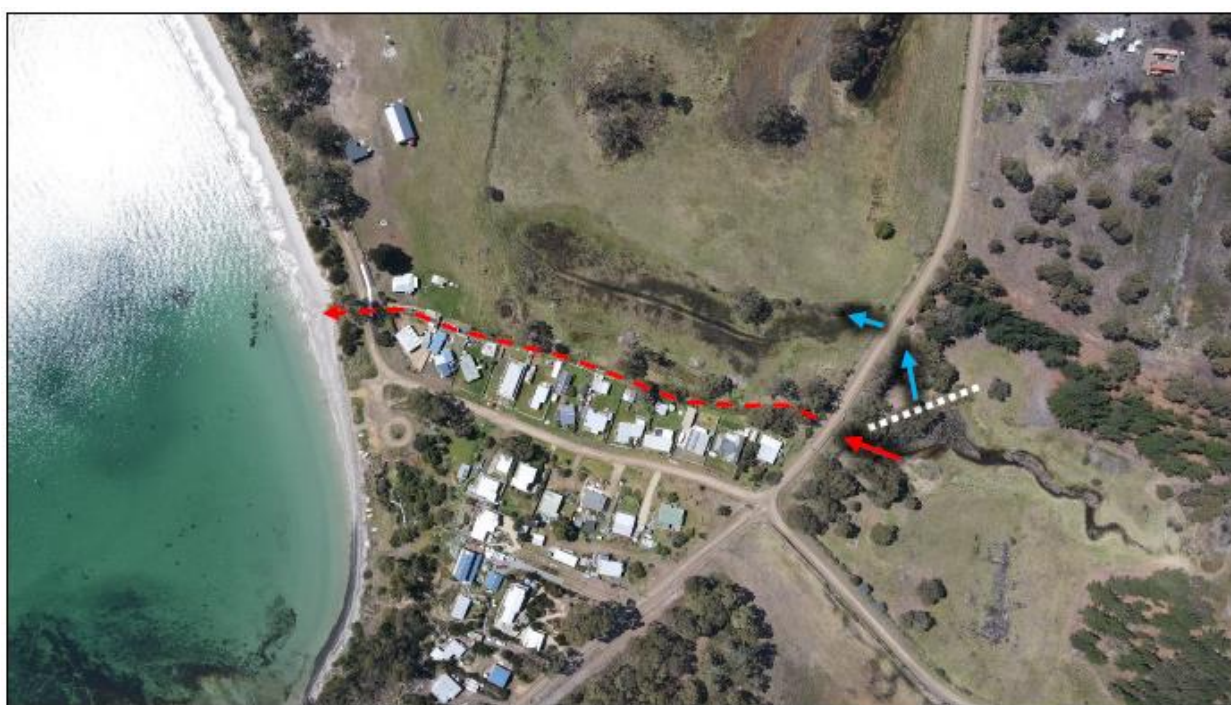
**Figure 39. The original flow direction of the southern catchment into Burdens Marsh (blue arrows), has been banked off (white dashed line), with this catchment now diverted (red arrow) via an artificial bypass drain to the sea (red dashed line). Photo: Mark Bachmann**

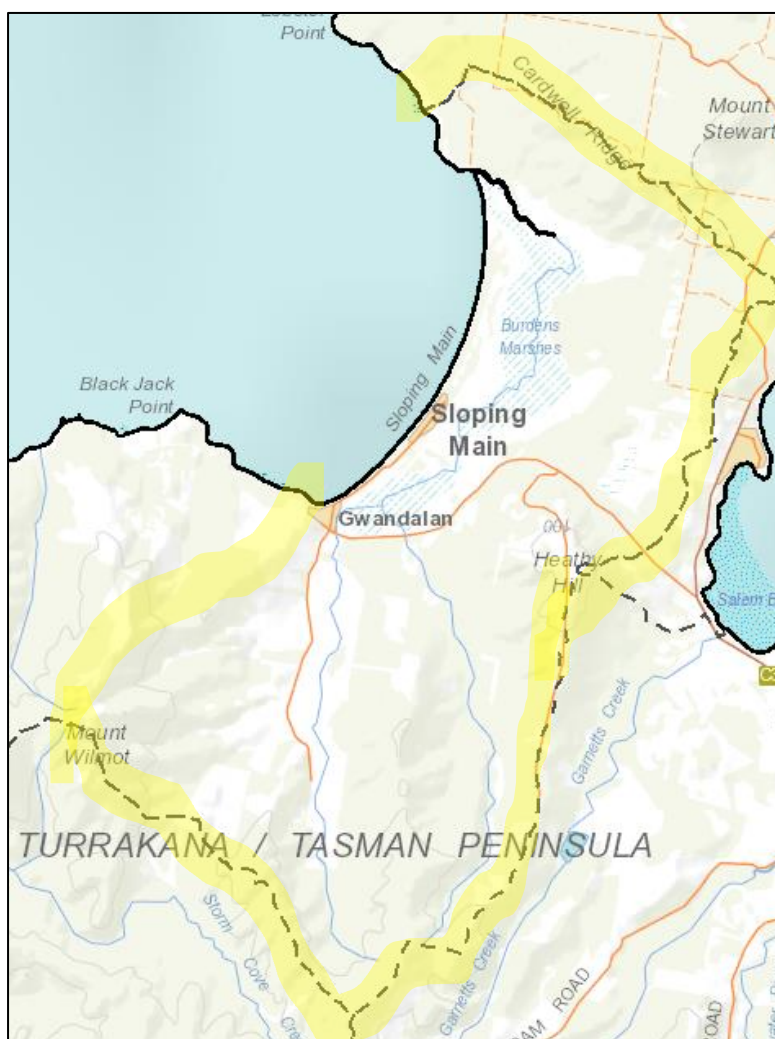
The Burdens Marsh catchment is approximately 20 km<sup>2</sup> in area (Figure 42). It captures flows south of the Cardwell Range, west of Coal Mine Hill and Saltwater River, north of Heathy Hill and east of Mount Wilmot. Minor inflows and runoff enter the mid and northern marsh from adjacent areas (including Turners Lagoon), whereas two delineated, though unnamed waterways, enter the marsh at the southern end. The most western of these is anecdotally purported to contribute the bulk (up to 90 %) of the inflow to the marsh complex. A number of both on and off stream small dams occur in the catchment, as do a number of small freshwater wetlands to the west of the marsh, together with the more significant Turners Lagoon.

Figure 42. Approximate boundary of Burdens Marsh catchment (yellow).

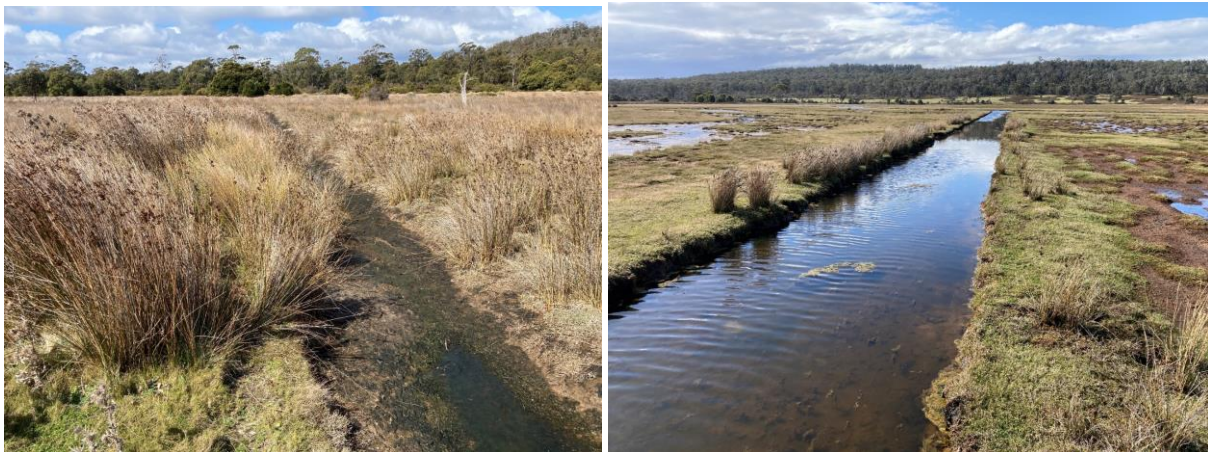
**Figure 45. Drain in Burdens Marsh with a backfill potential of 100% (left) and 10% (right).  
Photos: Ben Taylor, 21/9/23.**

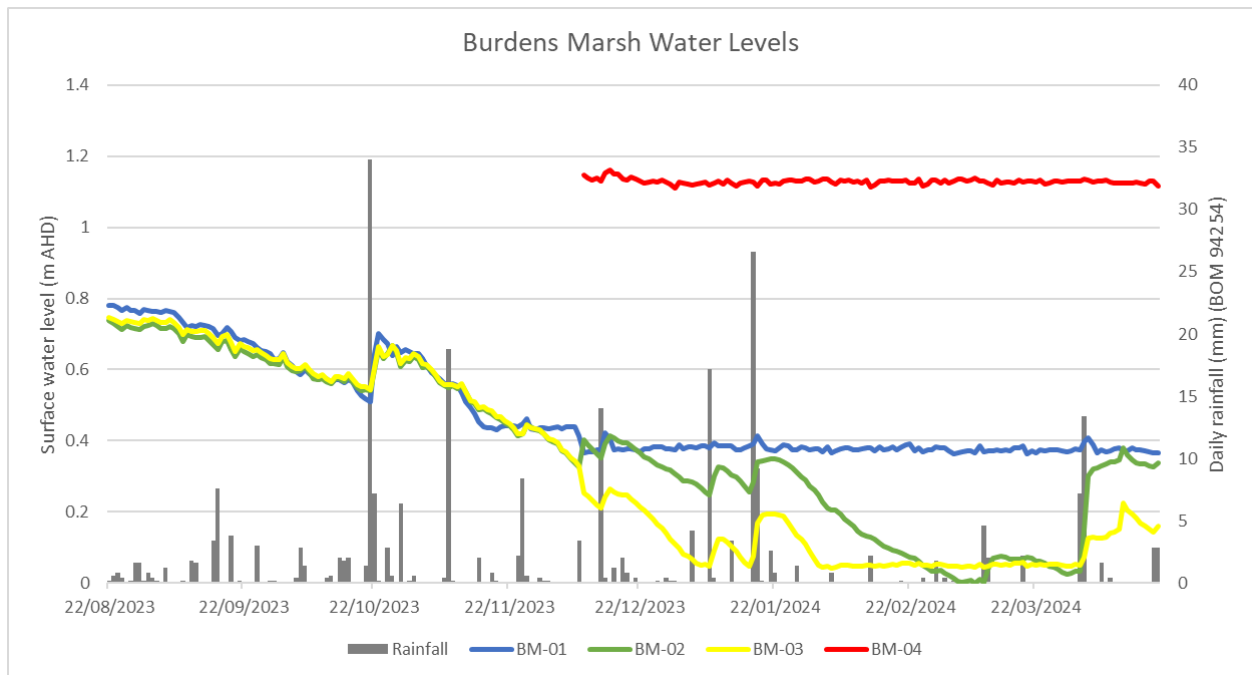
**Figure 49. Water level monitoring results from Burdens Marsh, August 2023 – April 2024.**

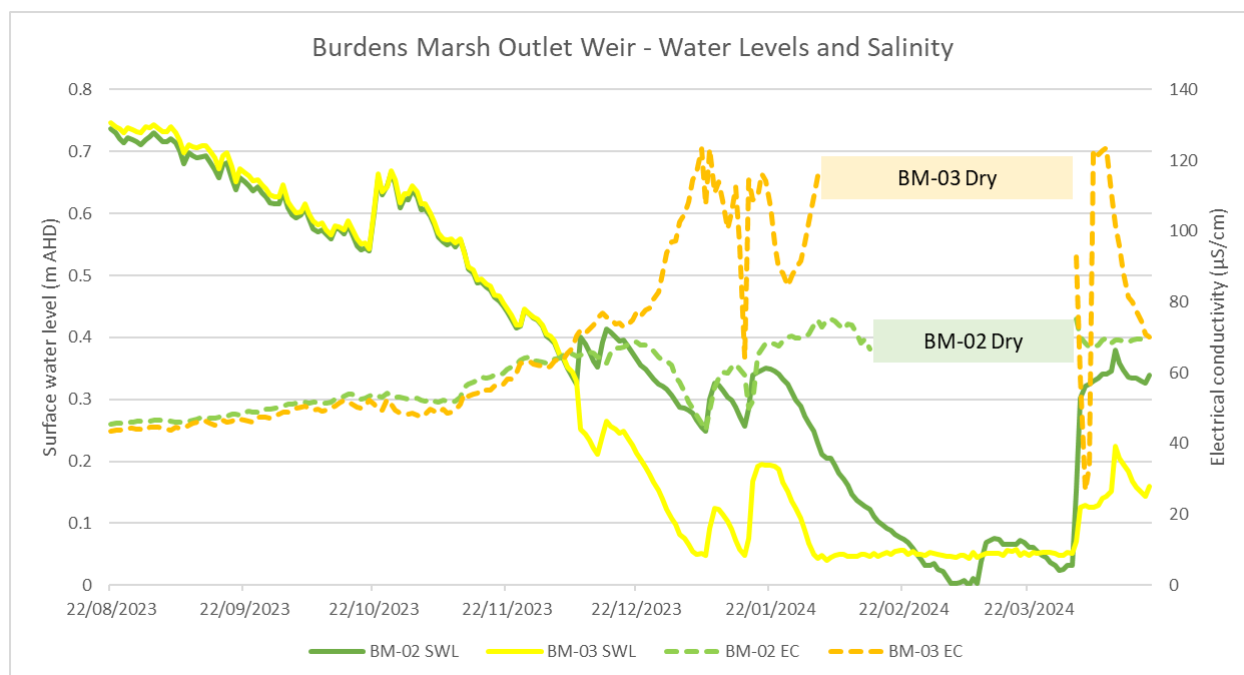
Figure 50. Salinity monitoring results from Burdens Marsh, August 2023 – April 2024.

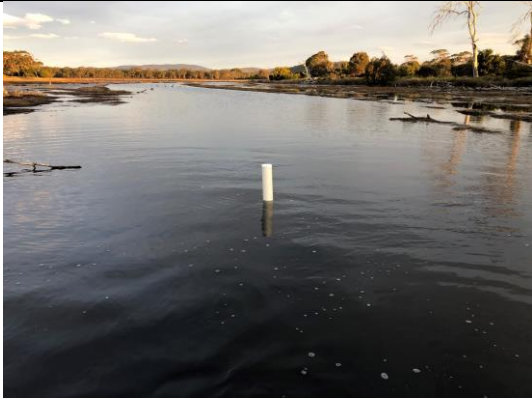
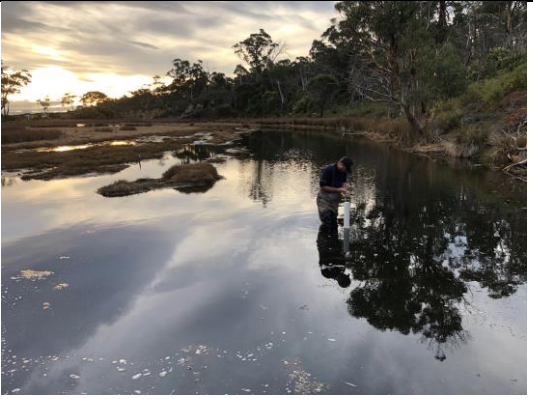
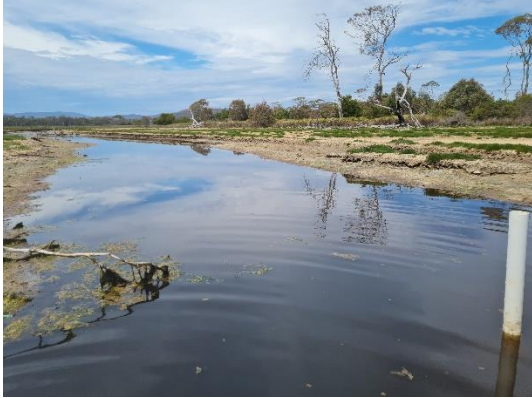
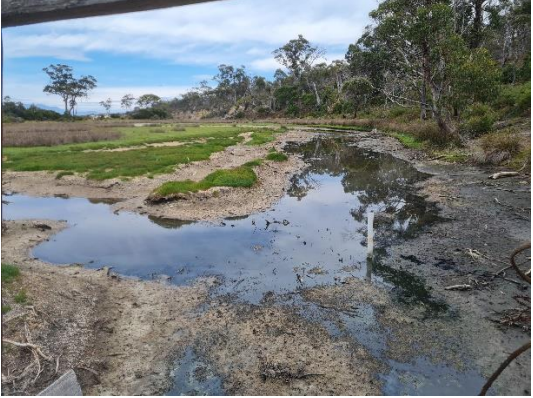
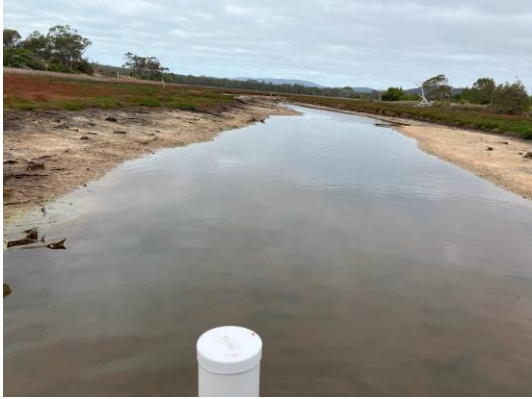
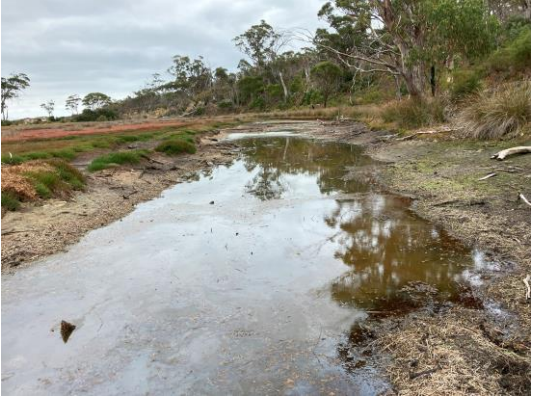
Date	Monitoring Site	
	Tidal outlet – Upstream (BM_03)	Downstream (BM_02)
Aug 2023

**Table 4. Overview of photo-point monitoring, Burdens Marsh, August 2023-April 2024.**

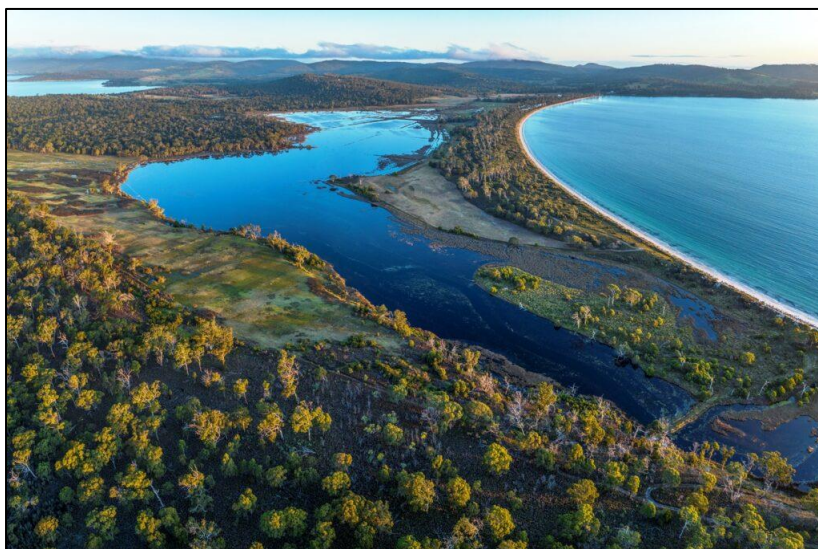
**Figure 51. The saltmarsh area of Burdens Marsh, full of water after heavy rainfall in October 2022. These are the conditions when the previous management regime would require an artificial mouth opening to drain the wetland. The artificial levee and weir location can be seen in the bottom right of this image. Photo: Rob Blakers.**

The prior management regime over decades of farming involved deliberate mouth openings when water levels were elevated in Burdens Marsh, as per Figure 51, and, once the saltmarsh was drained, restriction of subsequent tidal ingress (through the then-scoured outlet) via artificial closure of a timber weir (the most recent iteration of this system was installed c. 1990). Combined with the diversion of the catchment area to the south of the saltmarsh away from Burdens Marsh (since the 1960s), this management regime maintained the saltmarsh area in an artificially dehydrated state for more prolonged periods that would ordinarily occur under natural conditions.

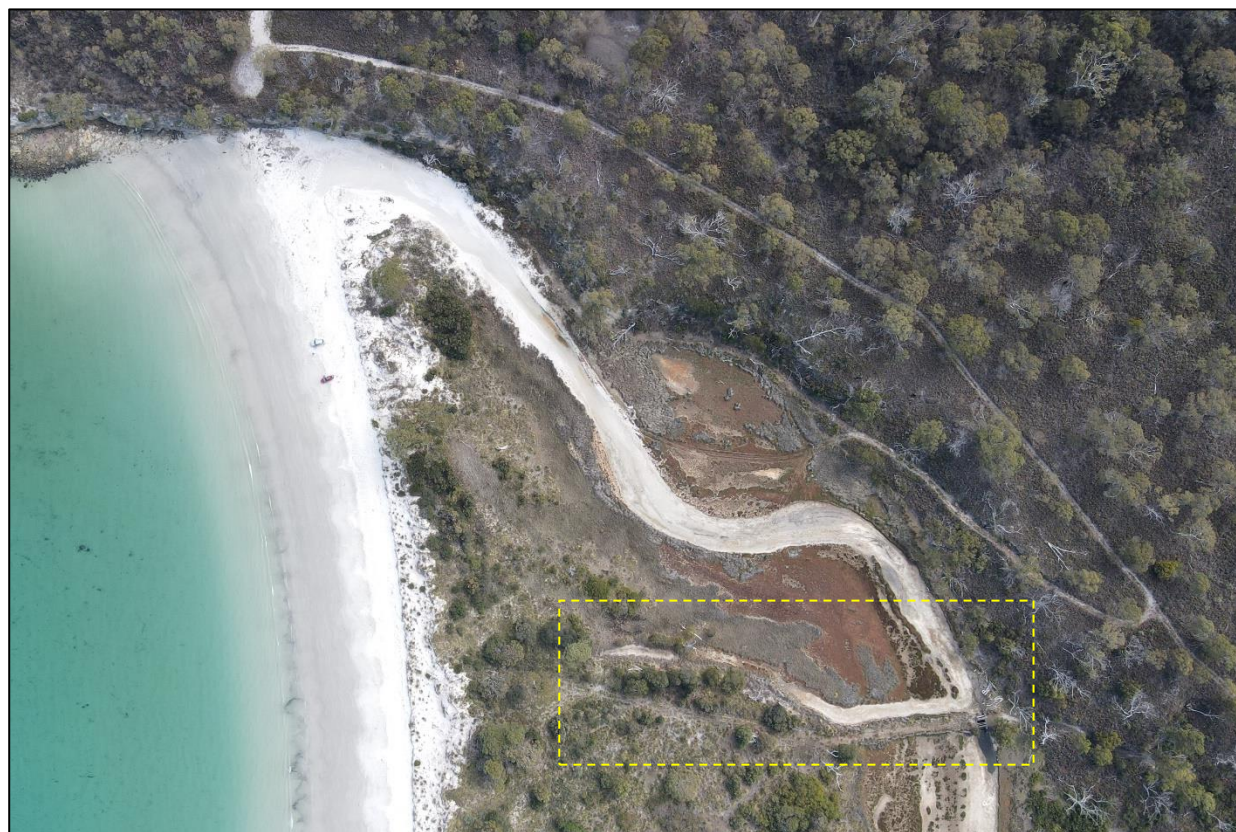
The general condition of the outlet from Burdens Marsh to the sea at the time of writing, is shown in Figure 54.

**Figure 54. The ocean outlet from Burdens Marsh in autumn 2024, with the focal area for remedial works indicated. Photo: Mark Bachmann.**

Remediation of the landform at this location would involve removal of the tidal weir structure and associated levee (which risks constricting natural fresh outflows to the sea, and interrupts tidal exchange after natural mouth openings), to enable recreation of natural outlet geomorphology.

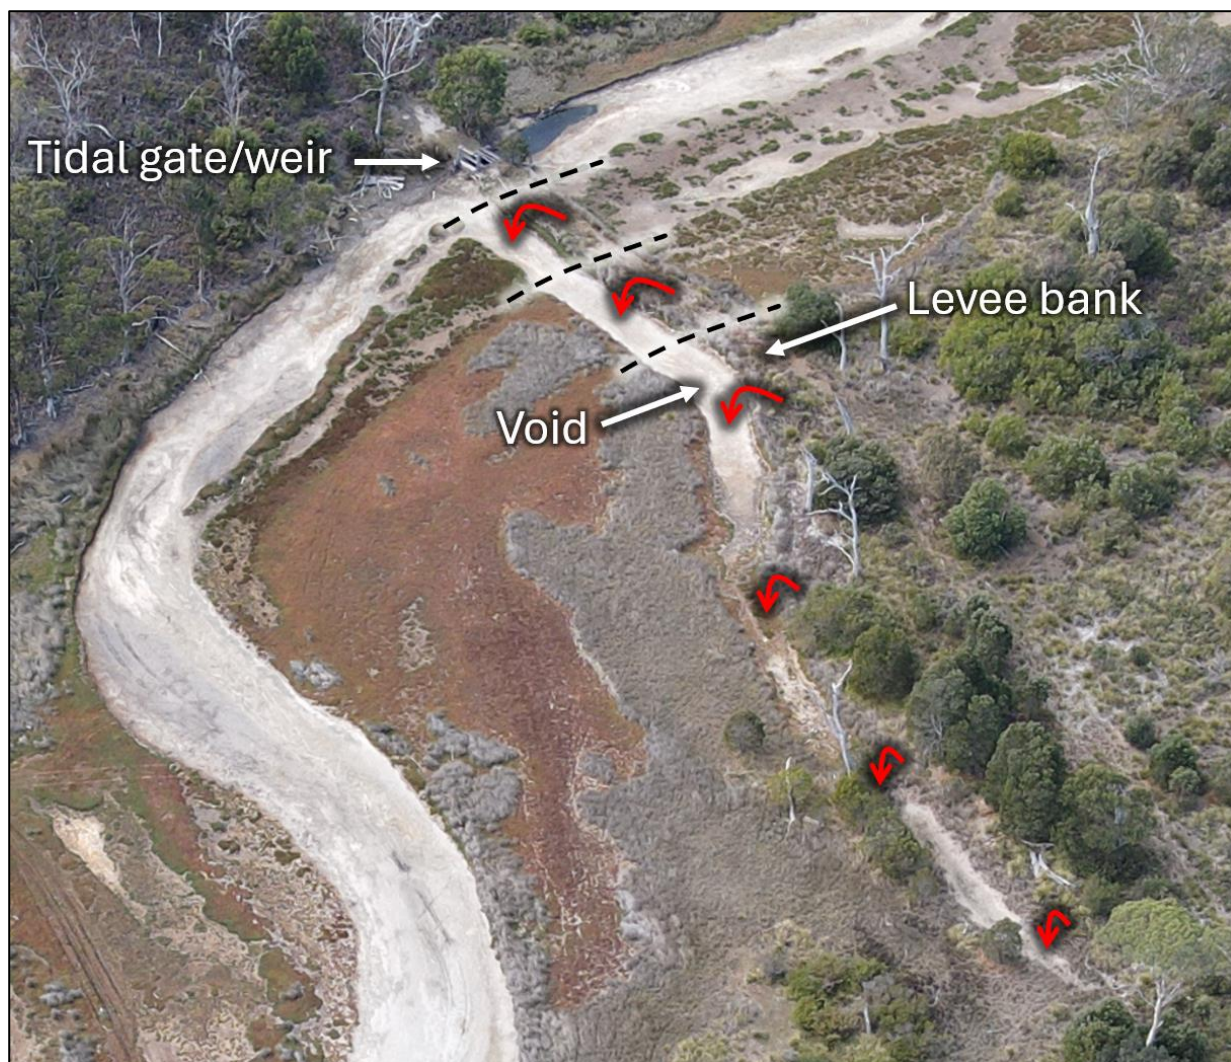
**Figure 55. The remedial earthworks required at the ocean outlet from Burdens Marsh. See text for explanation of notations. Photo: Mark Bachmann.**

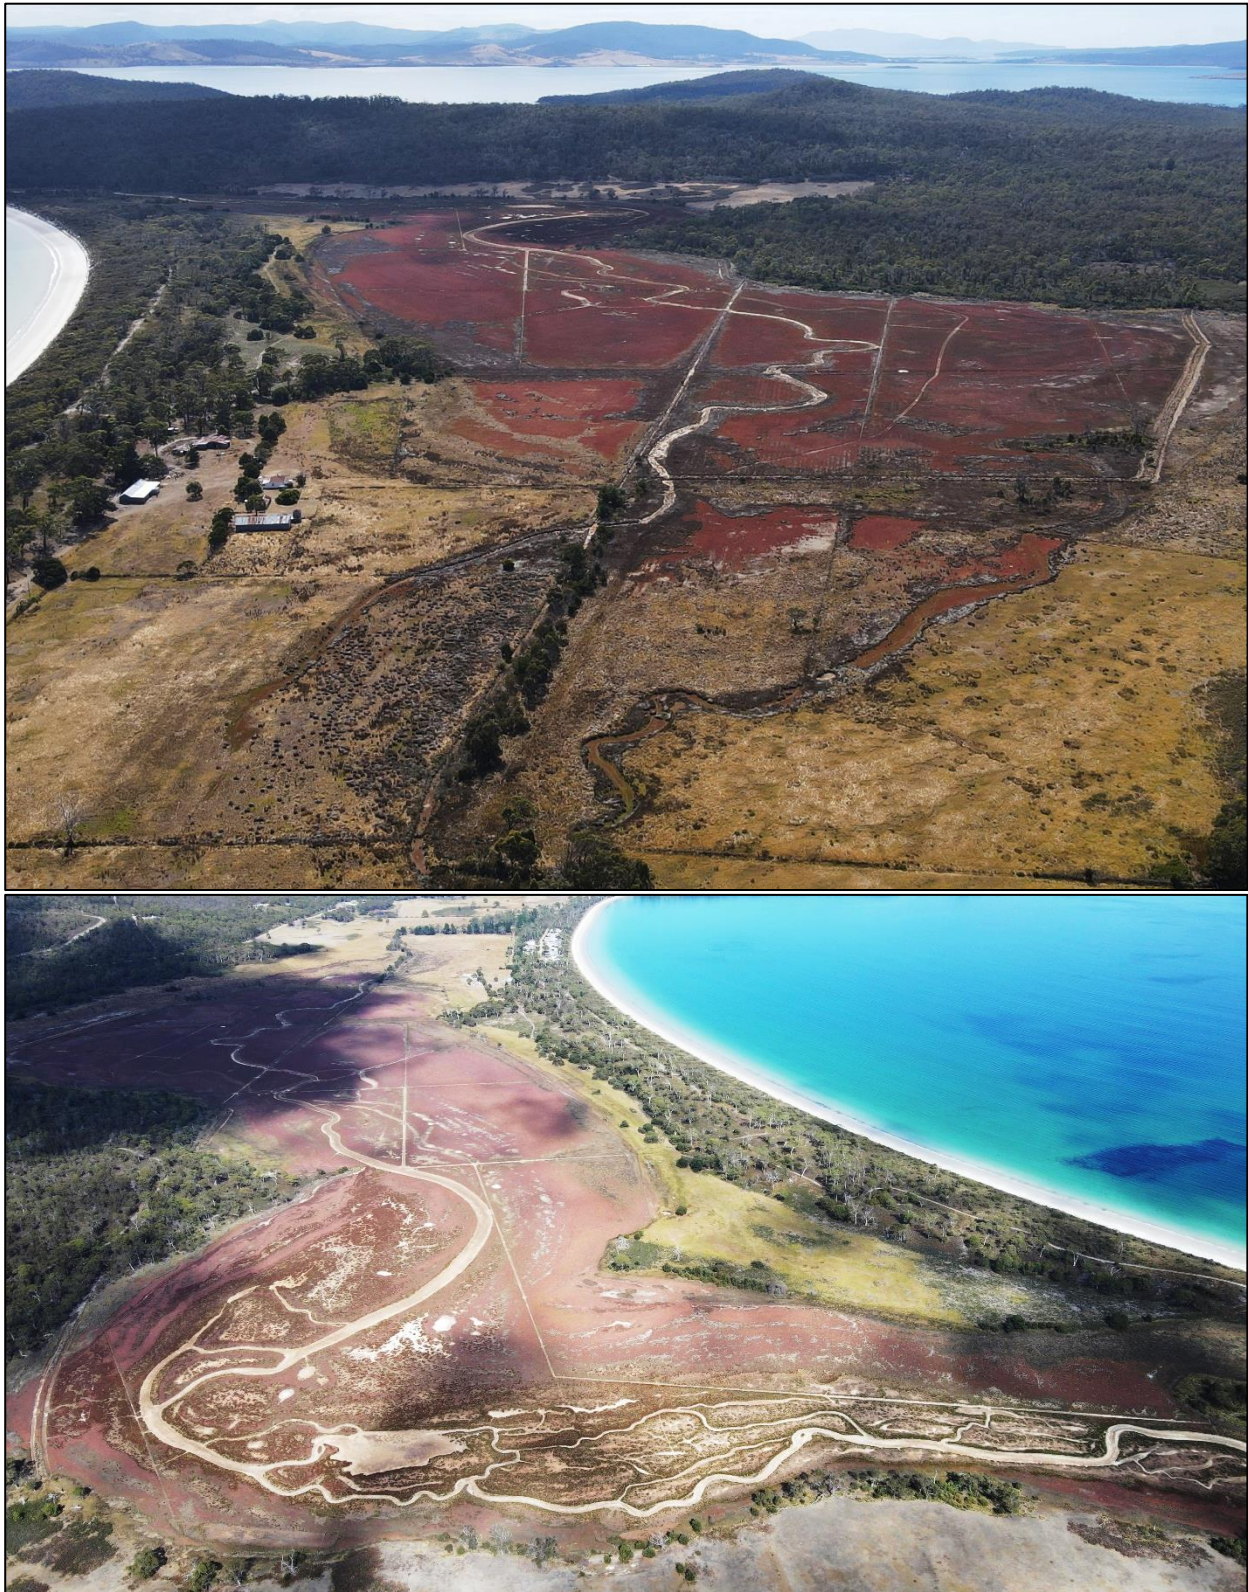
**Figure 56. Looking over the main saltmarsh area from the south to north (above) and north to south (below). The artificial works are in straight lines, while the meandering flow lines are natural. Photos: Mark Bachmann.**

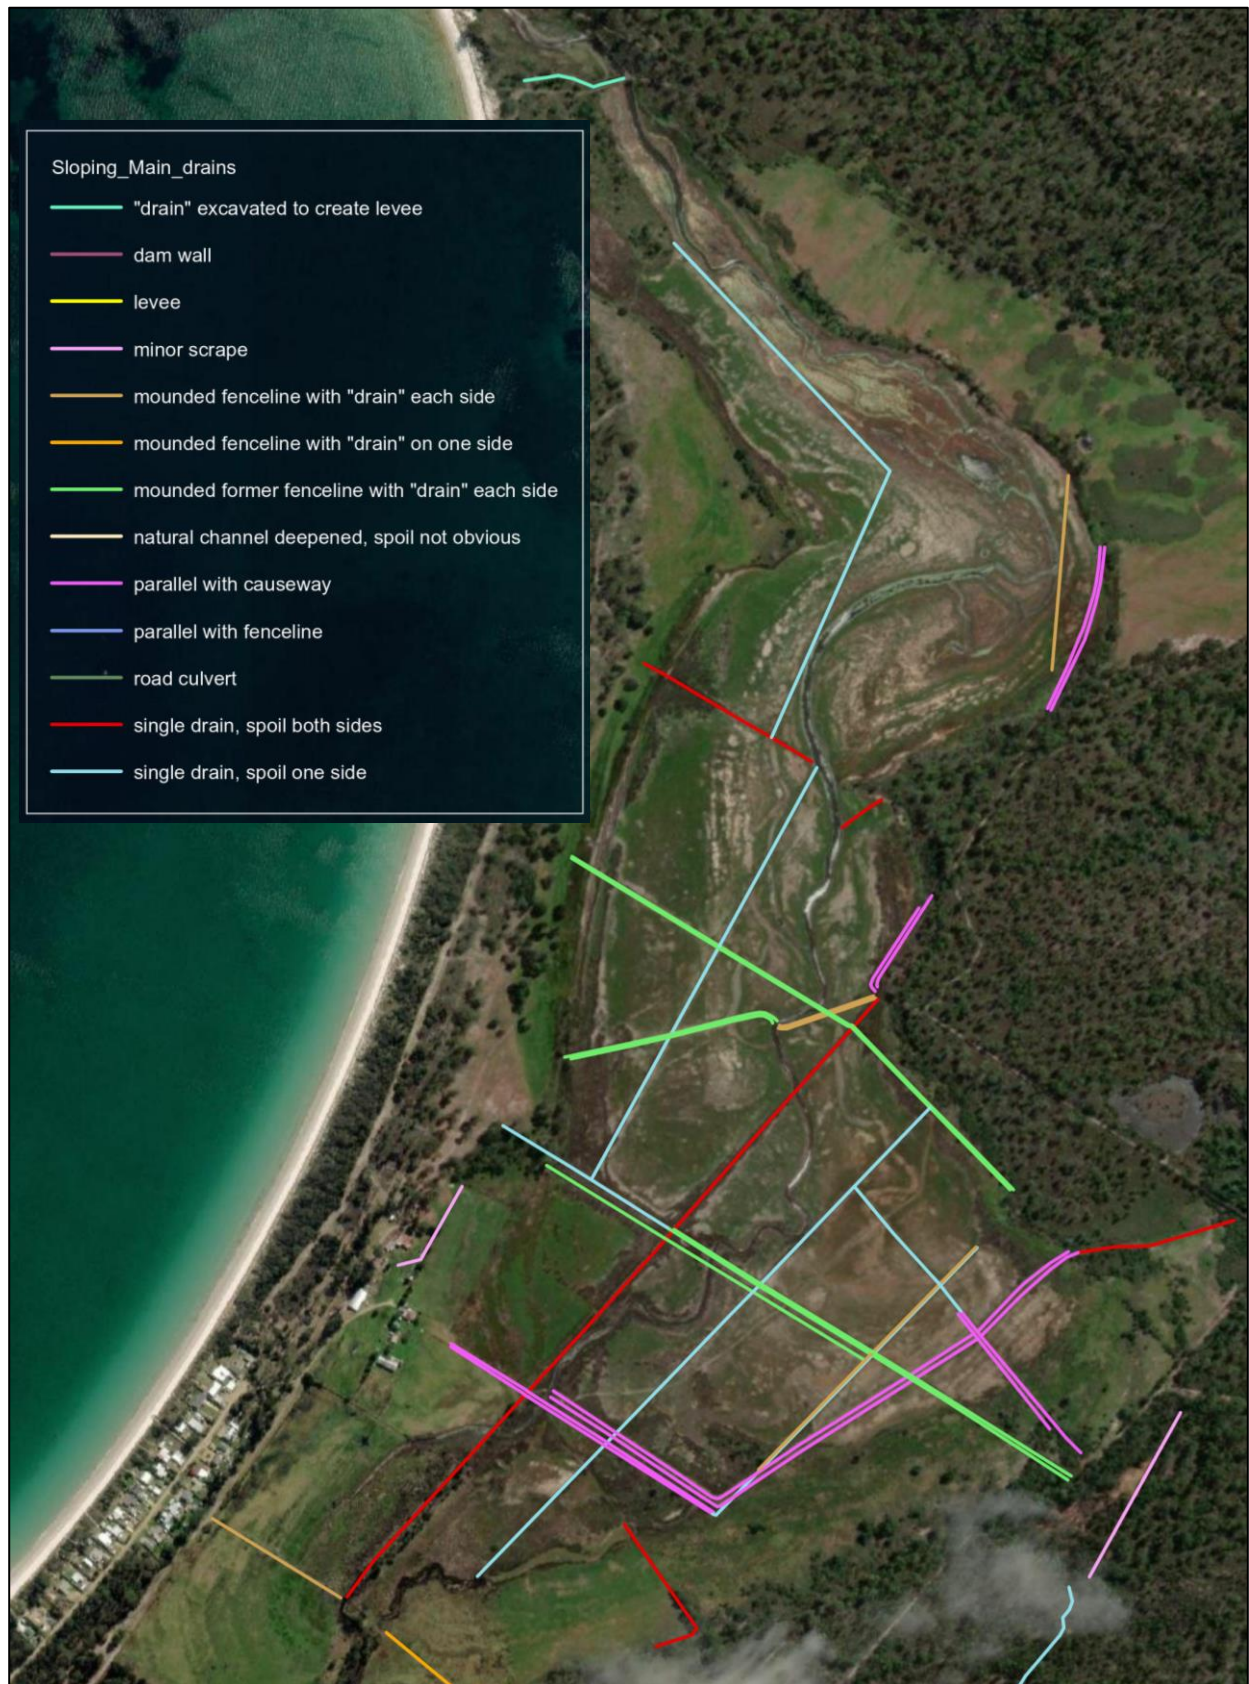
Figure 57. An overview of drain and embankment types across the saltmarsh area, earmarked for remediation.

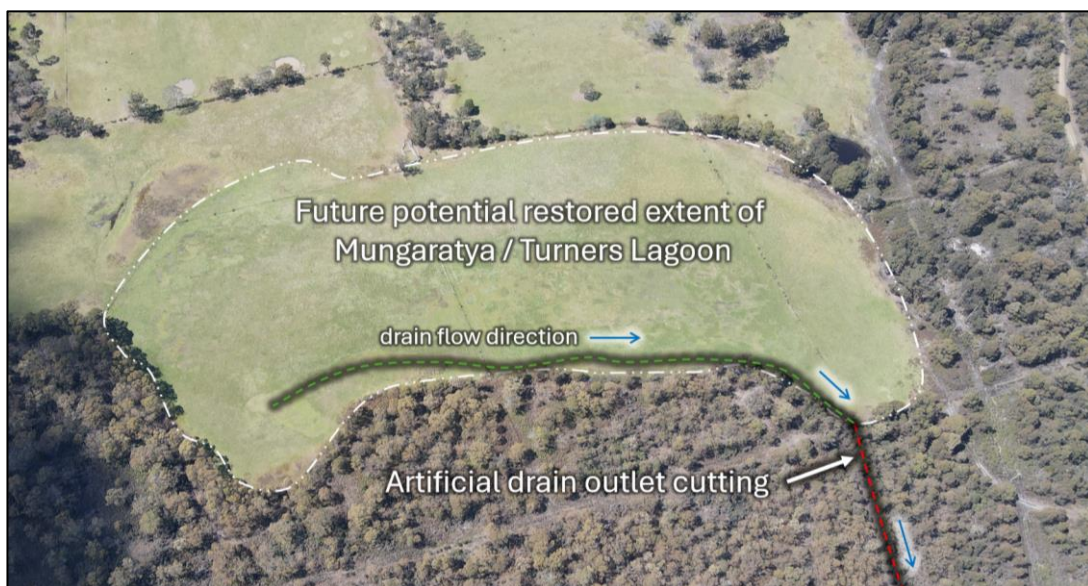
Figure 61. Future potential restored extent of Mungaratya / Turners Lagoon, and location of outlet drain (red) requiring remediation. Photo: Mark Bachmann
