Platypus habitat suitability survey of the River Torrens

Sylvia Zukowski and Nick Whiterod

A letter of report to Green Adelaide

November 2022

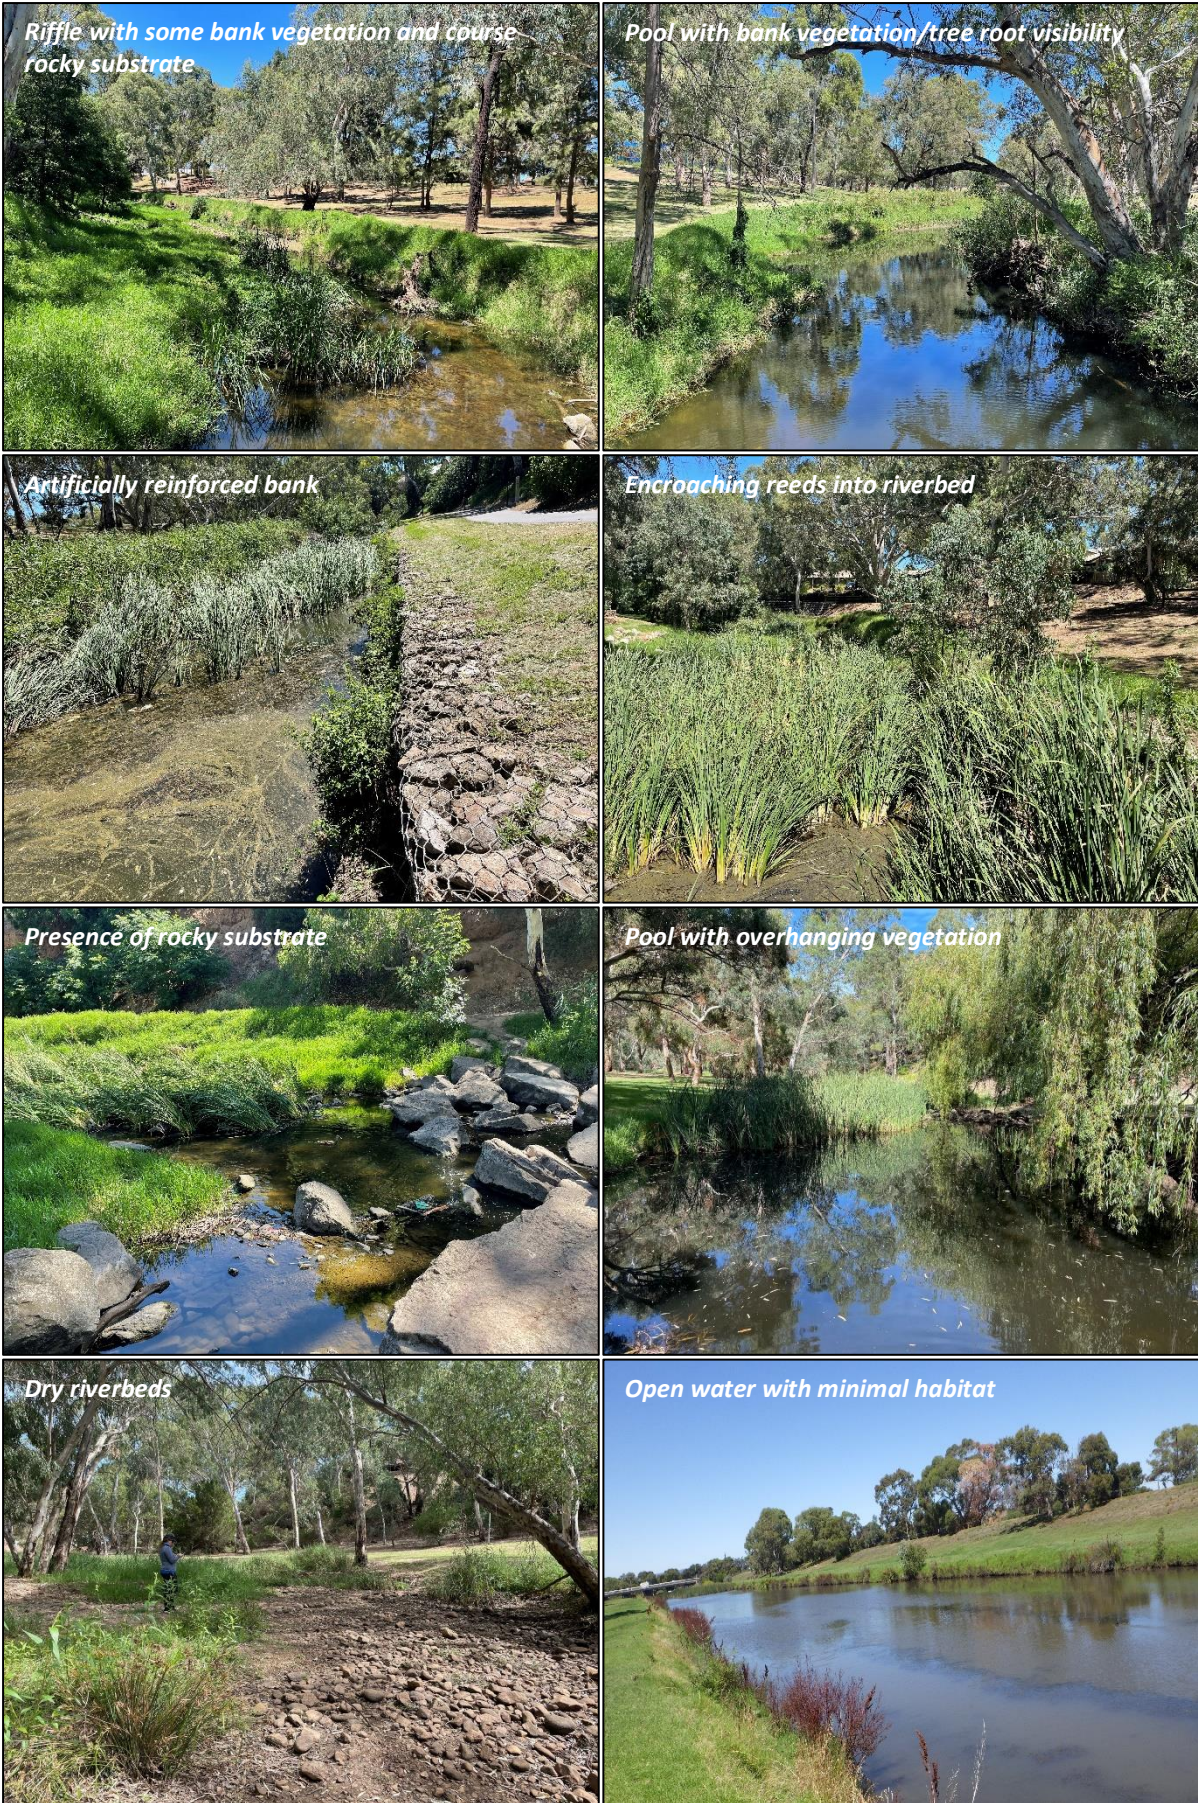
Figure 2. Selection of some differing habitats at sites sampled along River Torrens platypus habitat survey 2022.

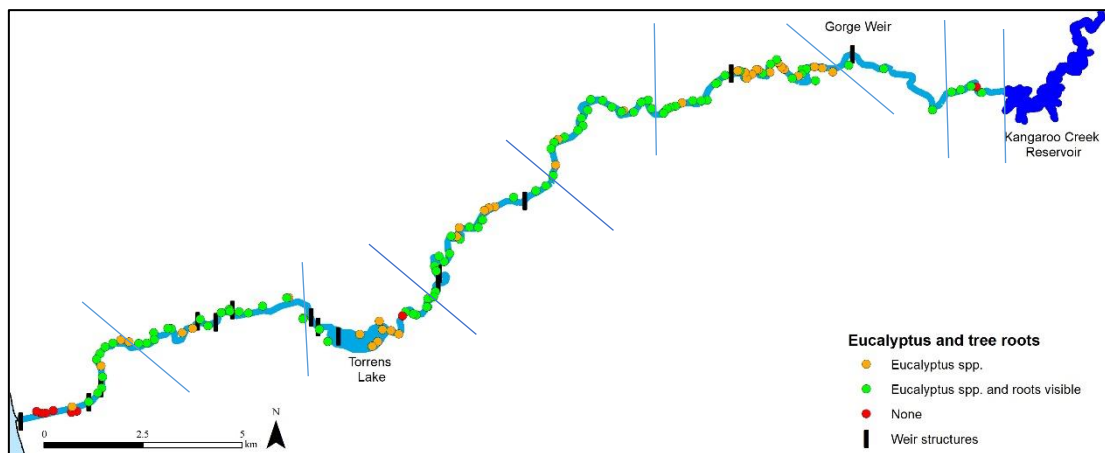
Both *Eucalyptus* trees and visible bank tree roots were recorded throughout most of the surveyed area but were lowest in the downstream part of section 1 (Figure 6). Less tree roots were noted in section 3 and 6 compared to sections 2, 4, 5, 7 and 8.

Figure 6. Eucalyptus trees and bank tree roots recorded on the banks of the River Torrens from the outlet to the Kangaroo Creek Reservoir.

Bank vegetation habitat preferences for platypus include consolidated earth banks, bank tree roots (to consolidate the banks and protect burrows from collapsing), large trees in the riparian zone, and overhanging vegetation in the river channel (provide instream organic material and macroinvertebrate food) ([Bryant 1993](#); [Ellem et al. 1998](#); [Serena et al. 2001](#)). During the current habitat survey, Eucalyptus trees and tree roots were visible throughout most of the sampling area, except for sections 1, 3 and 6 which did not have a high quantity of these.

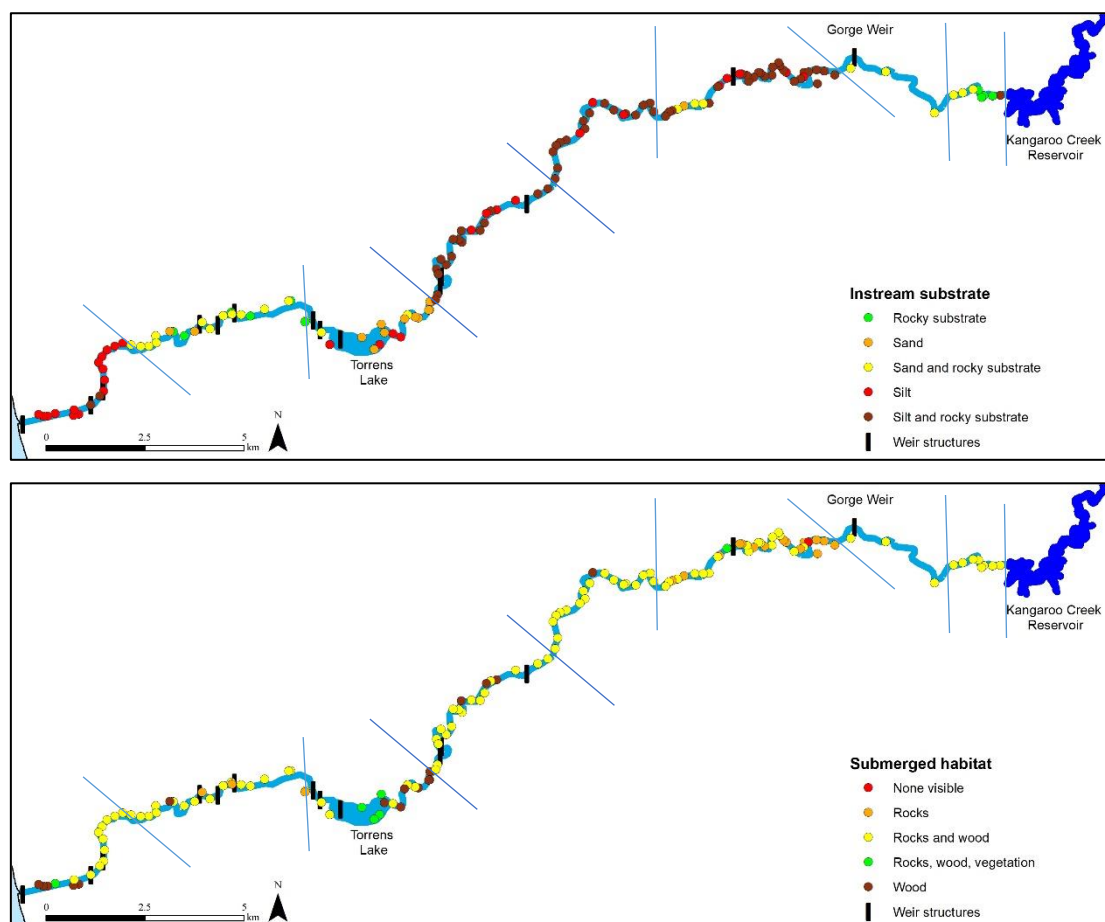
A combination of instream substrate was recorded throughout the surveyed area including rocky substrate (rock, cobble, boulder), sand and silt (Figure 7). Silt was predominantly recorded in section 1 of the surveyed area. In section 2, the instream substrate was mainly composed of sand and rocky substrate. Section 3 had mainly sand and silt present. Sections 4–6 mainly had a combination of silt and rocky substrate. Section 7 was predominantly sand and rocky substrate and section 8 was predominantly rocky substrate.

Submerged habitat recorded included rocks (small and large rocks), submerged aquatic vegetation and wood (sticks and logs) (Figure 7). Submerged habitat predominantly included rocks and wood throughout the survey area. A small number of sites had submerged aquatic vegetation visible, namely in section 3 and one site in sections 1 and 6. Site 6 closer to Gorge Weir had a higher density and number of small rocks present than wood compared to other sites.

Figure 7. Instream substrate and submerged habitat recorded on the banks of the River Torrens from the outlet to the Kangaroo Creek Reservoir.

Platypuses prefer a complex instream bed substrate with a rocky substrate that includes a variety of gravel, small rocks, cobbles, and larger rocks and boulders ([Grant 2004](#); [Rohweder and Baverstock 1999](#); [Serena et al. 2001](#)). Sections 1 and 3 had predominantly silt as the substrate with a lack of complexity favoured by platypus. Indeed a negative correlation was demonstrated between the presence of a silt substrate and platypus presence in previous research ([Serena et al. 2001](#)). A more complex instream bed substrate which included rocks, cobbles, wood was observed mainly in sections 2, 4, 5, 6 and 7. Submerged habitat preferences by platypus include woody debris, in-stream organic matter, and rocks ([Grant 2004](#); [Serena et al. 2001](#)). Instream submerged aquatic vegetation was scarcely visible throughout the survey, however, was noted in sections 1, 3 and 5. In section 6, rocks were predominantly visible, and there was not much wooden structure. Sections 2, 4 and 5 had the

highest amounts of rock and wood present in them and could be described as better suited as platypus habitat in terms of submerged habitat.

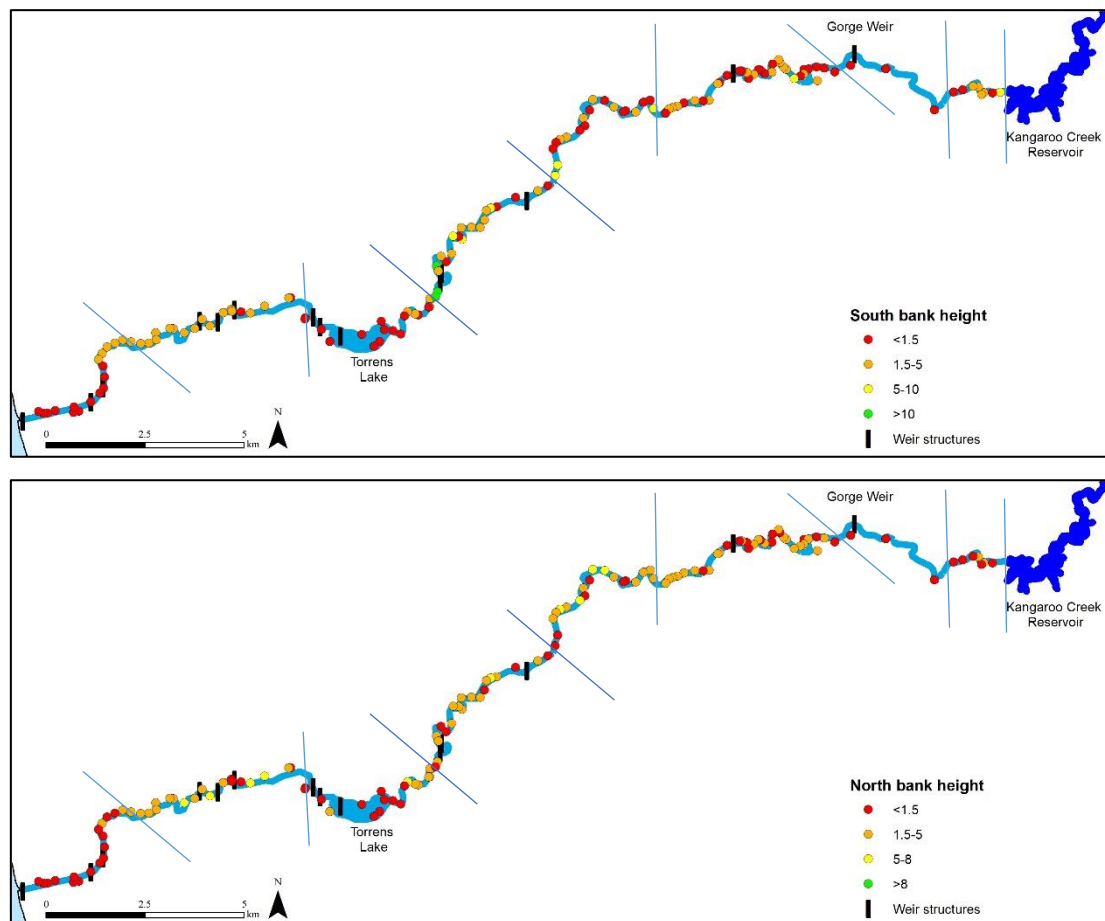
Bank height varied between 0.2 m to 20 m on the south bank and 0.5 to 30 m on the north bank (Figure 8). Bank height in sections 1 and 3 was generally low, and highest bank heights were noted in section 4. Predator accessibility was rated on the amount of vegetation and ease of access for predators (dogs, cats, foxes) with low being not permeable i.e., high bank vegetation, moderate being accessible with effort and high was easily accessible i.e., lawned. Although predator accessibility did vary between the north and south banks in some areas, predominantly, sections 1 and 3 had the greatest amount of high predator accessibility, whilst sections 2 and 6 had more sites with low predator accessibility (Figure 9). Sections 4 and 5 generally had moderate accessibility. Section 8 had a combination of low, moderate and high predator accessibility.

Figure 8. Bank height recorded on the south and north banks of the River Torrens from the outlet to the Kangaroo Creek Reservoir.

Banks can play a large role in platypus habitat selection, with a general preference by platypus for banks that are consolidated with vegetation and greater than 0.95 m in height ([Brunt et al. 2018](#)). Platypus resting burrows can be constructed up to a length of 3 m, and the entrances are generally built above the water line ([Bino et al. 2019](#)). Bank height was low in sections 1 and 3 but did range in height throughout the rest of the surveyed area with most sections having banks 0.5 to 5 m in height.

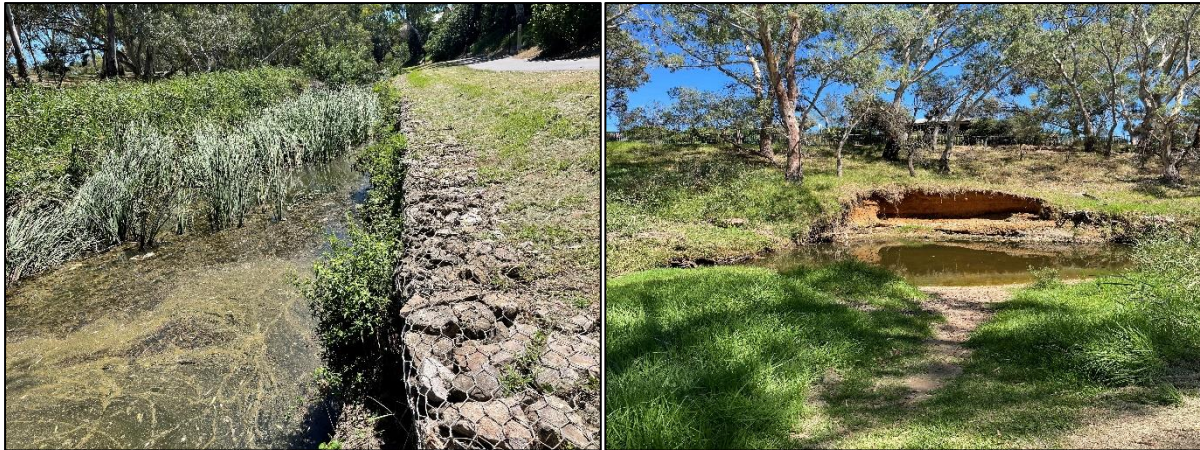
Figure 12. Bank condition in section 4.

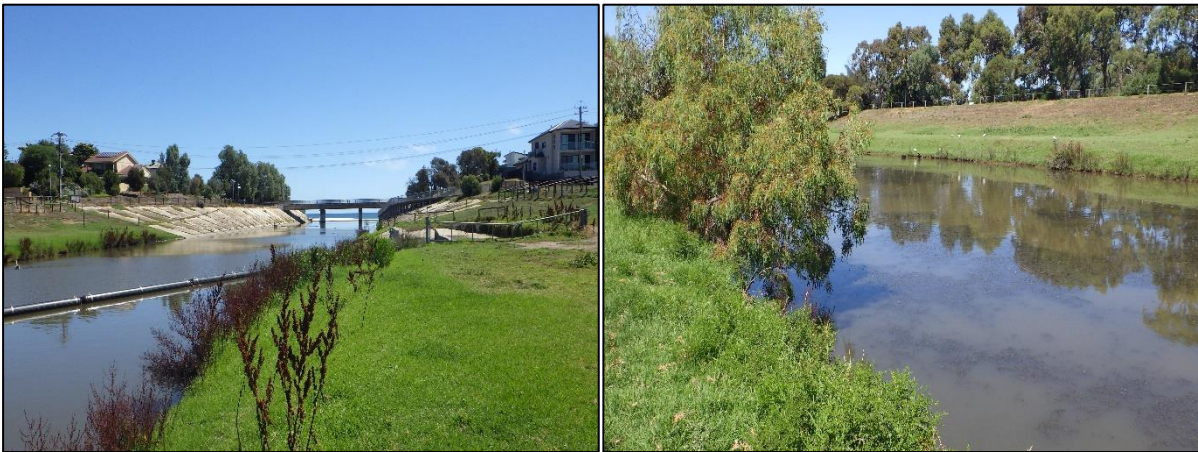
In terms of overall habitat suitability as sampled in this survey, it is evident that, under current managed flow regimes, some sections of the River Torrens appear less suitable for the species. Some of the surveyed sections of the River Torrens do seem to provide more appropriate conditions than others. For example, **section 1** does not have the appropriate instream habitat,

consisting mainly of silt, has a lack of favoured vegetation including *Eucalyptus* trees and tree bank root systems, general high predator accessibility, and a lack of riffle areas, thus would not be deemed as a preferred habitat for platypus in its current condition. It is also anticipated that the section will experience extended periods of cease to flow, potentially further reducing its suitability for platypus. Section 1 does provide an expansive body of water and adds to the overall available habitat in the region. This section is undergoing change in terms of the Breakout Creek redevelopment with the habitat targeted in this restoration project focused on conserving other key species but not focused on trees along the watercourse.

Figure 13. Representation of habitat in section 1.

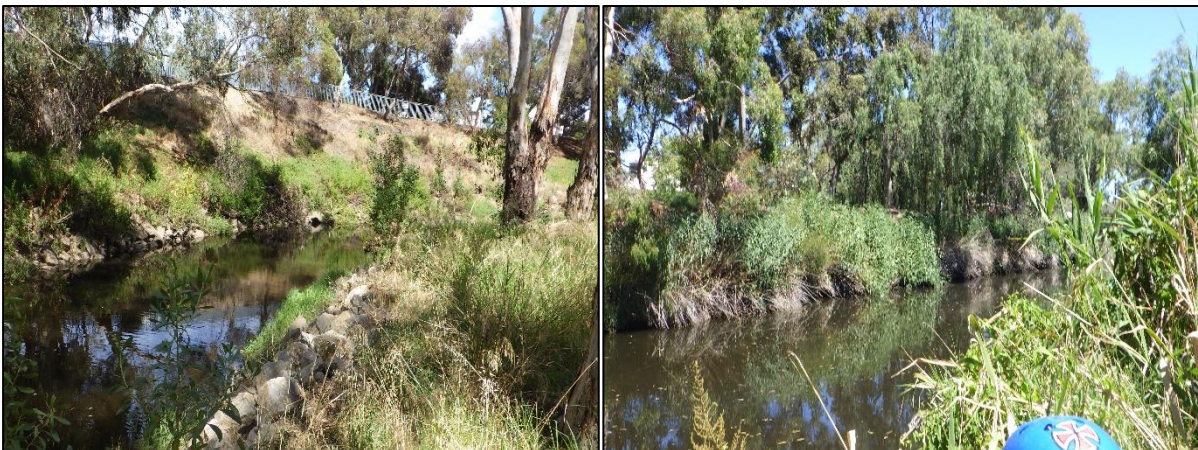
Section 2 of the River Torrens has a combination of possibly suitable habitat for platypus including *Eucalyptus* trees, bank tree root systems, sand and rocky substrate, presence of rocks and wood, higher bank heights, low to moderate predator accessibility, water depth of 1–2 m, with mainly pools but some riffle habitat and generally acceptable water quality levels, apart from hypoxic conditions recorded at two sites within this section. However, the hydrologic assessment of Bond (2022) revealed a high degree of cease to flow periods in this section that may make it less suitable for the species.

Figure 14. Representation of habitat in section 2.

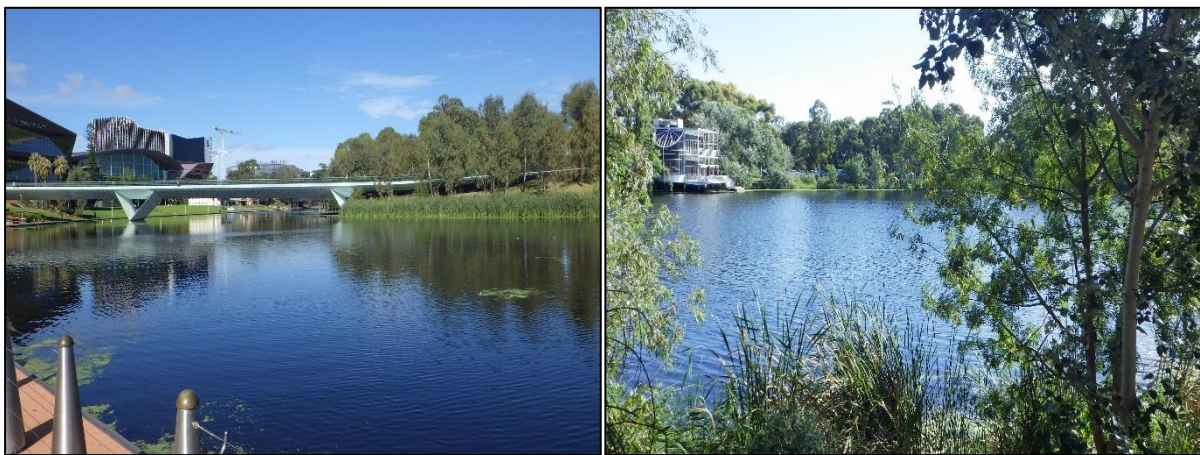
Section 3 is dominated by the large, deep open body of water in the Torrens Lake, high predator accessibility, instream substrate of silt and low bank heights, habitat characteristics which are generally not favoured for platypus. This section does however have good water quality present and a mixture of wood, rock and vegetation in some areas. The Torrens Lakes experiences cyanobacteria blooms, which may make it less suitable for the species. Algal blooms can result in decreased dissolved oxygen levels leading to the decline of aquatic invertebrate biodiversity and abundance ([Serena and Pettigrove 2005](#)). Increased algal growth can also decrease platypus foraging efficiency by physically impeding food detection and capture ([Serena and Pettigrove 2005](#)).

Figure 15. Representation of habitat in section 3.

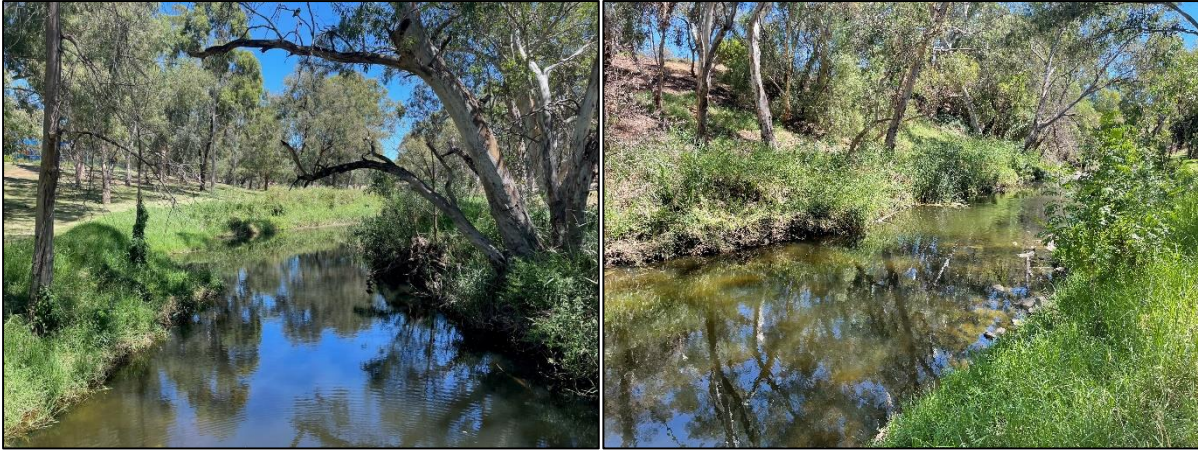
The habitat in **Section 4** consists of various habitat features favoured by platypus including the presence of rocky substrate, bank heights between 1-2 m, low to medium predator access, presence of bank vegetation, trees and bank tree roots. However, the presence of silt throughout some of this section and areas with reinforced banks are also evident. This section does experience cease to flow periods, which are generally short (e.g., average period is 3 days), although cumulative more than 90 cease to flow days were experienced in 2018 (Bond 2022). Whilst the prevailing flow regime may be suitable, further insight into the impacts of short time cease to flow periods is recommended.

Figure 16. Representation of habitat in section 4.

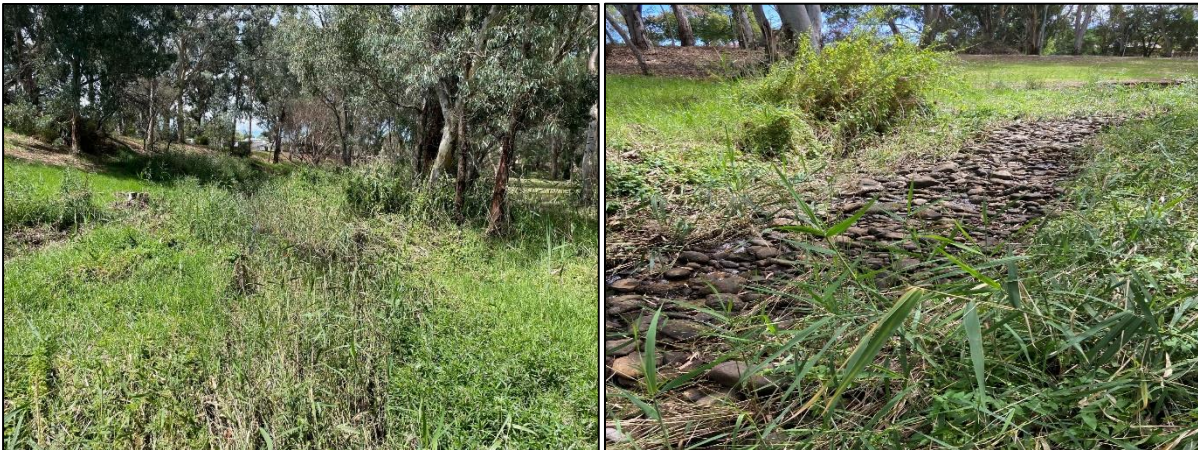
Habitat in **section 5** consisted of areas that may not be suitable habitat for platypus including dense typha and phragmites which encroached into the river channel and may reduce the amount of available foraging habitat for platypus. This section also has numerous dry areas which may increase the predation risk for platypus that tried to traverse the area during low/no flow periods. Information about flows for this section is also limited, however it may be like section 4 where the Second Creek monitoring gauge is located. Further investigations into flow conditions are recommended for this section of the river.

Figure 17. Representation of habitat in section 5.

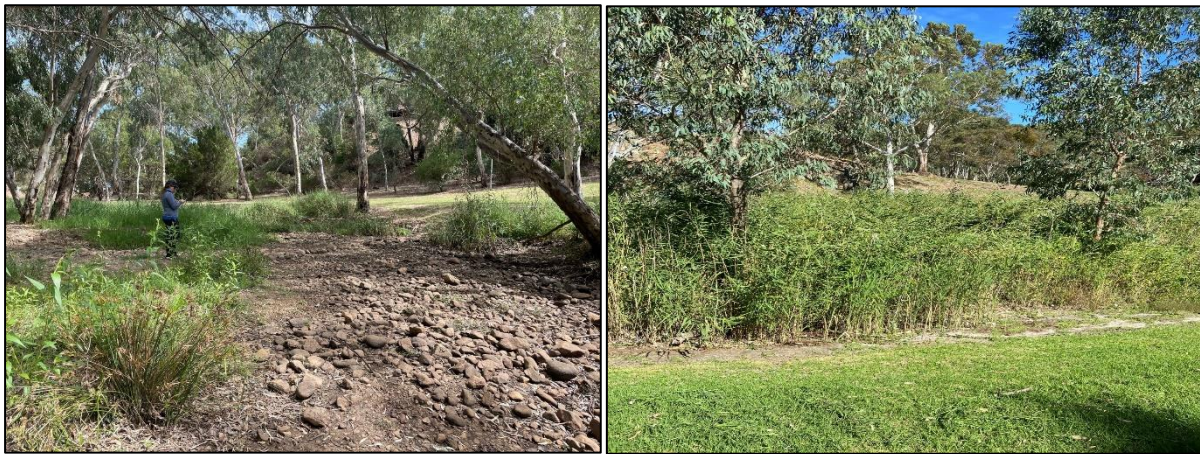
Large parts of **section 6** were considered unsuitable or seasonably unsuitable for platypus as the area consisted of dry riverbed and there were areas of dense *Typha* and *Phragmites* near the banks and within the river channel which would reduce the available foraging habitat for platypus. In addition, this section was also shallow in most sampled areas but did have a combination of riffle and pool habitat. Very limited bank tree roots were visible. Whiterod (2022) demonstrated that this section experienced long periods of cease to flow over recent years (e.g., 356 cease to flow days in 2019), further suggesting an unsuitability for platypus.

Figure 18. Representation of habitat in section 6.

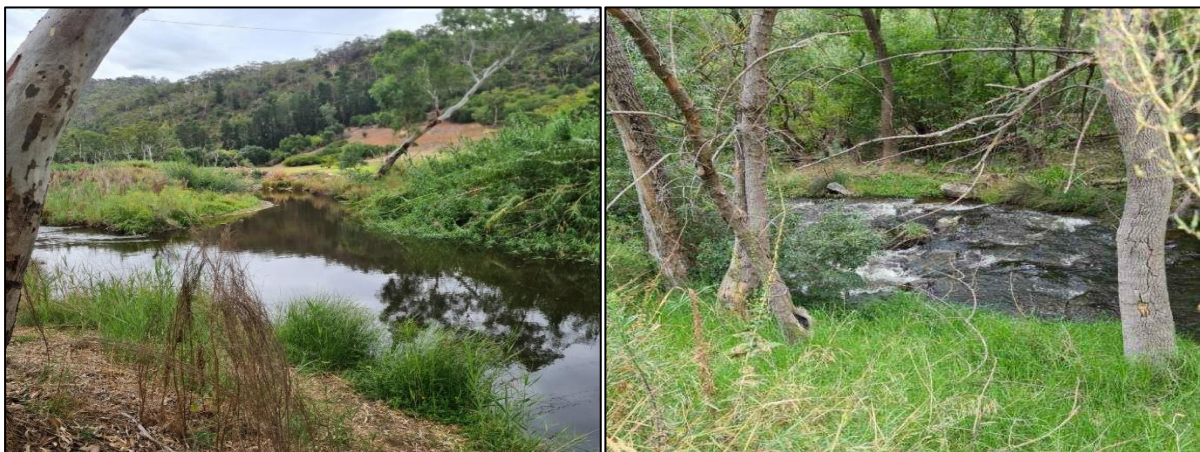
The River Torrens from downstream of Sixth Creek to the Gorge Weir (**section 7**) has a combination of habitat that may be suitable for platypus. Emergent vegetation, *Typha* and *Phragmites* is present in patches, however it does not encroach into and choke the river body. The presence of higher banks with *Eucalyptus* and tree bank roots and a more defined pool ripple pattern is apparent. However, there is presently no information on the flow regime (and extent of cease to flow periods) and how fluctuating flows from upstream in section 8 (see below) impact – further investigation of flow regimes is required.

Figure 19. Representation of habitat in section 7.

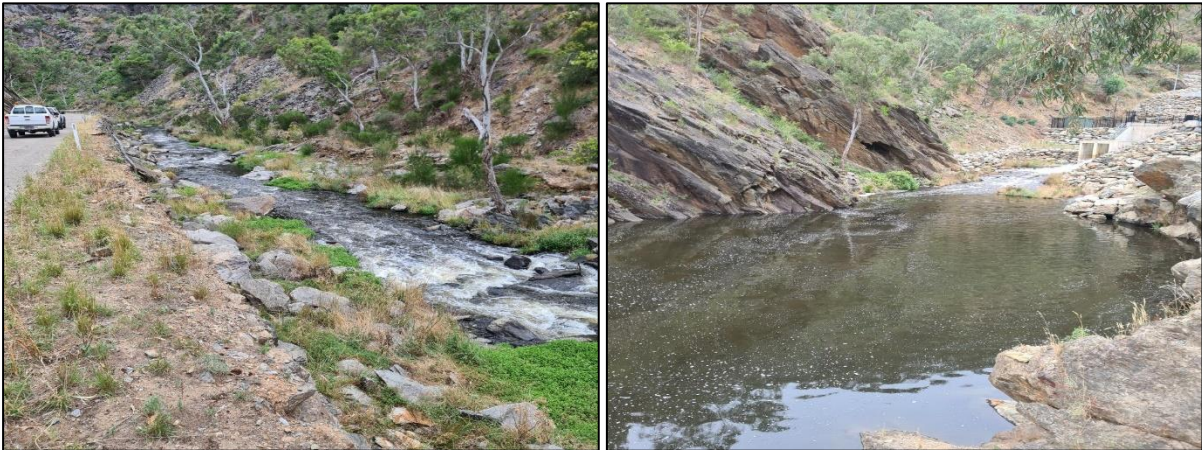
Although **section 8** showed promising results from a water quality, vegetation, bank height, predator access viewpoint, this section can vary in water depth greatly depending on rain and water releases from the Kangaroo Creek Reservoir. During dryer periods, this section can dry into a series of small pools and during high rain and flood periods water levels can rise by 20 m. This type of extreme flow would prevent platypus being able to have resting burrows in the bank below the water line during floods and would not provide enough water during dry times.

Figure 20. Representation of habitat in section 8.
