Moulting Lagoon Wetland Restoration Field Day – 31st May 2022

Bec Sheldon and Mark Bachmann, Nature Glenelg Trust (NGT)

Site 1. Yards Hole Outlet Restoration

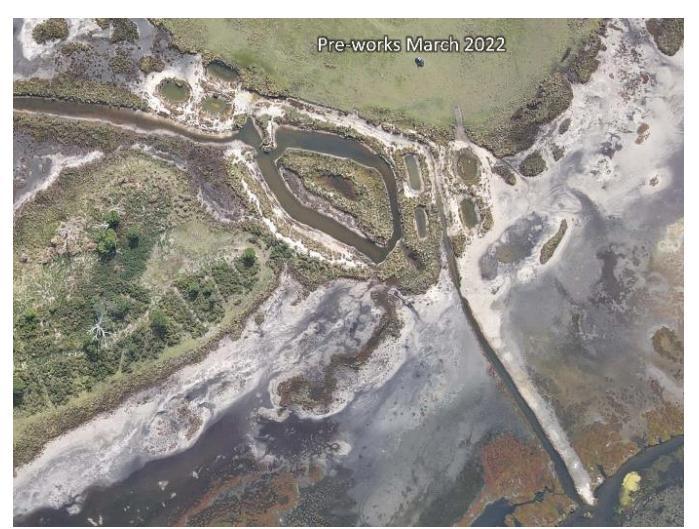
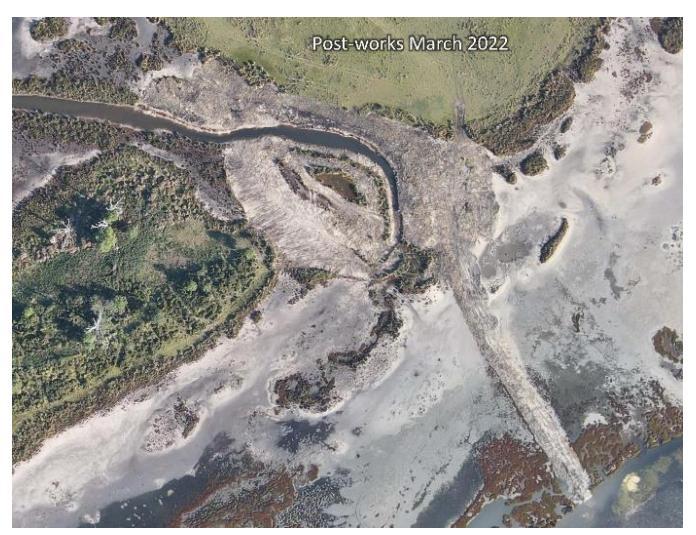
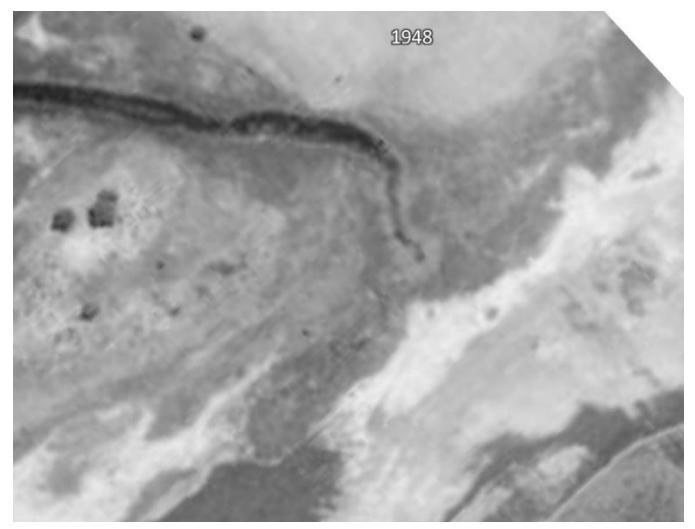
The natural outlet from Yards Hole to Moulting Lagoon and surrounding area was significantly modified in the 1990s during the development phase of the unrealised aquaculture project. As shown below, restoration works were undertaken at this site in March 2022. The aerial image from 1948 was used as a template for restoration which aimed to restore the natural geomorphology and therefore hydrology of the site.

RIGHT: The modified Yards Hole outlet, showing pre and post works in March 2022, and restoration template from 1948 aerial image.

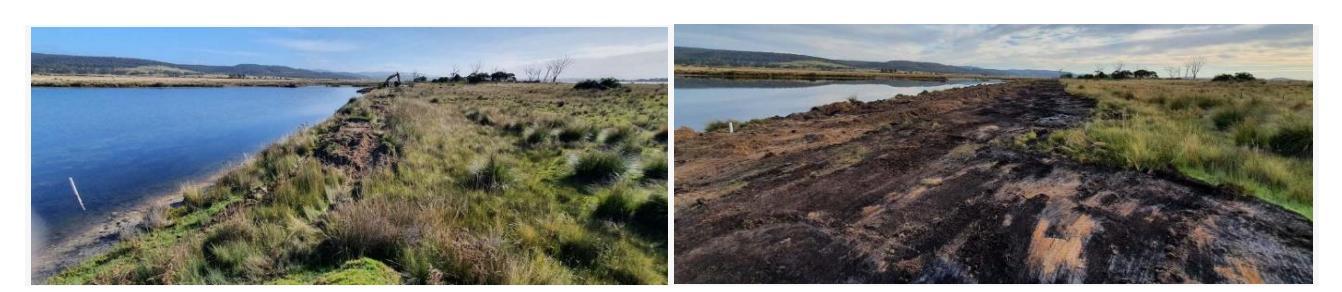
The historic aquaculture works resulted in the entire perimeter of Yards Hole being modified with the construction of a deep channel which, in turn, left a steep artificial bank and a large spoil heap the whole way around the margin.

Bulk earthworks created this major change in the 1990s and were now also required to reverse that impact. The works redistributed the large spoil bank back into its former location within the drain around the wetland edge, a zone where this material will slowly compact and settle to form a reinstated bank with a gentler slope. This will provide fresh opportunities for fringing saltmarsh and sedgeland vegetation to re-establish.

The dark colour of the original surface level which has been re-exposed through the removal of the spoil heap provided a clear visual guide for the contractors to determine the natural contours and elevation of the surface during works.

Modified perimeter of Yards Hole showing the eastern bank before (left) and after (right) remediation.

Whilst we were unable to manually compact the remediated margin of redistributed spoil material effectively this year due to the water level, we expect this bank zone to naturally settle and compact over time in response to rain and inundation events. We will re-evaluate the progress of this process and change in condition ahead of continued works next year.

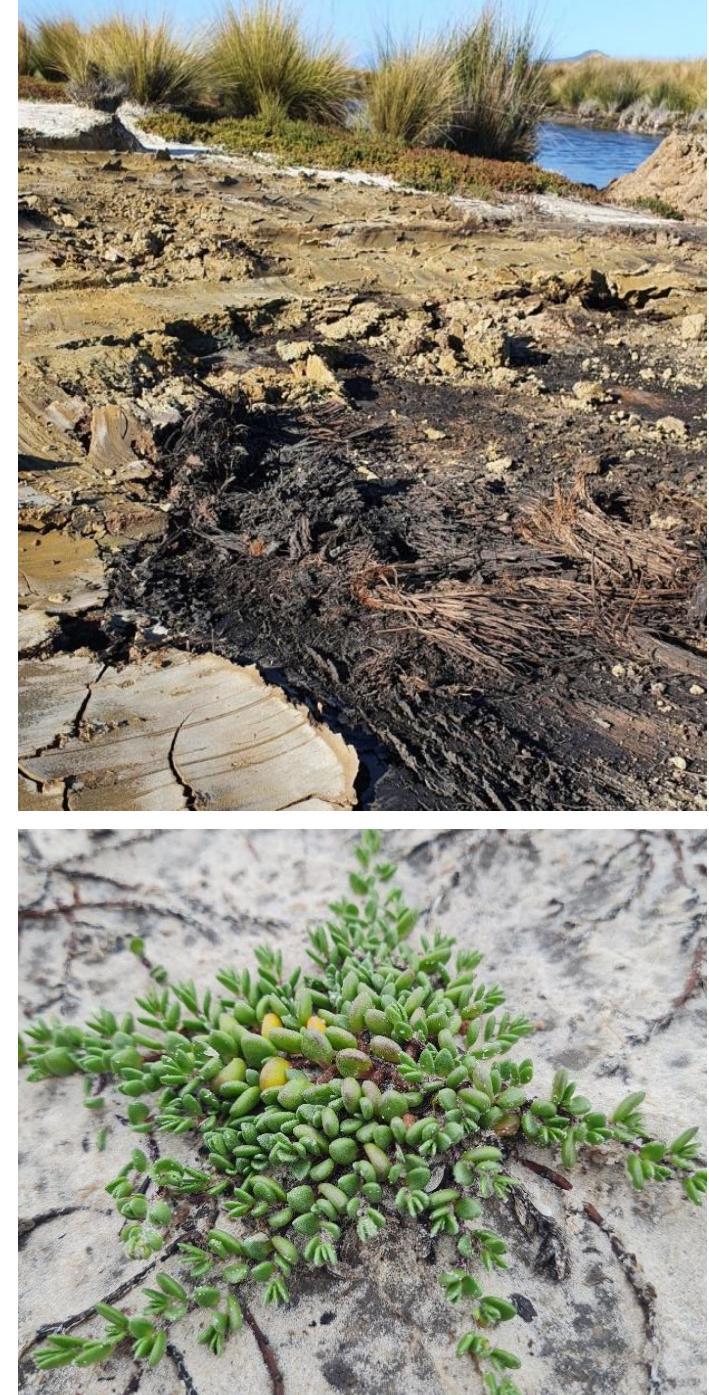
As shown right, a close inspection of this layer, because it was suddenly buried 30 years ago, shows evidence of the compacted plants and roots of the former surface (in this case *Gahnia filum*), as well as the sudden change in texture and colour caused by the deeper soil and sediment, excavated from nearby, being deposited on top at the time of those works.

RIGHT: Evidence of Gahnia filum compressed beneath spoil at the level of the former surface

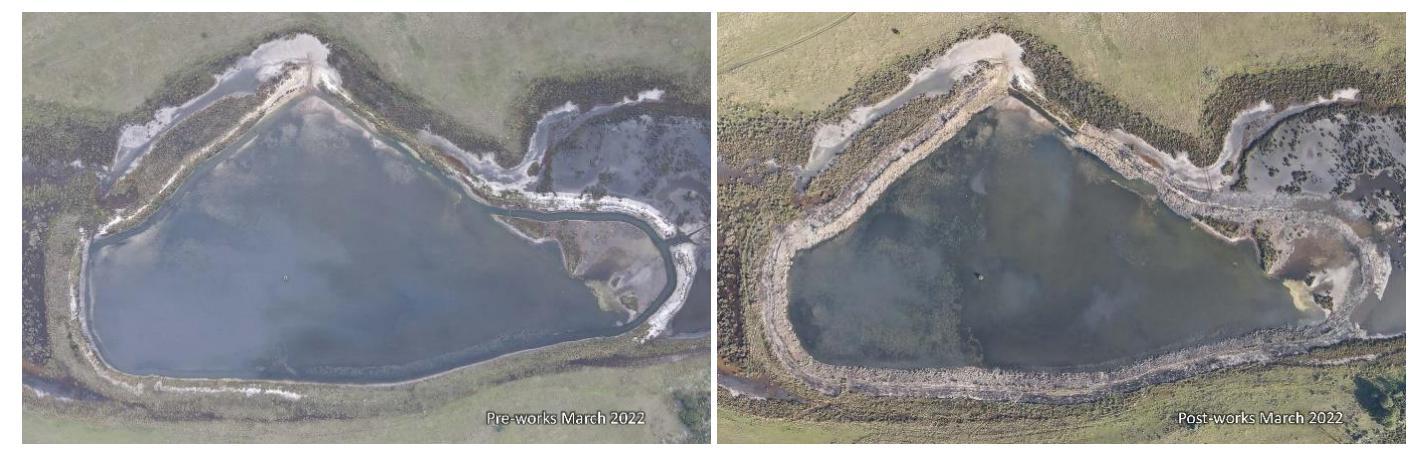
There is also a small section of bank on the northern margin of Yards Hole that was not remediated this year, to give us time to more closely assess a rare species of saltmarsh growing in that area, *Wilsonia rotundifolia*, before determining the best approach for continuing works in this area next year (i.e. once we have an agreed plan in place with our project partners).

Completed restoration works around the margins of Yards Hole (pre and post works). See 50m section of northern bank still intact due to the interim protection of a rare saltmarsh species, which germinated and now grows on the excavated sediment in this section of spoil.

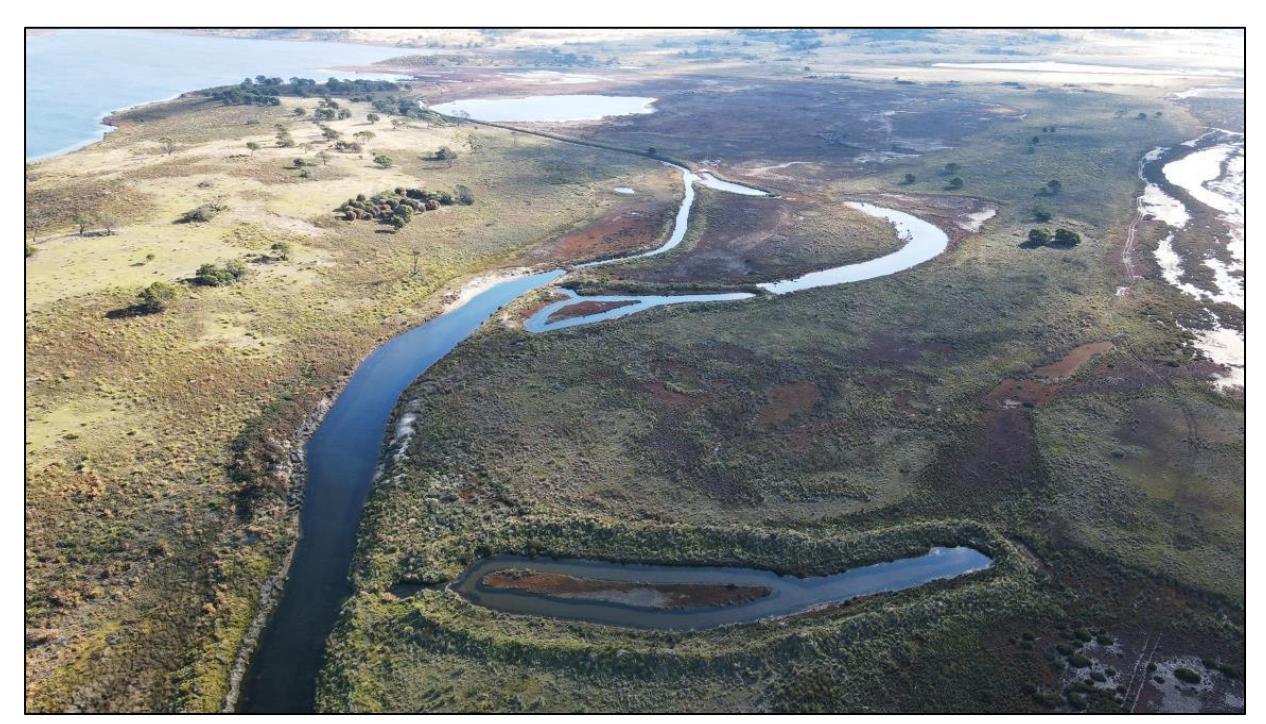
This channel has extended and deepened a natural drainage feature and several other smaller features have been connected to it as part of aquaculture works. The water regime of all of these features has now been artificially altered. It is likely that the channel is also intercepting shallow groundwater flow or seepage from the higher Barkstand Point onto the lower saltmarsh areas.

The water regime of Opening Hole may now align more closely with the tidal regime within the greater Moulting Lagoon than previously. Preliminary hydrological analysis also suggests that this wetland is now regulated at 0.4 m AHD until it dries internally from seepage and/or evaporation.

Overview of the Barkstand channel, associated drainage areas and Opening Hole in the background.

Bulk earthworks, similar to those undertaken at Yards Hole, will be undertaken at this site early in 2023 and will aim to restore the channel and associated drainage areas to their original condition. The 1948 aerial image will guide on-ground works and be used as a remediation template. Remediation of this site will involve disconnecting the channel from Moulting Lagoon and remediating the adjacent saltmarsh surface.

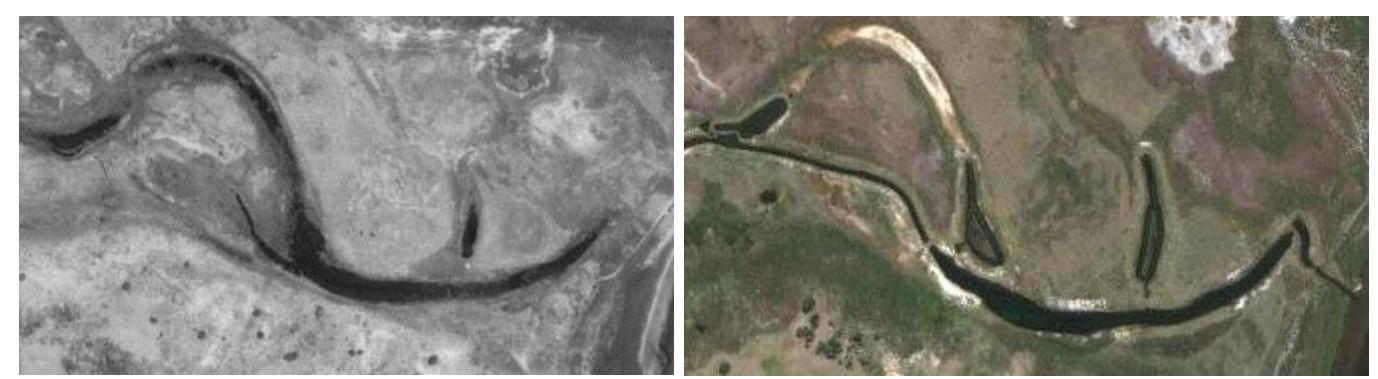
Barkstand channel, 1948 image prior to aquaculture works, and present day.

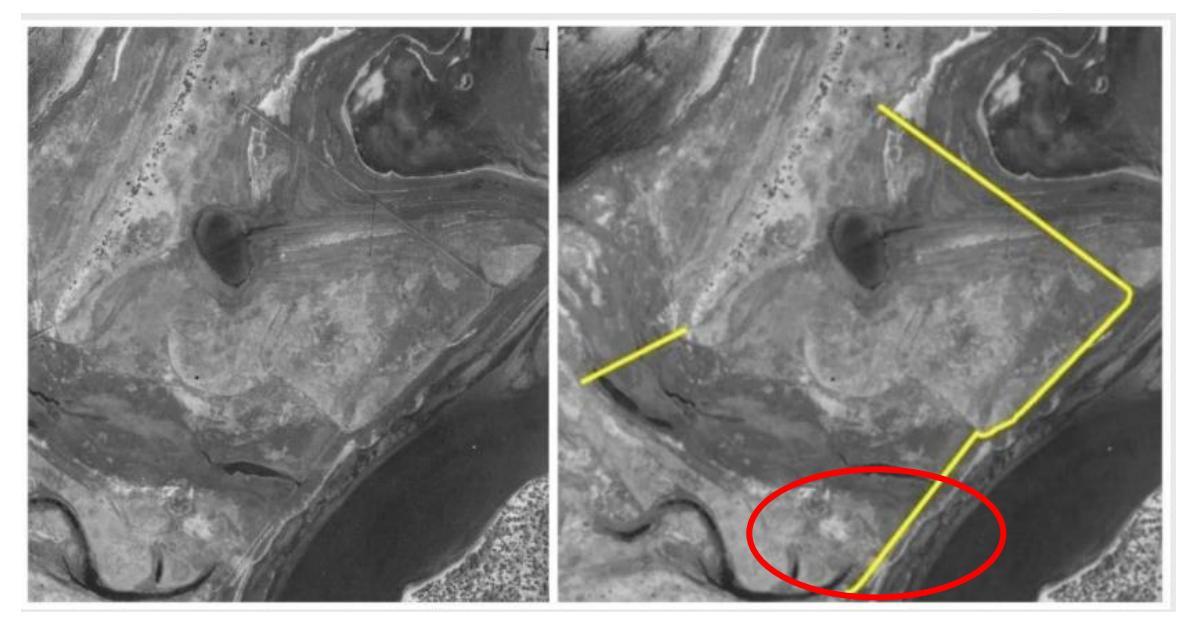
The main L-shaped levee and adjacent drain have not only compromised the saltmarsh habitat along its length by creating a disturbance footprint with an altered elevation profile, but the levee system appears to be having an ongoing impact on contemporary hydrology and saltmarsh condition, including flood flows, attenuation and natural drainage across the saltmarsh.

There is evidence that the levees are impeding the movement of water (northern levee) and altering the mixing of fresh and saline water (eastern levee) across the eastern area of Long Point, despite them being breached in many places. This is due to the substantial impact that any barriers to flow can have in tidal saltmarsh communities, where the extremely flat terrain, combined with the lowenergy and temporary nature of tides prevents the efficient equalisation of water levels either side of such barriers, even if they are breached in some locations.

Due to wet conditions experienced in summer/autumn 2022, restoration works have so far only been completed at the southern end of the eastern levee, south of the floodway.

Convict-era levee banks constructed at Long Point, shown (left) and marked up (right) in the earliest aerial imagery from 1948. Area of restoration works able to be achieved at Long Point in March 2022 shown in red.

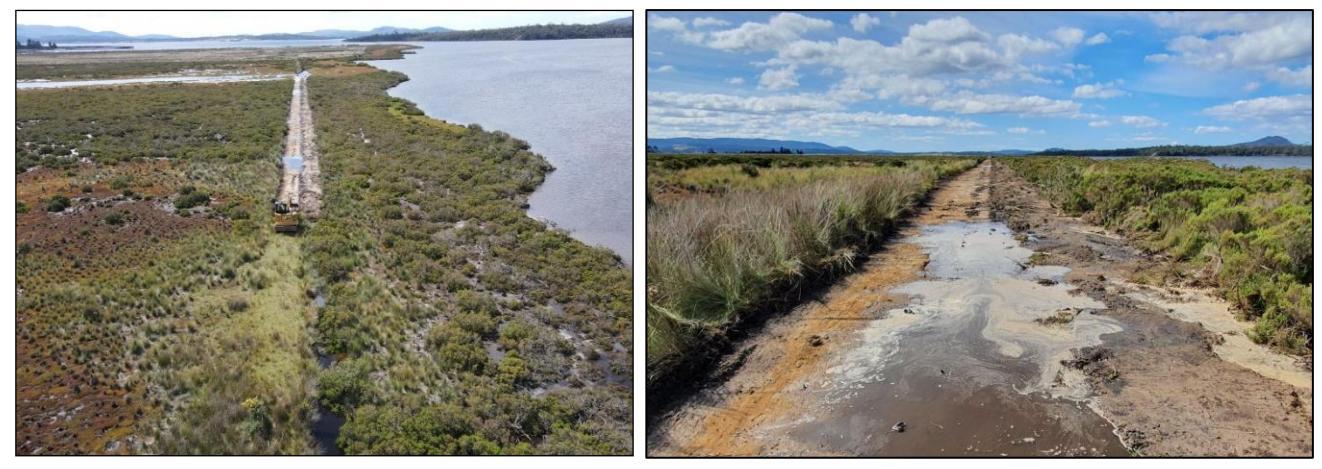
The work required along this levee bank is more sensitive in nature than the bulk earthworks at Yards Hole and was undertaken with a much smaller and lighter excavator, with rubber tracks, to minimise the degree of disturbance associated with the remediation works footprint. Note the present-day disturbance, as part of the remediation process, is limited to the narrow, original disturbance footprint.

Sensitive levee bank remediation in progress, left, and completed, right, March 2022.

The existing levee bank was used to infill the associated drains and the topography of the typically flat natural (undisturbed) ground either side of the levee was used as an accurate visual guide for works (see right).

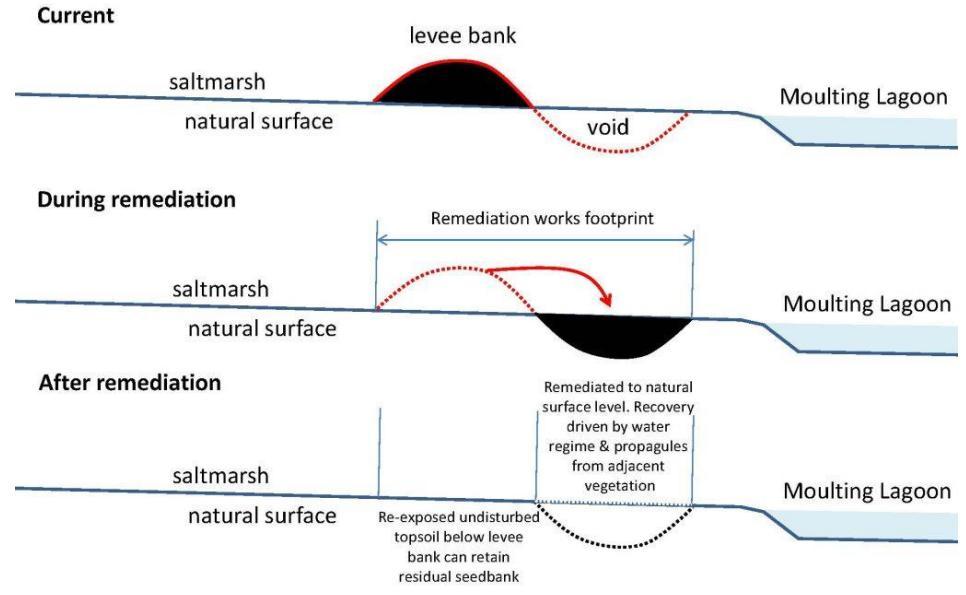
Once complete in 2023, approximately 5 ha of levee and/or drainage footprints will be directly restored and another 80 ha of indirectly affected land rehabilitated.

RIGHT: Long Point drainage/levee footprints. Hatched area represents an additional 80 ha zone which is set to benefit from restoration works.

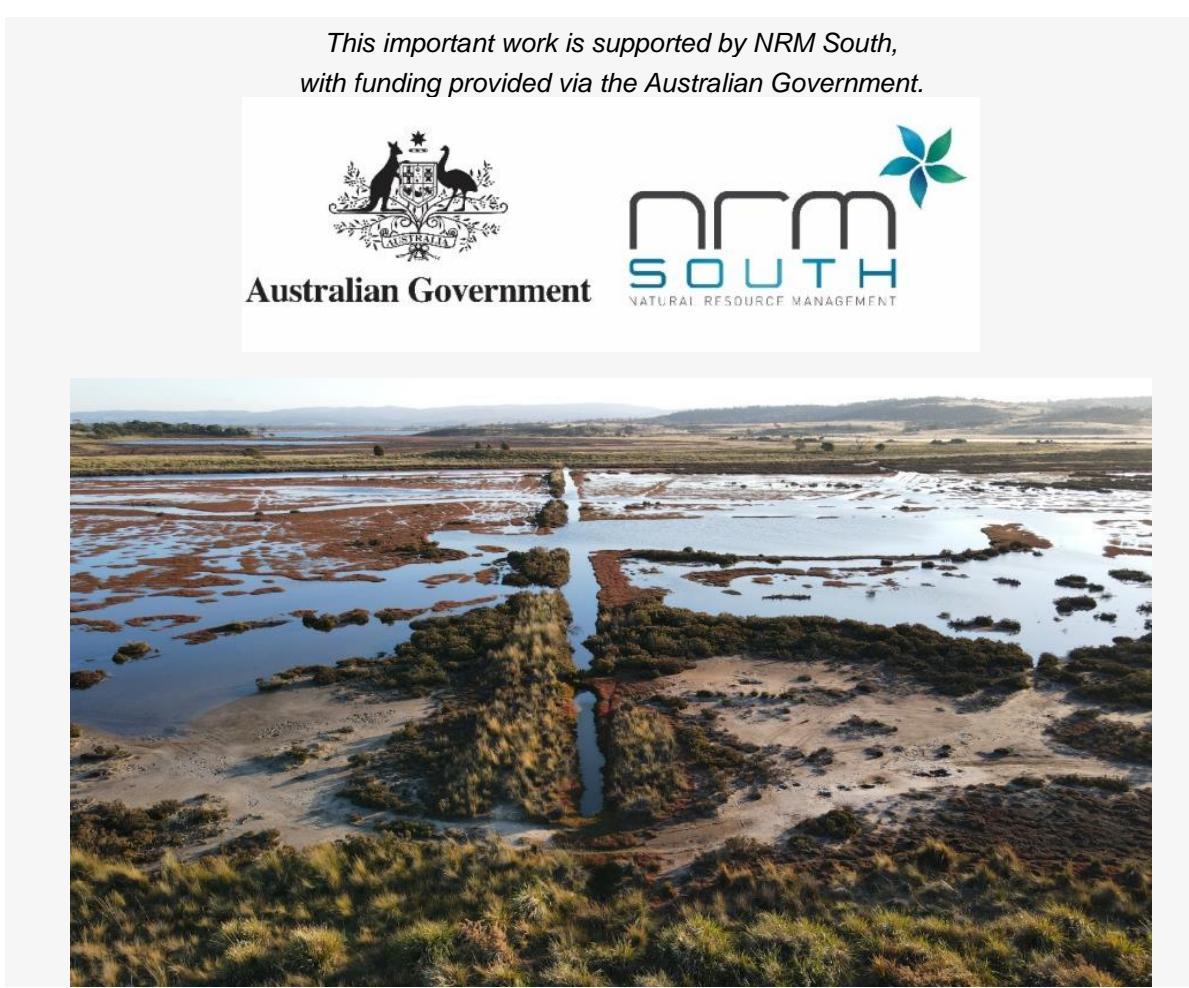
The shorter, breached western levee, Long Point.

- Continuing to address the main L-shaped eastern levee.
- Tackling the short, minor western levee
- Bulk earth works at Barkstand channel and associated wetland areas.
