Eastern springs: April 2022 works summary

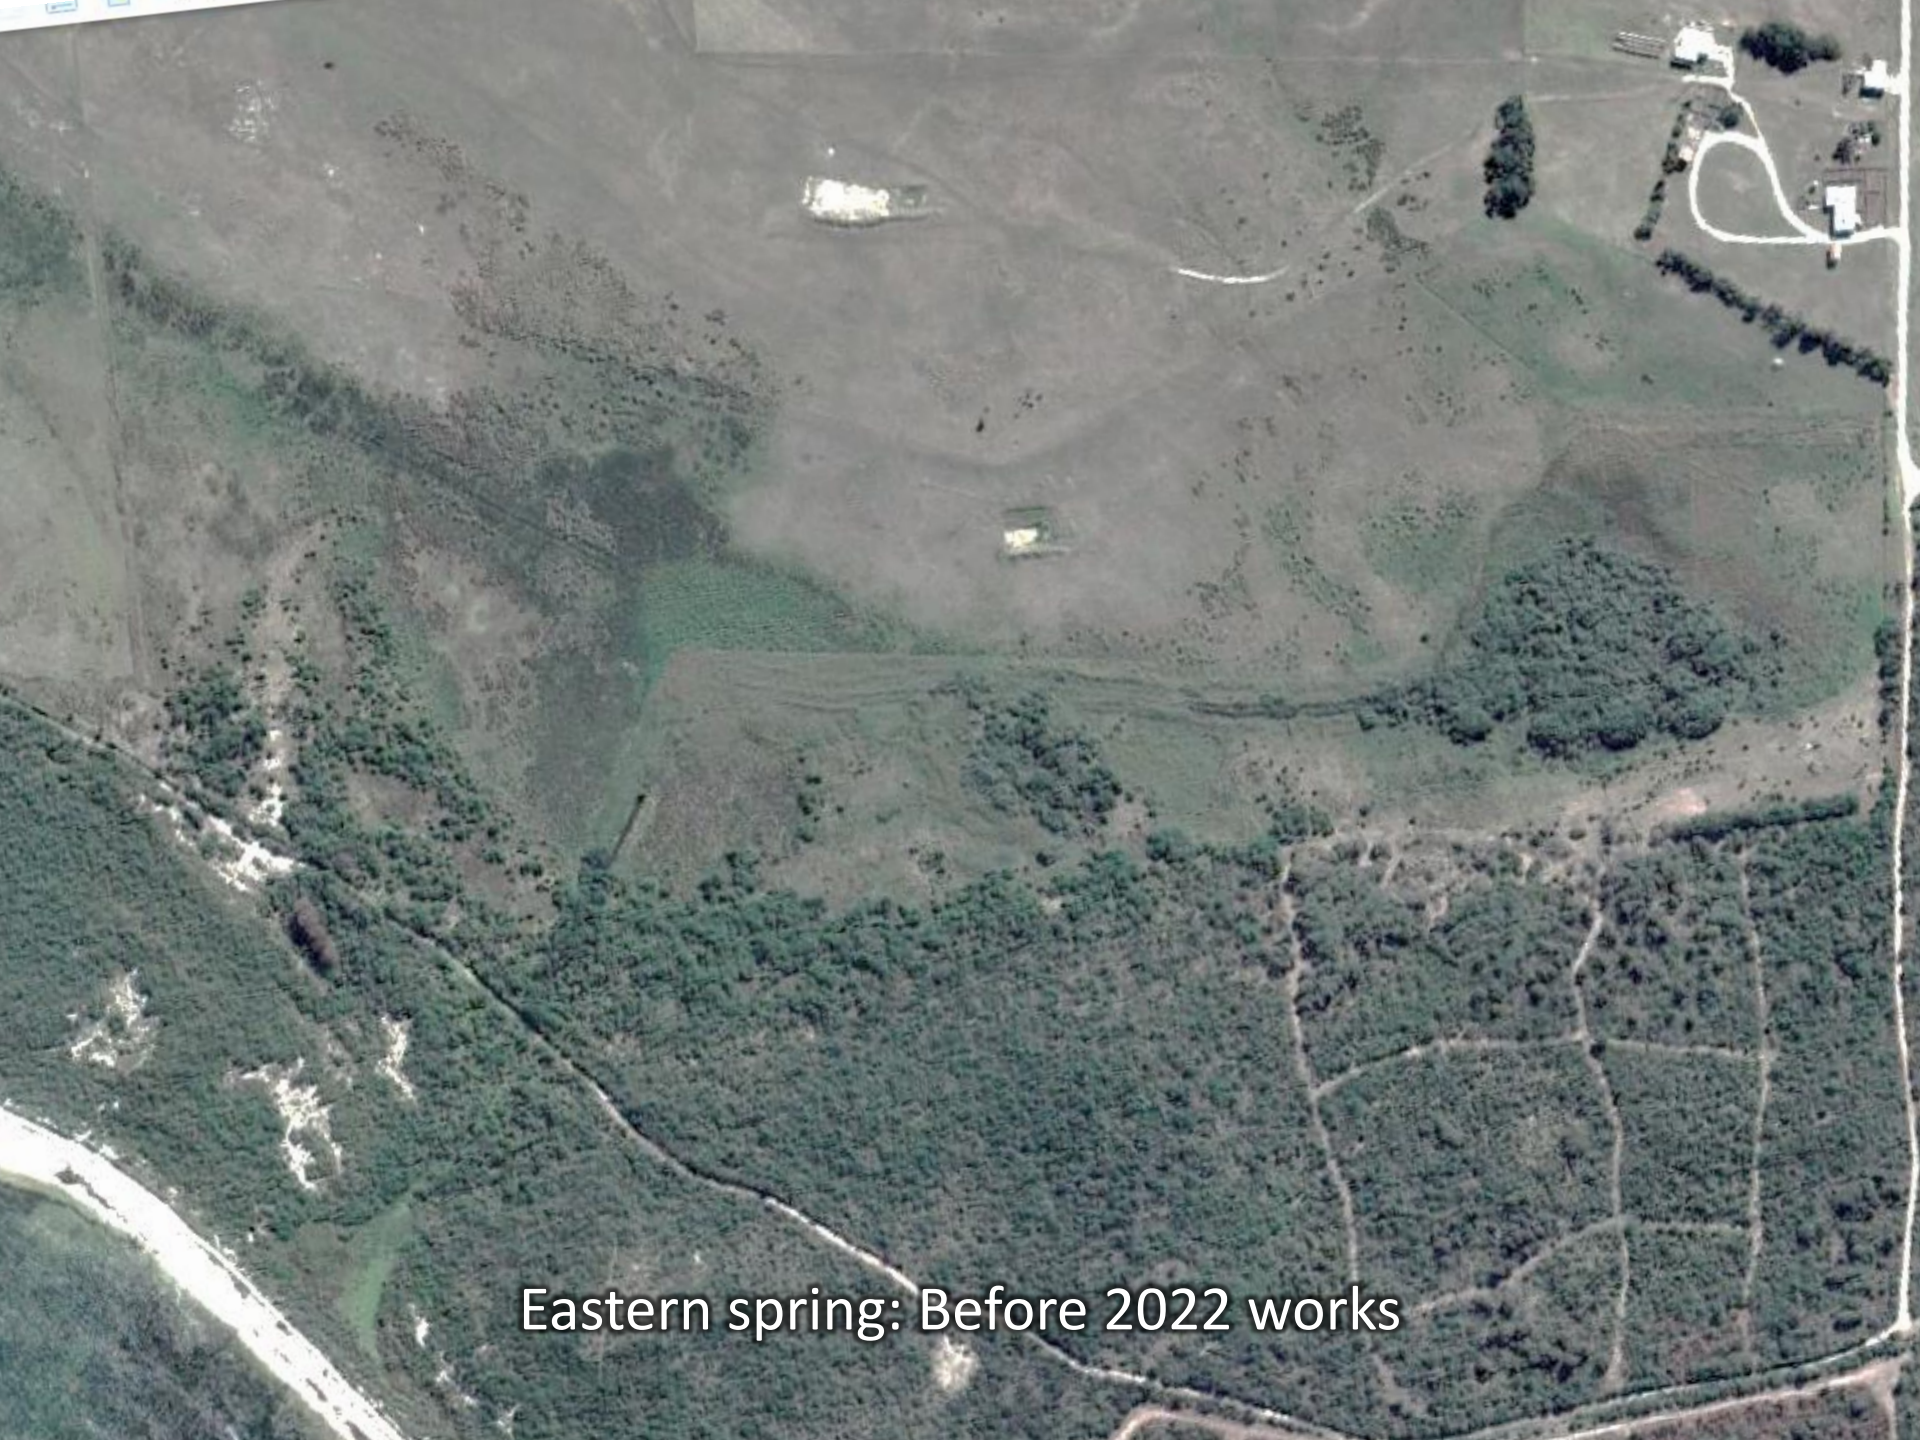
Eastern spring: Before 2022 works

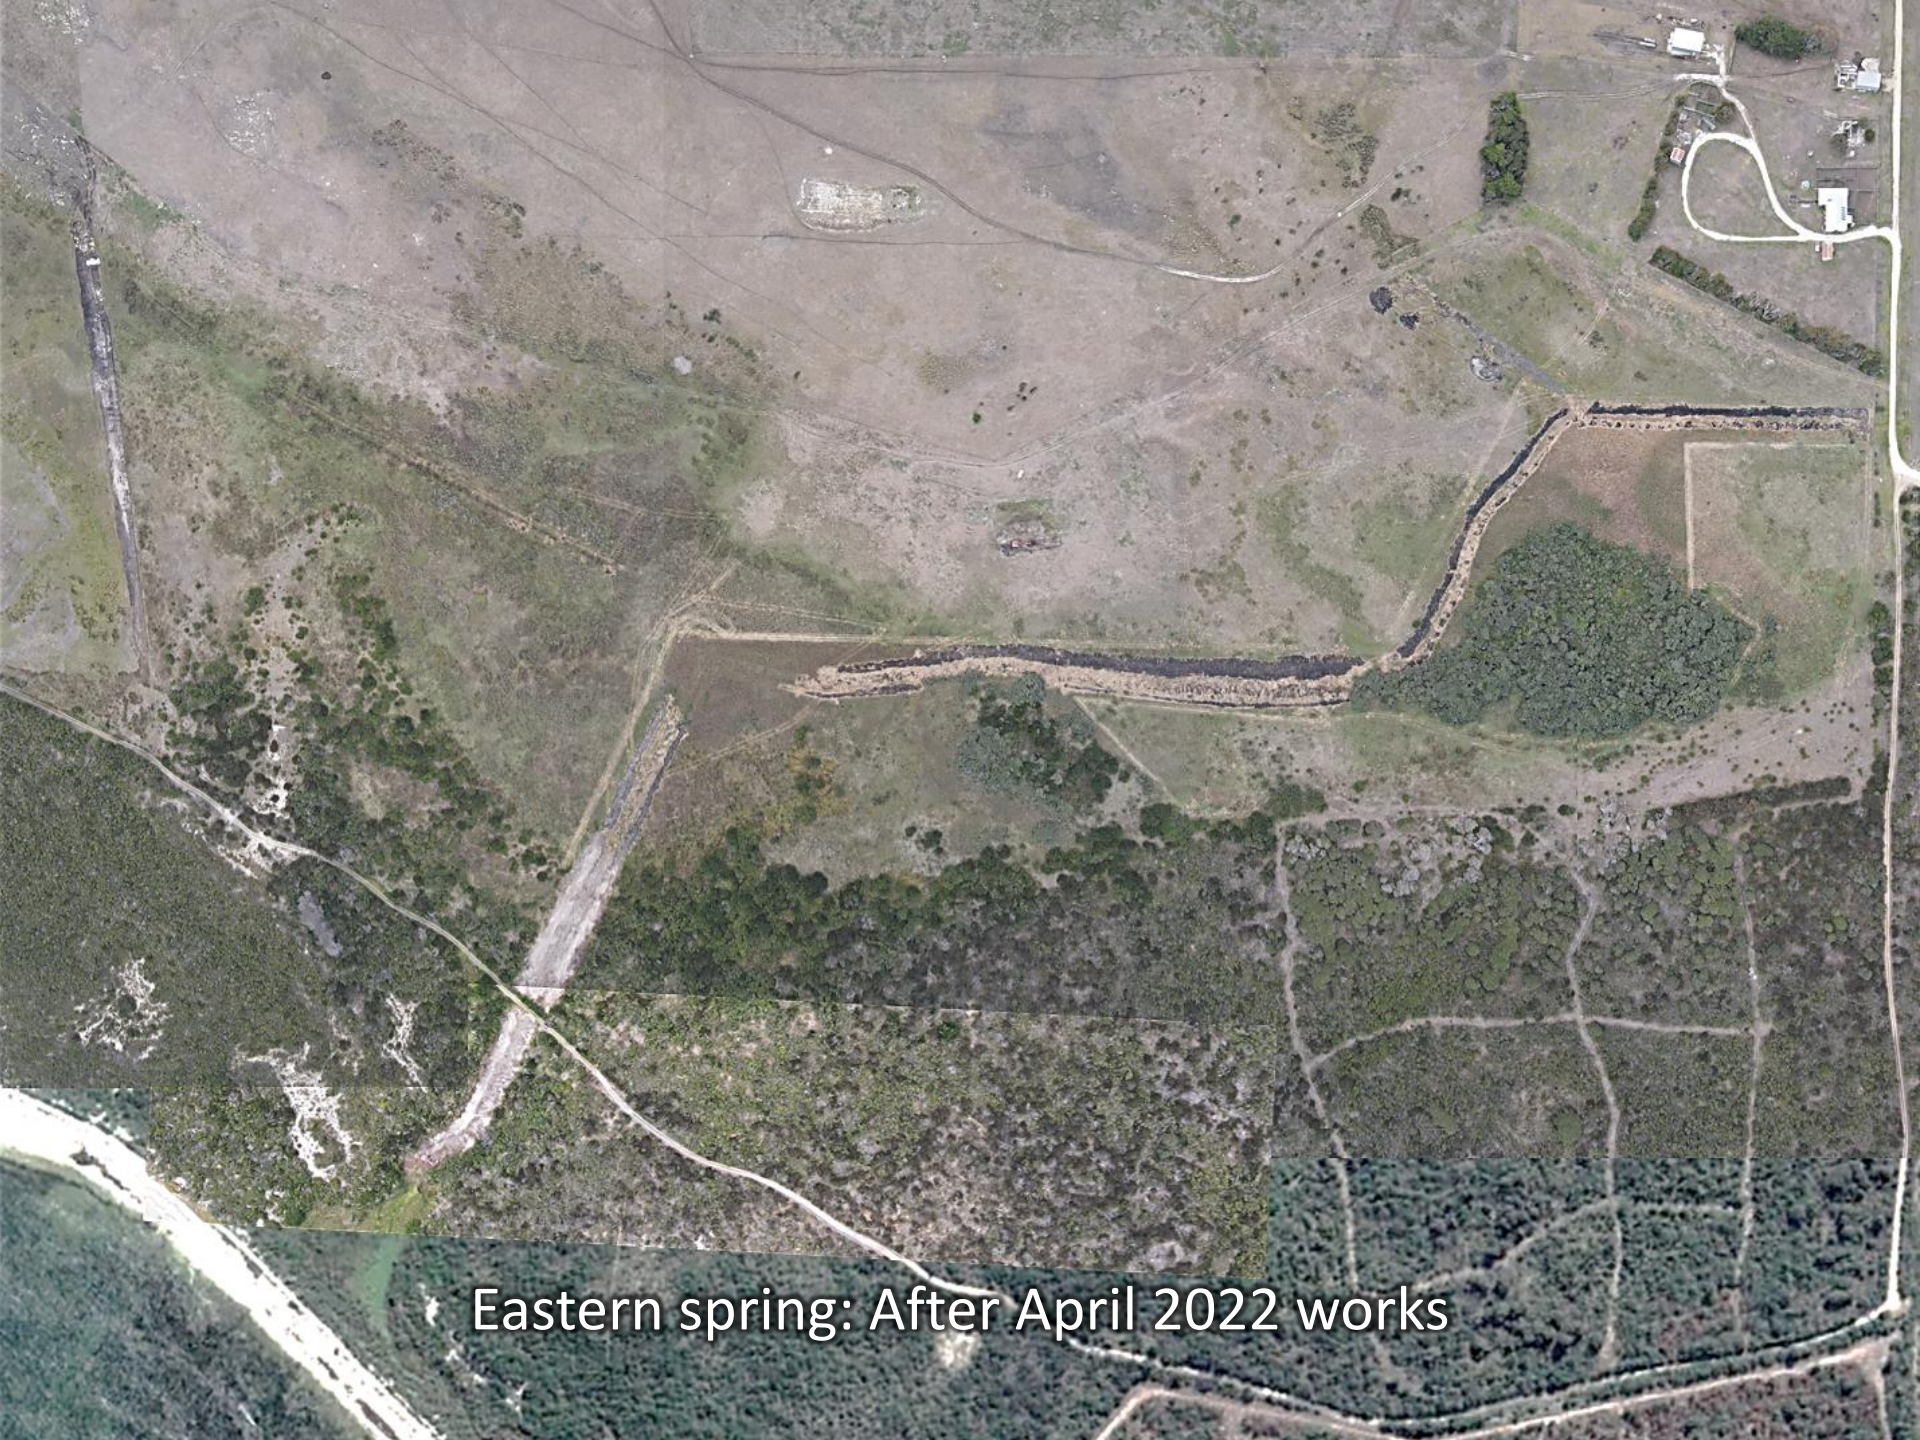
Eastern spring: After April 2022 works

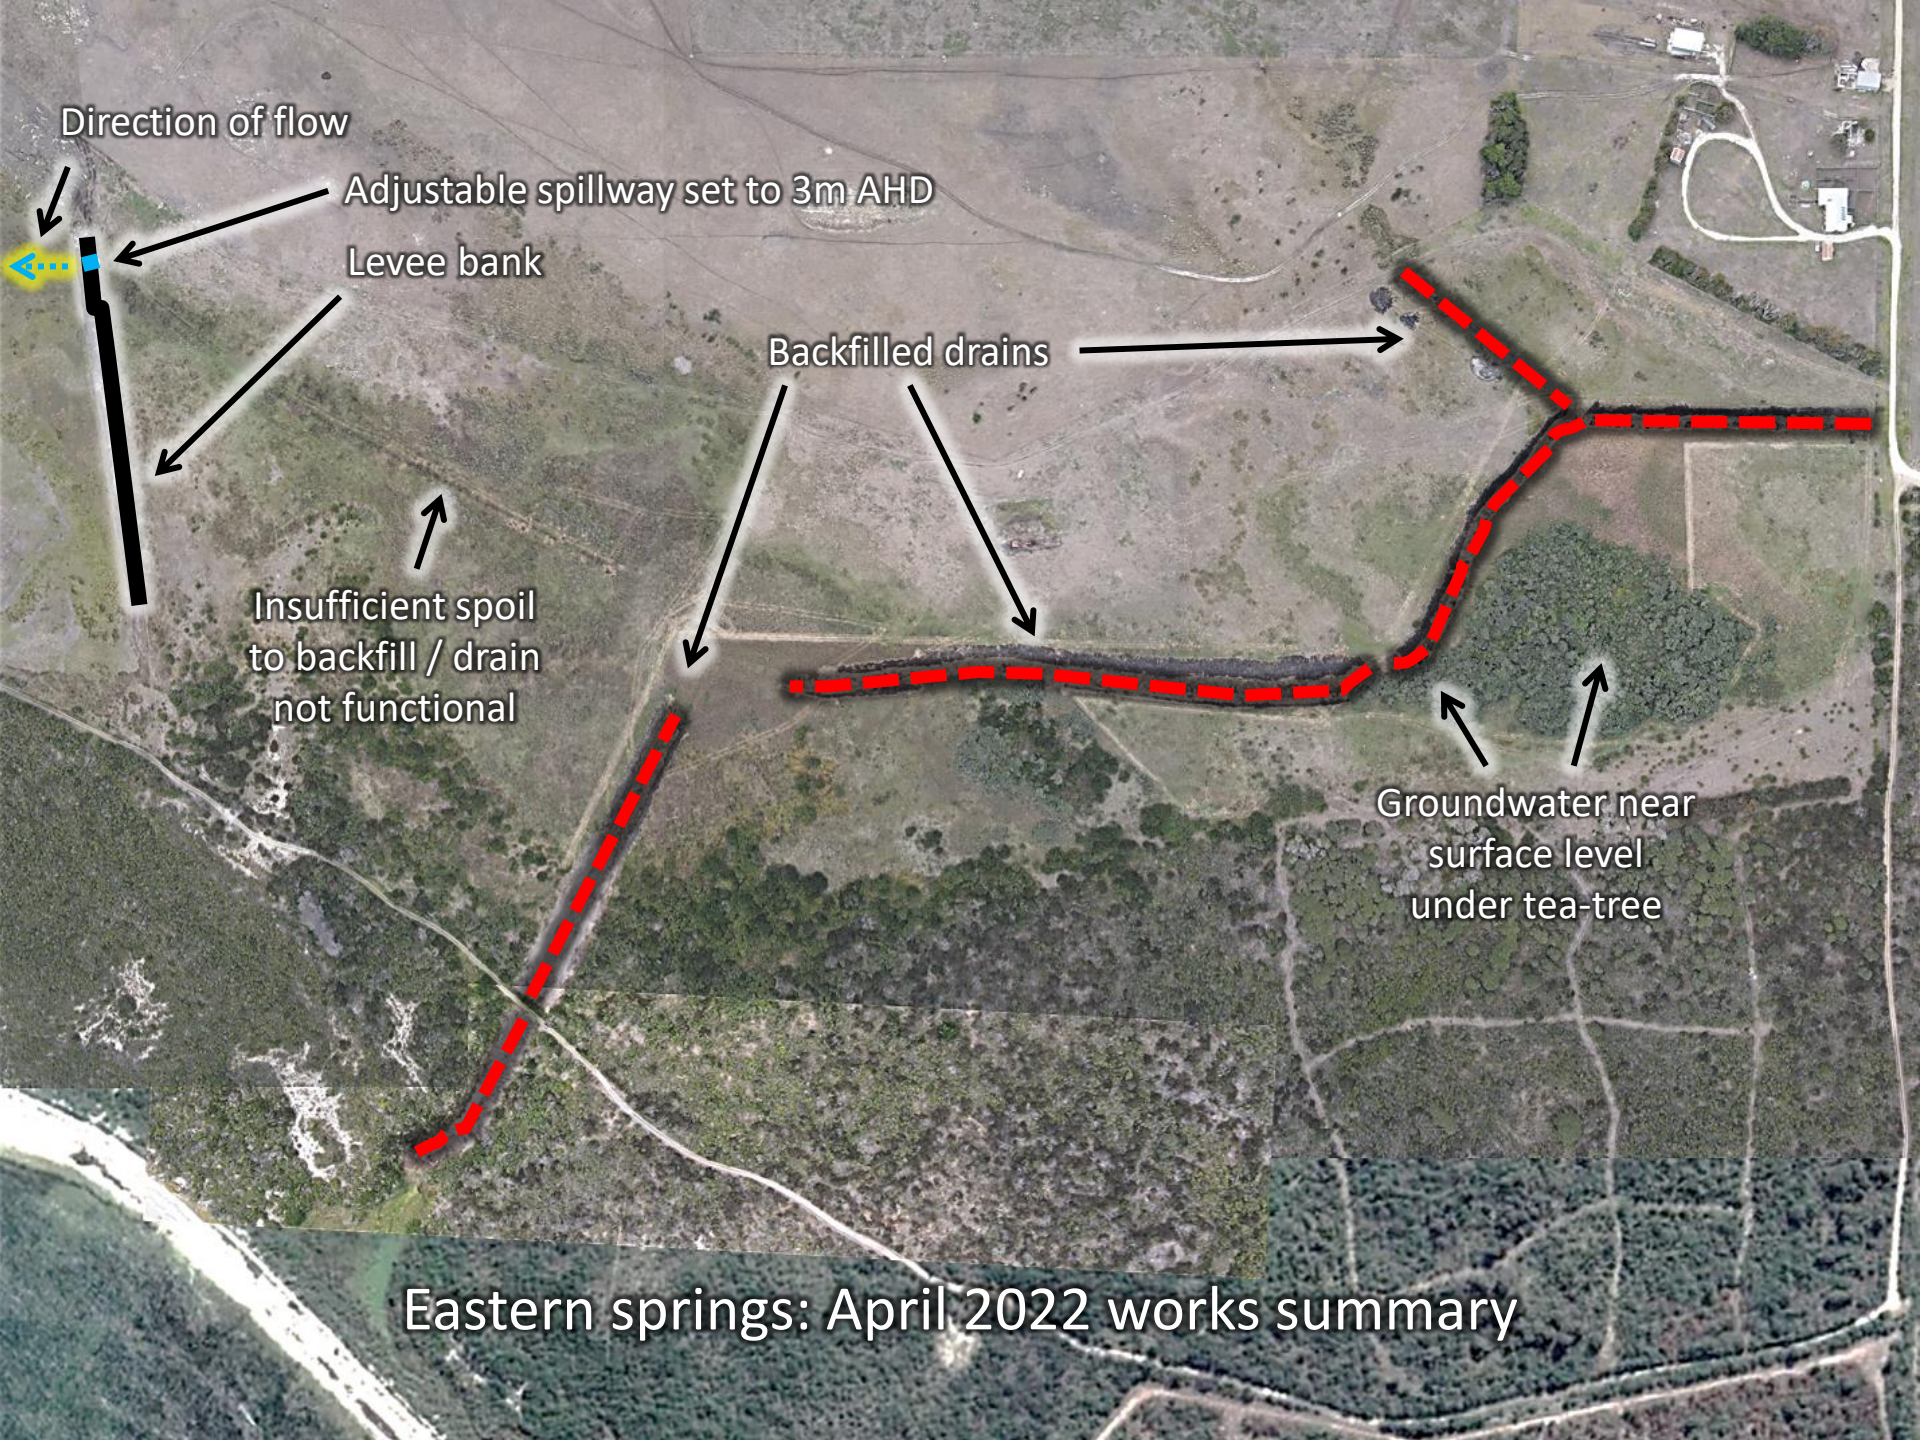
Direction of flow

Adjustable spillway set to 3m AHD

Levee bank

Backfilled drains

Insufficient spoil to backfill / drain not functional

Groundwater near surface level under tea-tree
